**Freightliner  
Service Bulletin**

# Adjusting Tilt Lock Force on TRW Steering Columns

# 46-41

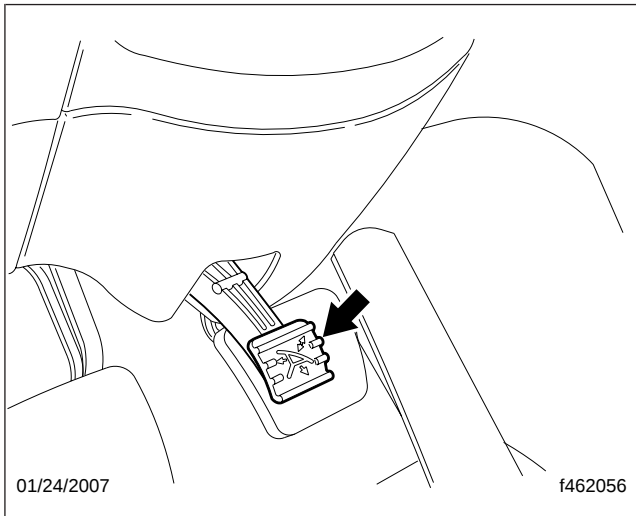
**Fig. 1, Foot Pedal on TRW Adjustable Steering Columns.**

Some TRW tilt/telescope steering columns may not have the correct tilt lock force if the column does not hold firmly in place after a tilt adjustment. The castle nut can be tightened to provide the correct force.

NOTE: TRW steering columns can be differentiated from other columns by their tilt-adjust foot pedal. See [Fig. 1](#).
