AirLiner™ Suspension Air-Spring Bag Misalignment Troubleshooting

32-40

**Freightliner
Service Bulletin**

Description of Revisions: *This bulletin replaces the version dated May 2010. The part numbers in [Table 2](#) have been revised.*

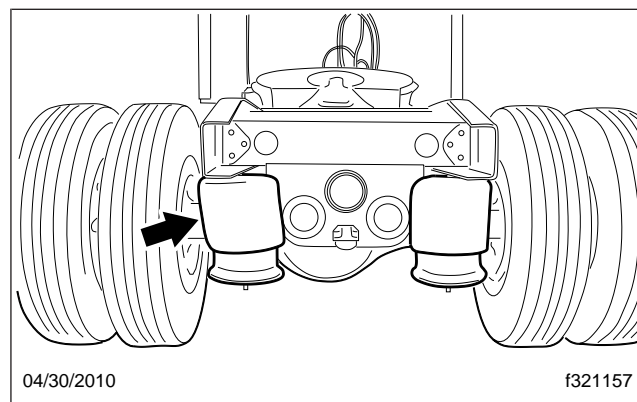
Fig. 1, Rear of Vehicle with Misaligned Air Bags

The most common air-spring bag alignment complaints are a leaning or tilted air-spring bag or different air-spring bag heights between left and right sides. See [Fig. 1](#).

The critical leaf spring dimensions that directly affect these complaints are:

- kick-twist angle
- air-spring mounting hole location
- rear-end camber

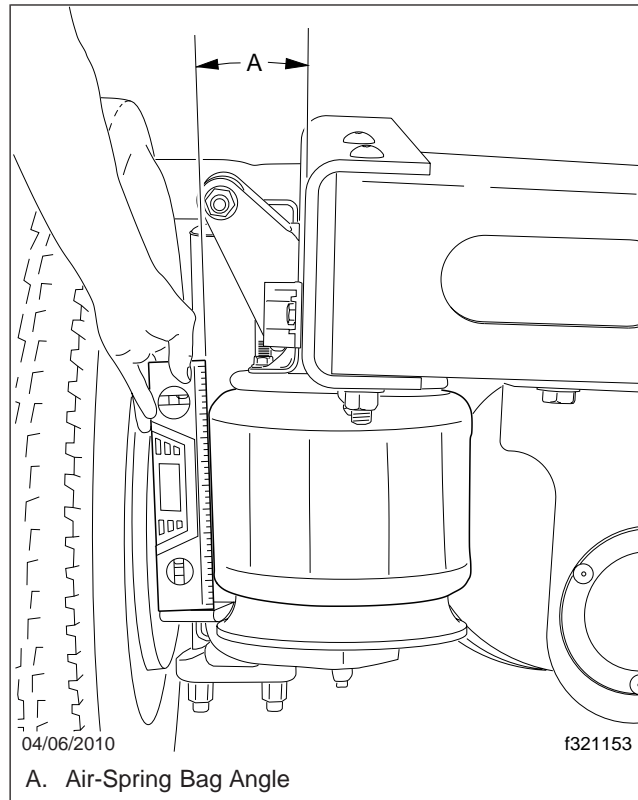
Fig. 2, Checking the Air-Spring Bag Angle

- 2.2 Place the level tool vertically against the outside of the air-spring bag as shown in [Fig. 2](#). If the angle is less than 6.0 degrees the air-spring bag angle is within specifications and no further action is required. If the angle is more than 6.0 degrees from vertical, proceed to the next step.

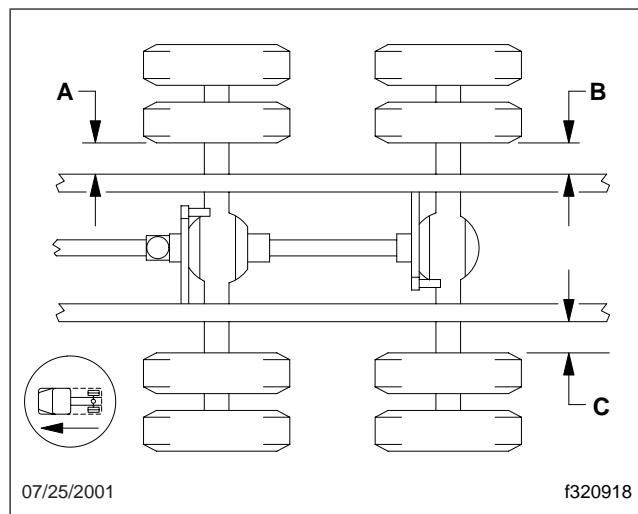
Fig. 5, Axle Tracking Measurements

6. Check the rear axle(s) tracking. See [Fig. 5](#).
 - 6.1 Measure from the inner side of the rear tire, to the outer side of the frame rail, at the right side of the forward-rear drive axle.
 - 6.2 Measure the same distance at both sides of the rearmost drive axle.

Dimensions "B" and "C" must not vary from dimension "A" by more than 1/4 inch (6 mm).

- 6.3 If dimensions "B" and "C" vary from dimension "A" by more than 1/4 inch (6 mm), loosen the lateral torque rods at the frame rail and add or subtract shims as necessary, following the instructions in the section titled Freightliner Airliner Rear Suspension, in **Group 32**, of the applicable workshop/service manual.
7. Check that the axle clamps are correctly aligned on the axle housing and not shifted inboard or outboard. See **Fig. 6**. The distance from the brake spider flange to the outside surface of the leaf spring should be 4-7/8 to 5-1/4 inches (124 to 133 mm). The upper axle clamps should align with the dowels on the top surface of the axle housing.
- If the axle clamps are not correctly aligned, raise the vehicle and support the frame rails with safety stands. With the axle supported, loosen the U-bolts then install the axle clamps correctly.

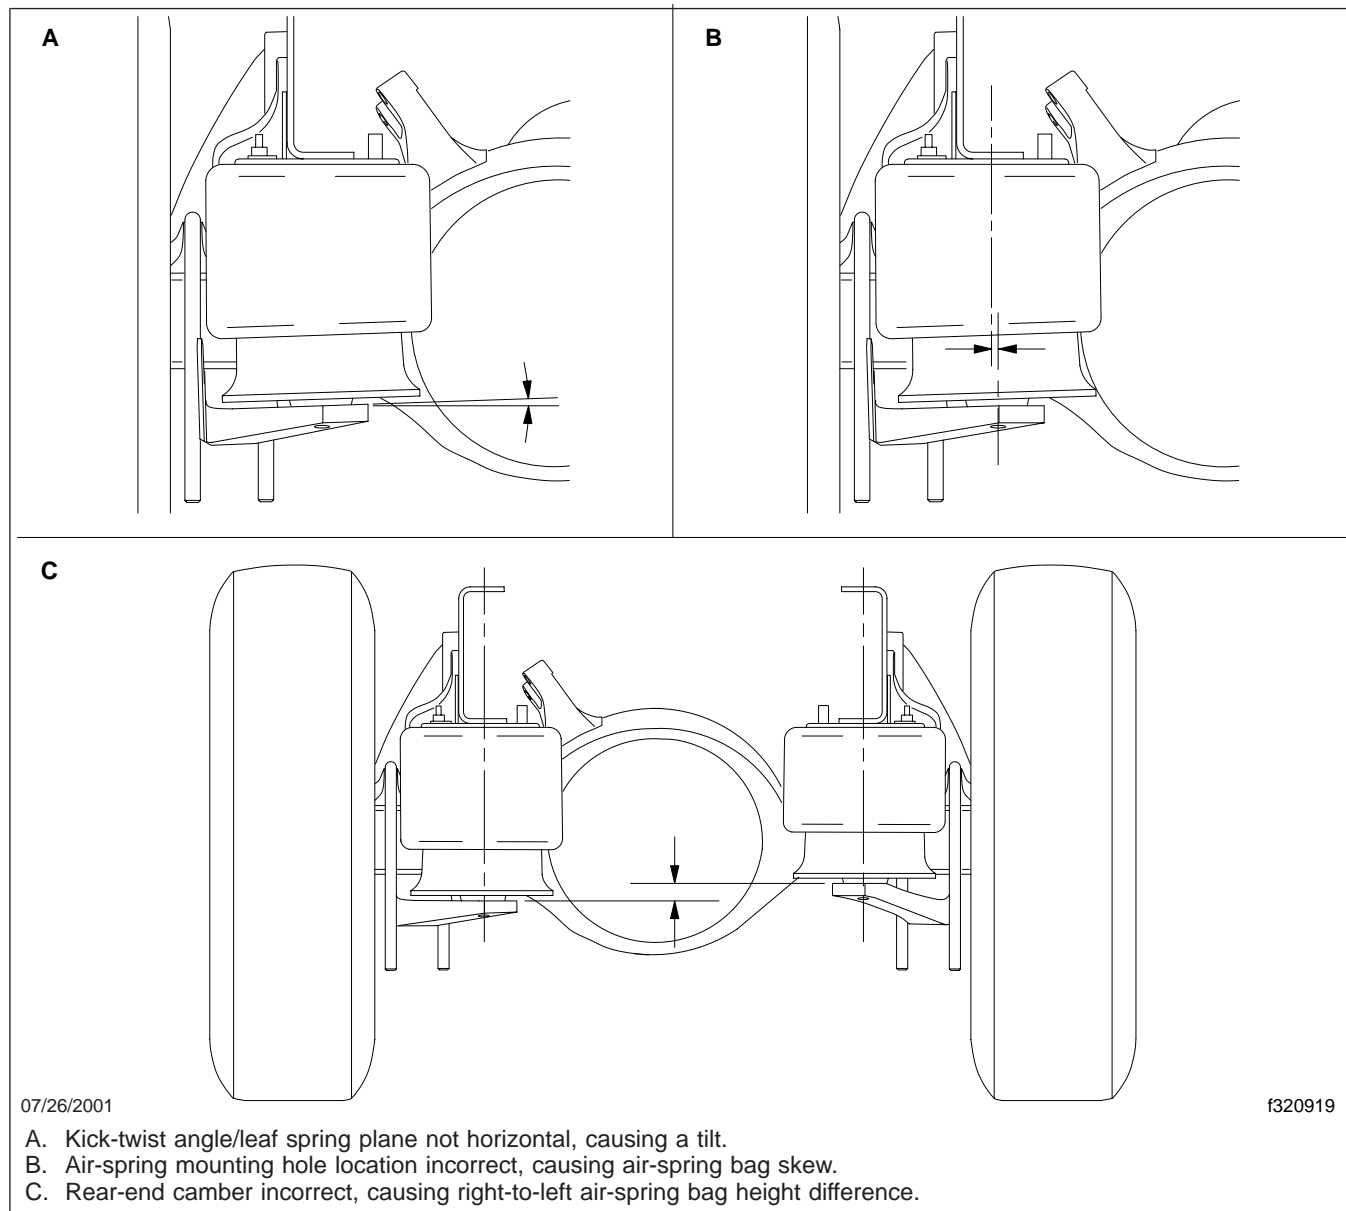
Fig. 7, Most Common Airbag Misalignment Complaints

- Confirm that the leveling valve(s) is (are) plumbed correctly. Use PartsPro® module 910, EZWiring to view the plumbing schematic.
- If the air-spring bag still appears to be out of alignment after completing the steps in "General Troubleshooting," determine the nature of the misalignment. See [Fig. 7](#).

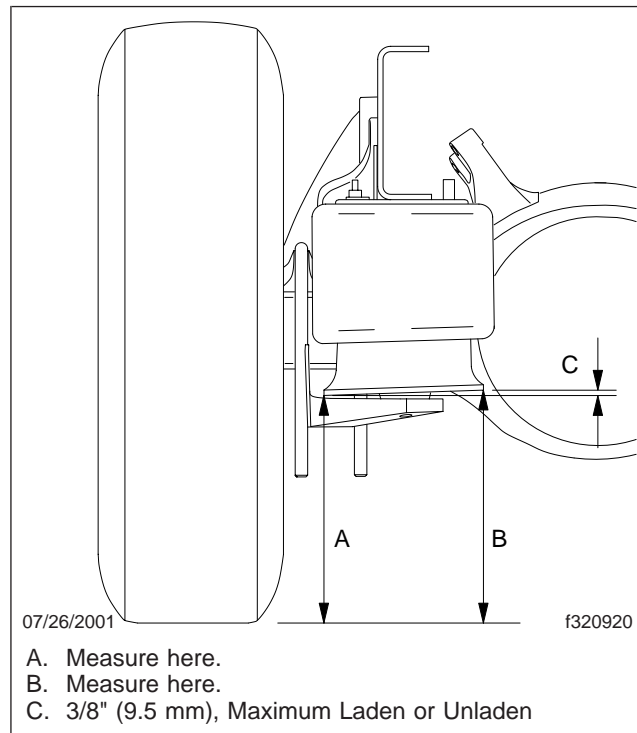
Fig. 8, AirLiner Leaf Spring Kick-Twist Angle Measurement

The plane of the leaf spring kick should be 0.0 degrees to + 4.0 degrees from the horizontal with the spring unladen, or ± 2.0 degrees from the horizontal when fully laden. Do the following procedure to determine if the kick-twist angle is within specification.

- From the rear of the vehicle, measure the distance from each end of the air-spring piston to the ground. See [Fig. 8](#). Repeat each measurement three times to ensure accuracy.
- If the difference between the two measurements in the previous step is less than 3/8 inch (9.5 mm), no further modification is necessary.

If the difference between these two measurements is more than 3/8 inch (9.5 mm), the leaf spring is out of tolerance. Replace it following the instructions in the section titled Freightliner Airliner Rear Suspension, in **Group 32**, of the applicable workshop/service manual.

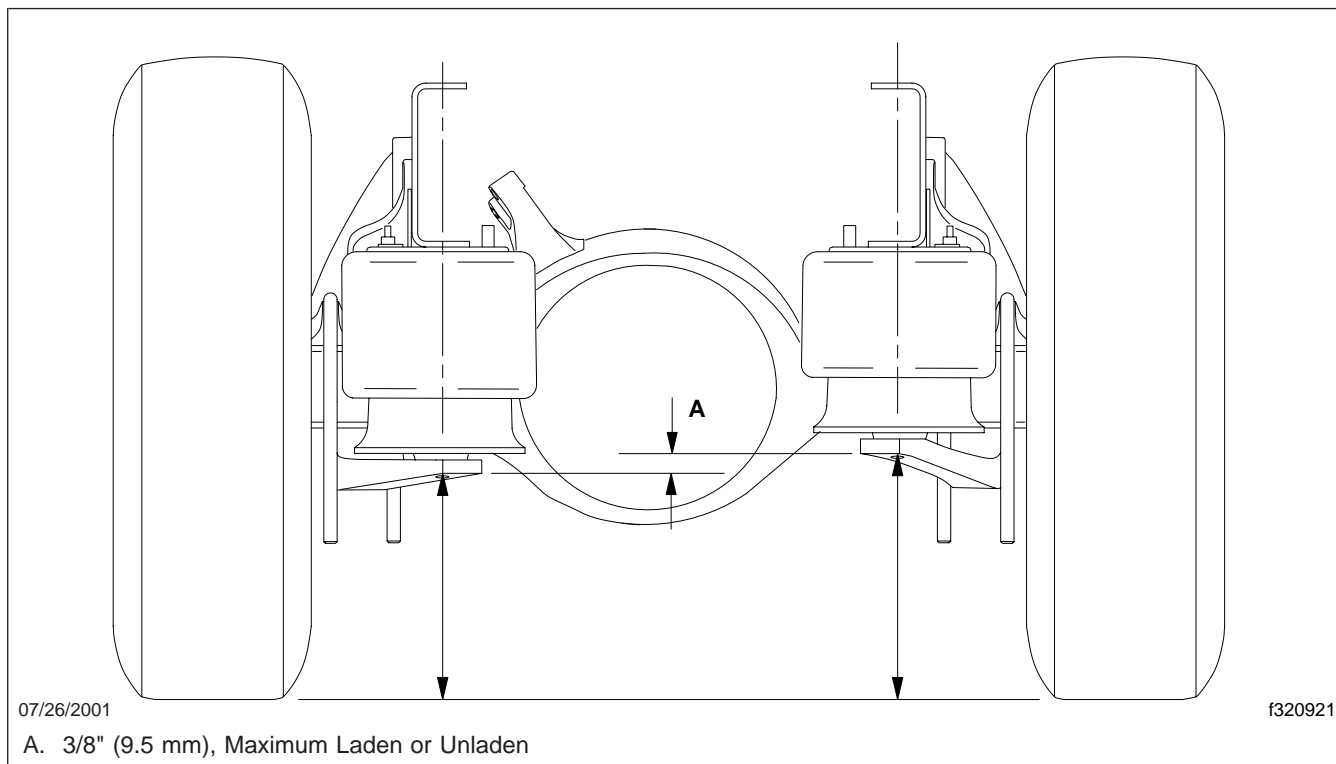
Fig. 11, AirLiner Leaf Spring Rear-End Camber Measurement

1. Measure the distance from the bottom of each leaf spring to the ground. Measure at the air-spring mounting hole. See [Fig. 11](#). Repeat each measurement three times to ensure accuracy.
2. If the difference between the two leaf-spring measurements is less than 3/8 inch (9.5 mm), no further modification is necessary.

If the difference between the two measurements is more than 3/8 inch (9.5 mm), one or both of the leaf springs is out of tolerance. Go to the next step.

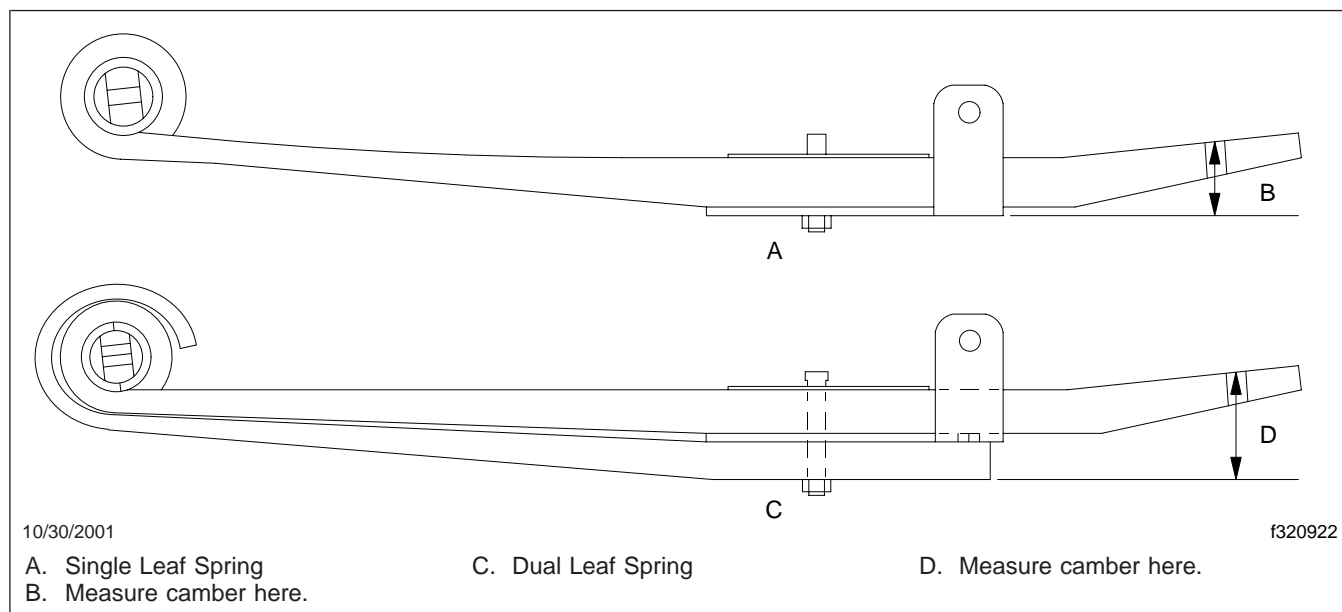
Fig. 12, AirLiner Leaf Spring Rear End Camber Measurements

3. With the leaf springs installed on the vehicle, using a straight edge, measure the rear-end camber at the air-spring mounting hole on the leaf spring. See [Fig. 12](#). Repeat each measurement three times to ensure accuracy.
4. Compare the measured values to the camber specification shown in [Table 2](#).

5. If a leaf spring is out of tolerance, remove it from the vehicle and repeat the rear-end camber measurement with the leaf spring lying on a flat surface.
6. If the leaf spring is still out of tolerance replace it, following the instructions in the section titled Freightliner Airliner Rear Suspension, in **Group 32**, of the applicable workshop/service manual.
