Coronado
> Business Class M2
> Cascadia
> 108SD/114SD

**Freightliner
Service Bulletin**

General Information

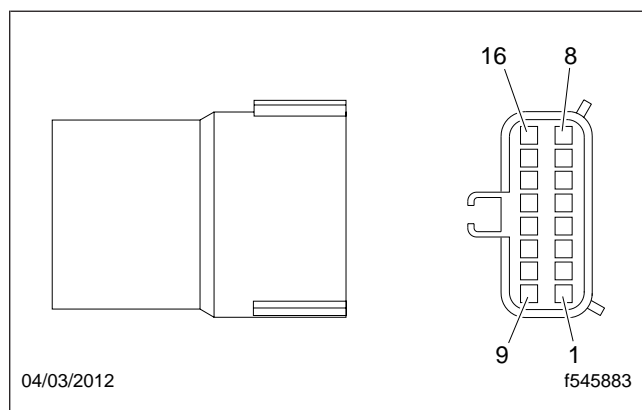
Fig. 1, Standard Transmission Interface Connector

Vehicles built between June 1, 2011, and October 1, 2011, may have an alternate transmission interface connector installed due to a shortage from the supplier. See [Fig. 1](#) and [Fig. 2](#).

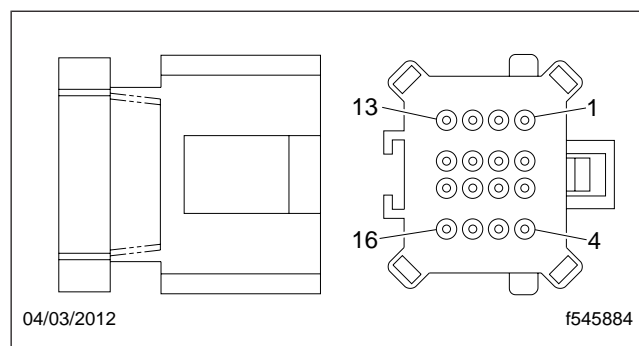
Fig. 2, Alternate Transmission Interface Connector

The alternate connector is mapped 1-to-1 with the standard connector, and the wiring remains the same. Refer to [Table 1](#) for connector and terminal details.
