# Cascadia Chassis Side Fairing Lower Air Deflector Retention

# 31-32

**Freightliner  
Service Bulletin**

**Description of Revisions:** *This bulletin replaces the version dated May 2013. The procedure has been revised to use production retaining clips.*

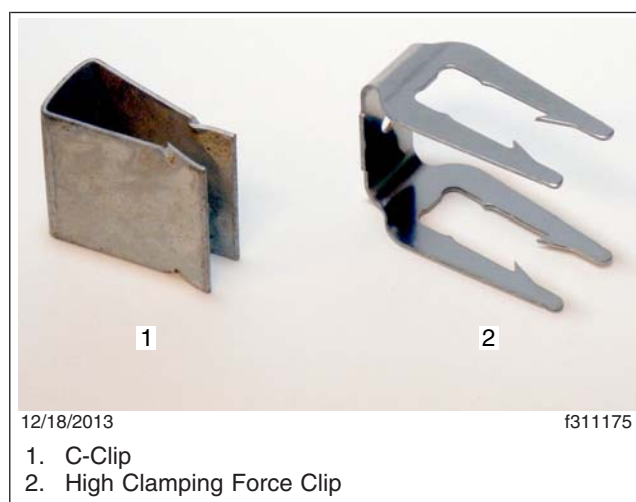
Cascadia vehicles with aerodynamic side fairings built before August 19th, 2013 have chassis side fairing lower air deflectors attached with C-clips that could become loose if dislodged or disturbed. In certain circumstances, a deflector may separate from the vehicle. To improve the retention of air deflectors, these C-clips can be replaced with current production clips that have more clamping force.

**IMPORTANT:** Vehicles built on and after August 19th, 2013 already have the newer retaining clips with higher clamping force installed. See [Fig. 1](#) for the difference between the older C-clips and the newer clips.

**Fig. 1, The older C-clip and more recent high clamping force clip.**

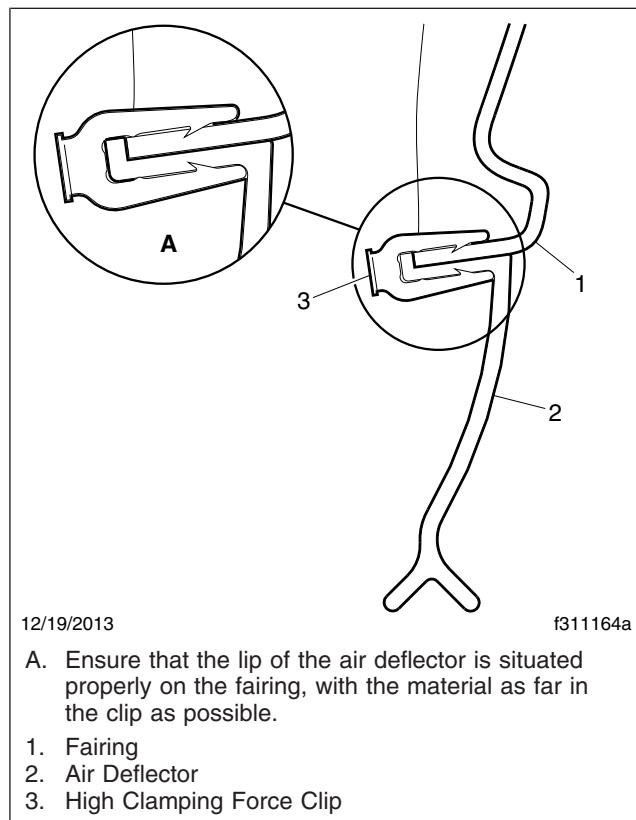
**Fig. 2, Air Deflector and Fairing Installation**

3. Ensure that the lip of the air deflector is situated properly on the fairing, with the material as far in the clip as possible. See [Fig. 2](#).
4. Working one clip location at a time, pry each existing C-clip off with a flathead screwdriver and replace it with a new retaining clip in the same location. Tap the new clip into place with a rubber mallet. Repeat this task for every clip.

**NOTE:** Make sure to use the same location and spacing as the existing clips. If clips are missing, the clip spacing for particular fairing configurations are shown in the installation drawing D22-69272 via EZWiring in PartsPro.
