# Chassis-Mounted Trailer PDM, Battery Power Cable Terminal Corrosion

# 54-275

**Freightliner  
Service Bulletin**

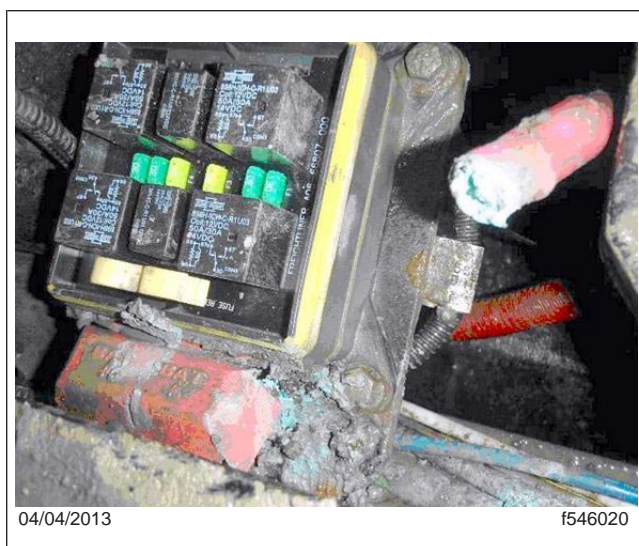
Maintenance of all electric components against various environmental factors is important for the proper operation of the PDM. In some climates and applications, foreign material like water, snow, road salts, chemicals, or mud can accumulate on the PDM power terminal, increasing the risk of corrosion. Corrosion can damage the PDM, even on units equipped with a severe-duty PDM and a stainless steel power stud. See [Fig. 1](#). The accumulation of corrosion can cause an alternate electrical path to ground through the mounting bracket or the frame rail.

**Fig. 1, Corroded Trailer PDM**

Sealed-power connections provide improved protection against power terminal corrosion. See [Fig. 2](#). Mounting the new sealed-power PDM with the connectors oriented horizontally can also reduce exposure to foreign materials.

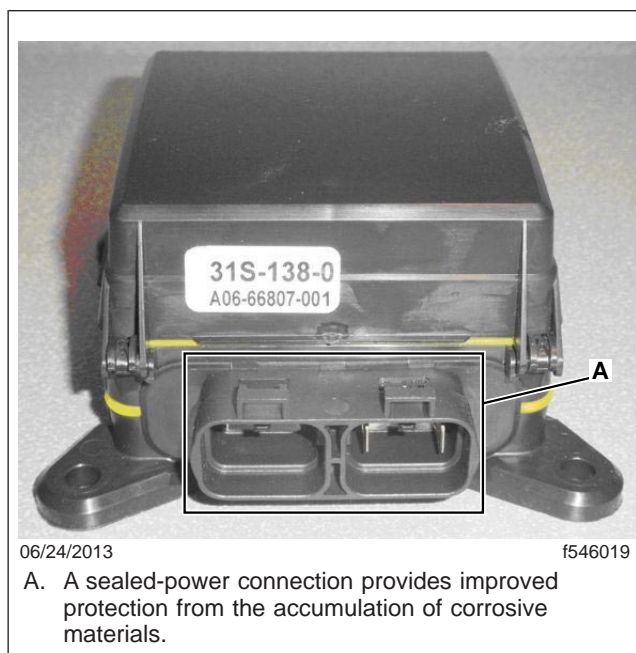
**Fig. 2, New Sealed-Power PDM**

**NOTE:** The sealed-power PDM bolt pattern may differ from earlier PDM installations. In this case, a new bracket is required. See [Table 1](#). The most recent PDMs with a yellow case seal ( [Fig. 2](#) ) have the same bolt pattern as the sealed-power PDM, and should not require a bracket change.

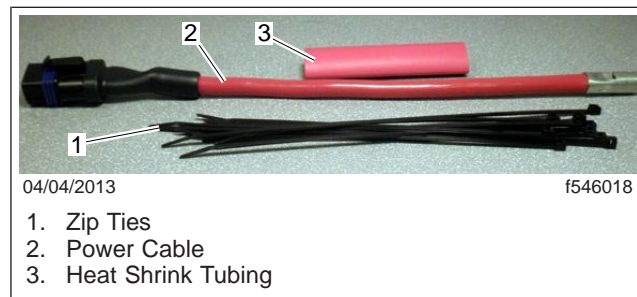
**Fig. 4, New Power Cable (as needed)**

- Trim the existing cable back 12 inches (30 cm) and inspect the remaining cable. If there is evidence of corrosion, replace the corroded cable with a new cable (A06-84616).

**IMPORTANT:** If there is extensive power cable corrosion, the entire cable needs to be replaced with a new cable (A06-84616). See [Fig. 4](#).

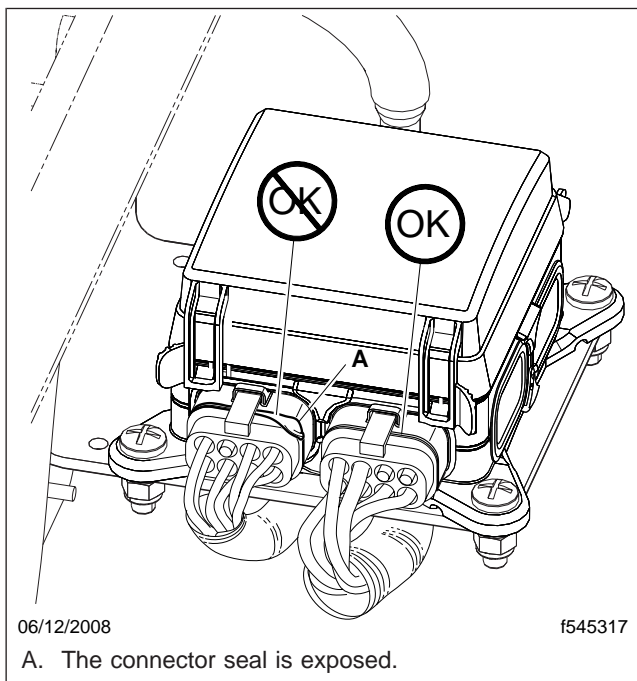
**Fig. 5, Correct and Incorrect PDM Harness  
Connections**

**NOTE:** Corrosion will continue to occur if the heat shrink is not installed properly (fully extruded).
