FLA COE
FLB COE
> FLD Conventional
Business Class

**Freightliner
Service Bulletin**

General Information

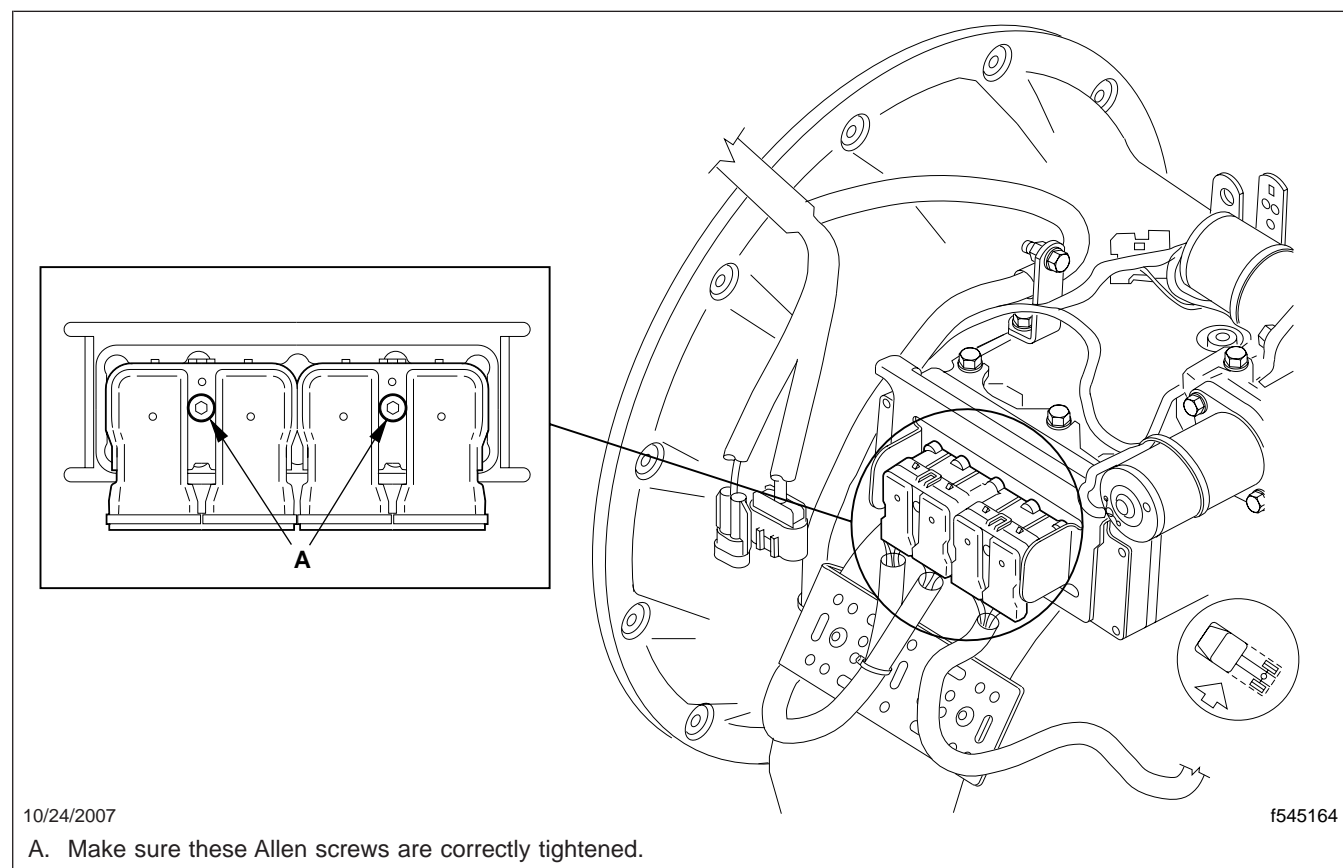
Fig. 1, Transmission Electrical Connections

The electrical connections between the transmission ECU and the transmission harness are critical to the correct operation of the transmission. A poor connection can cause a variety of transmission problems, such as rough or delayed shifting, or failure to shift.

1. If not already done, shut down the engine, set the parking brake, and chock the tires.
2. Find the transmission ECU on the left side of the transmission.
3. Using a torque wrench with a 5/32 inch (4 mm) Allen wrench attached, check the tightness of the two Allen screws that connect the transmission harness connectors to the transmission ECU. See [Fig. 1](#).

The torque should be 22 to 28 lbf·in (240 to 320 N·cm).

If either of the Allen screws is incorrectly tightened, remove the connector and check the harness and ECU terminals for signs of corrosion. If any corrosion is found, go to the next step; otherwise, attach the connector to the control unit, and tighten the Allen screw 22 to 28 lbf·in (240 to 320 N·cm). Continue with the troubleshooting procedure.

5. If corrosion is found, try cleaning the terminal(s) with an electrical contact cleaner. If you cannot remove the corrosion from the harness terminal, replace the terminal. If you cannot remove the corrosion from the ECU terminal, replace the ECU.

Attach the connector to the ECU, and tighten the Allen screw 22 to 28 lbf·in (240 to 320 N·cm).
