Freightliner  
Service Bulletin

**Description of Revisions:** *This bulletin replaces the version dated September 2013. Step 3 of "Resetting the Clutch" has been revised.*

# Clutch-Related No-Start Diagnostics, Cascadia

# 25-34

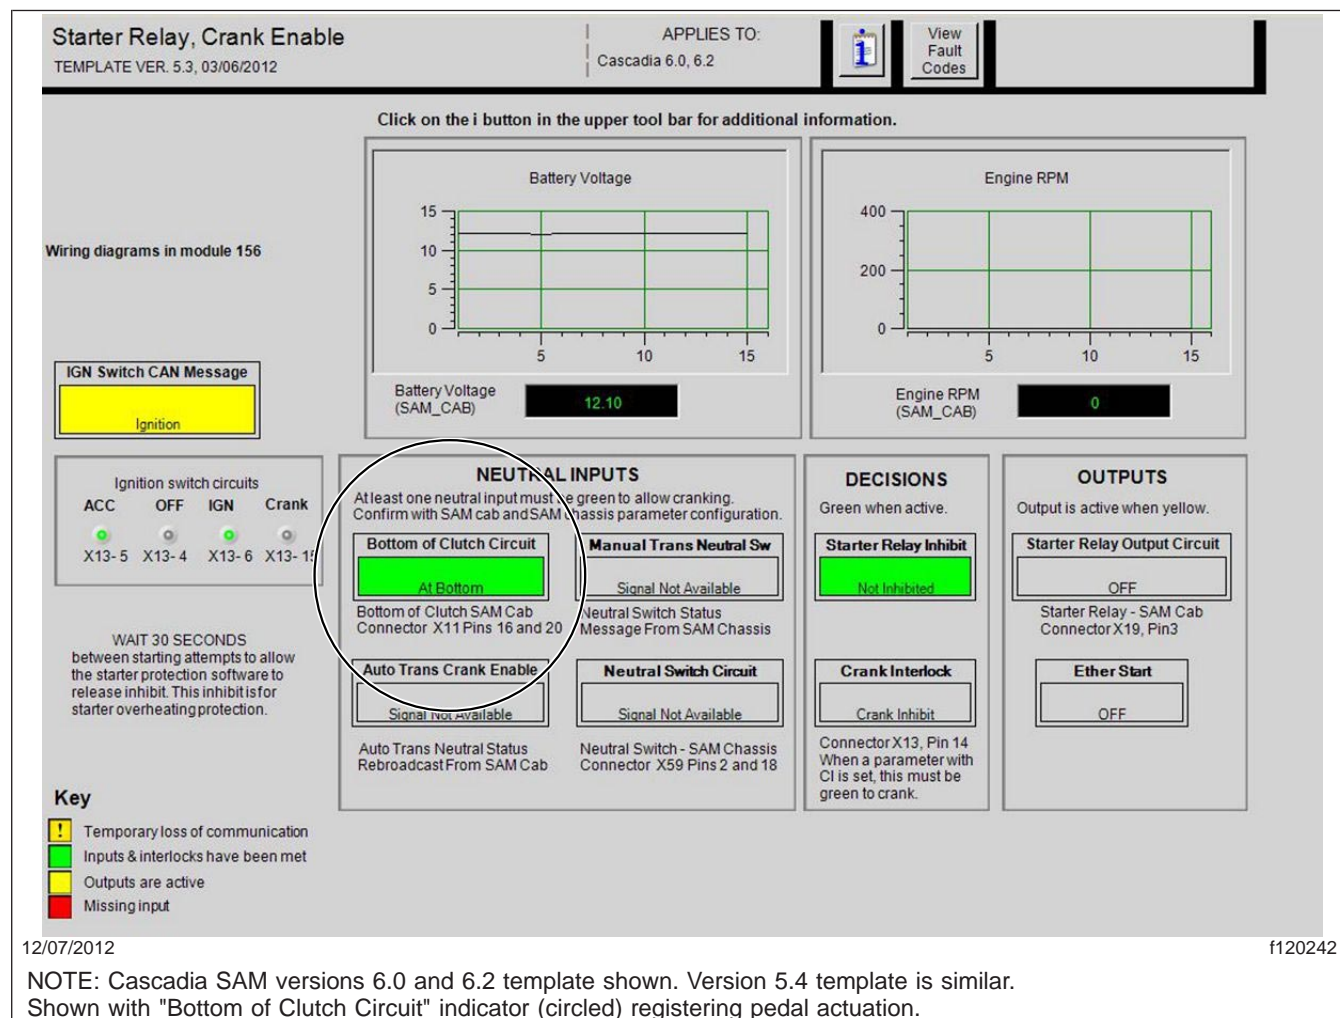
**Fig. 3, "Starter Relay, Crank Enable" Template**

1. Park the vehicle on a level surface, shut down the engine, and set the parking brake. Chock the tires.
2. Make sure the batteries are charged. Turn the ignition key ON.
3. Connect the vehicle to the ServiceLink diagnostic tool. Select the SAM Cab ECU, then go to the "Templates" tab and select "Starter Relay, Crank Enable." See [Fig. 1](#).
4. While pushing the pedal to the point of clutch brake squeeze ([Fig. 2](#)), check the SAM Cab Template. Does the actuation of the pedal switch register? The actuation of the pedal is registered when the "Bottom of Clutch Circuit" indicator turns green and reads "At Bottom," as shown in [Fig. 3](#).

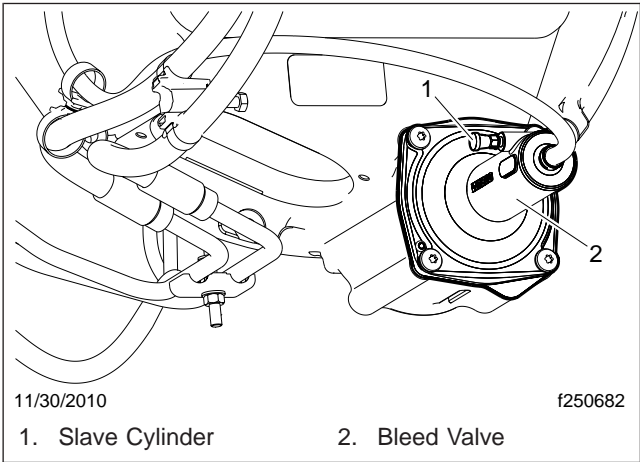
Fig. 4, Slave Cylinder Bleed Valve

5. Continue to monitor the SAM Cab ECU while having an assistant open the bleed valve on the slave cylinder (see [Fig. 4](#)), allowing the pedal to travel all the way to the floor. Have the assistant close the valve. Does the actuation of the pedal switch register on the "Bottom of Clutch Circuit" indicator? If necessary, top off fluid with DOT 4 brake fluid.

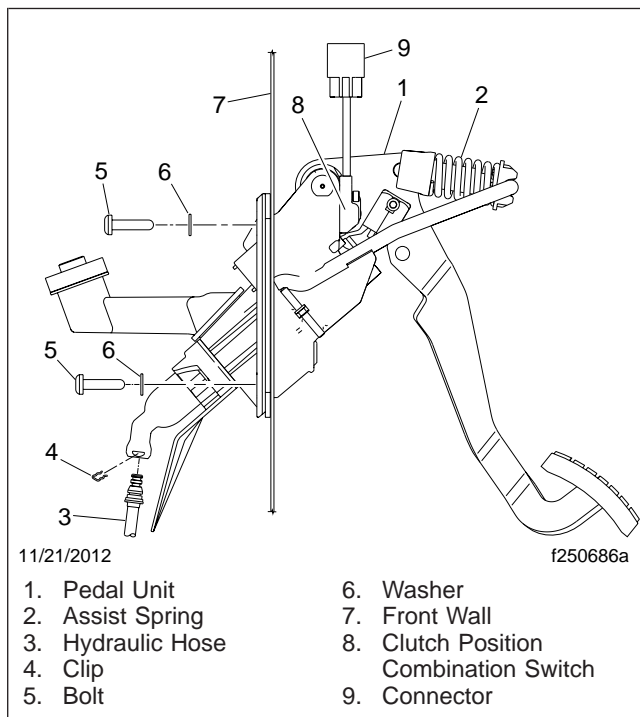
**Fig. 5, Clutch Pedal Assembly**

6. Disconnect the chassis harness from the clutch position combination switch. See [Fig. 5](#).
7. Use a jumper wire to close the clutch low position control circuit on the chassis side (between pins A and C in [Table 1](#)), and look for a response on the SAM Cab ECU template. Does the response register on the template?

*If YES, replace the switch with the newer version that is marked with a yellow dot, indicating the seal has been removed. See *Cascadia Workshop Manual*, **Section 25.01, Subject 150**.*

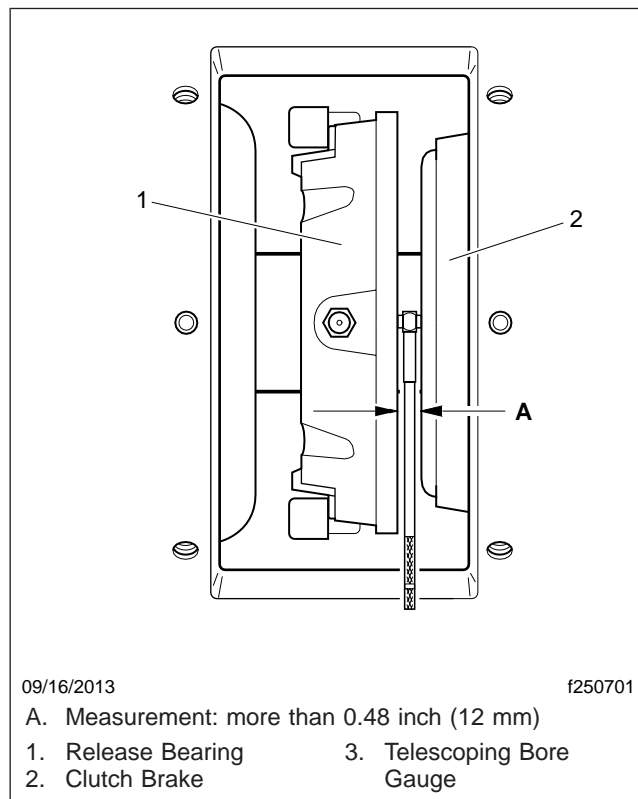
**Fig. 6, Clutch Gap**

8. Remove the clutch inspection cover.
9. Using a telescoping bore gauge, measure the gap between the clutch brake and the release bearing, then measure the gauge with a digital caliper. The distance should be more than 0.48 inch (12 mm). See Fig. 6.
- If the distance is correct, install the inspection cover. Tighten the screws 14 to 18 lbf-ft (19 to 24 N·m). Replace the hydraulic pedal assembly. See Cascadia Workshop Manual, Section 25.01.
- If the distance is less than 0.48 inch (12 mm), reset the clutch (see “Resetting the Clutch”).

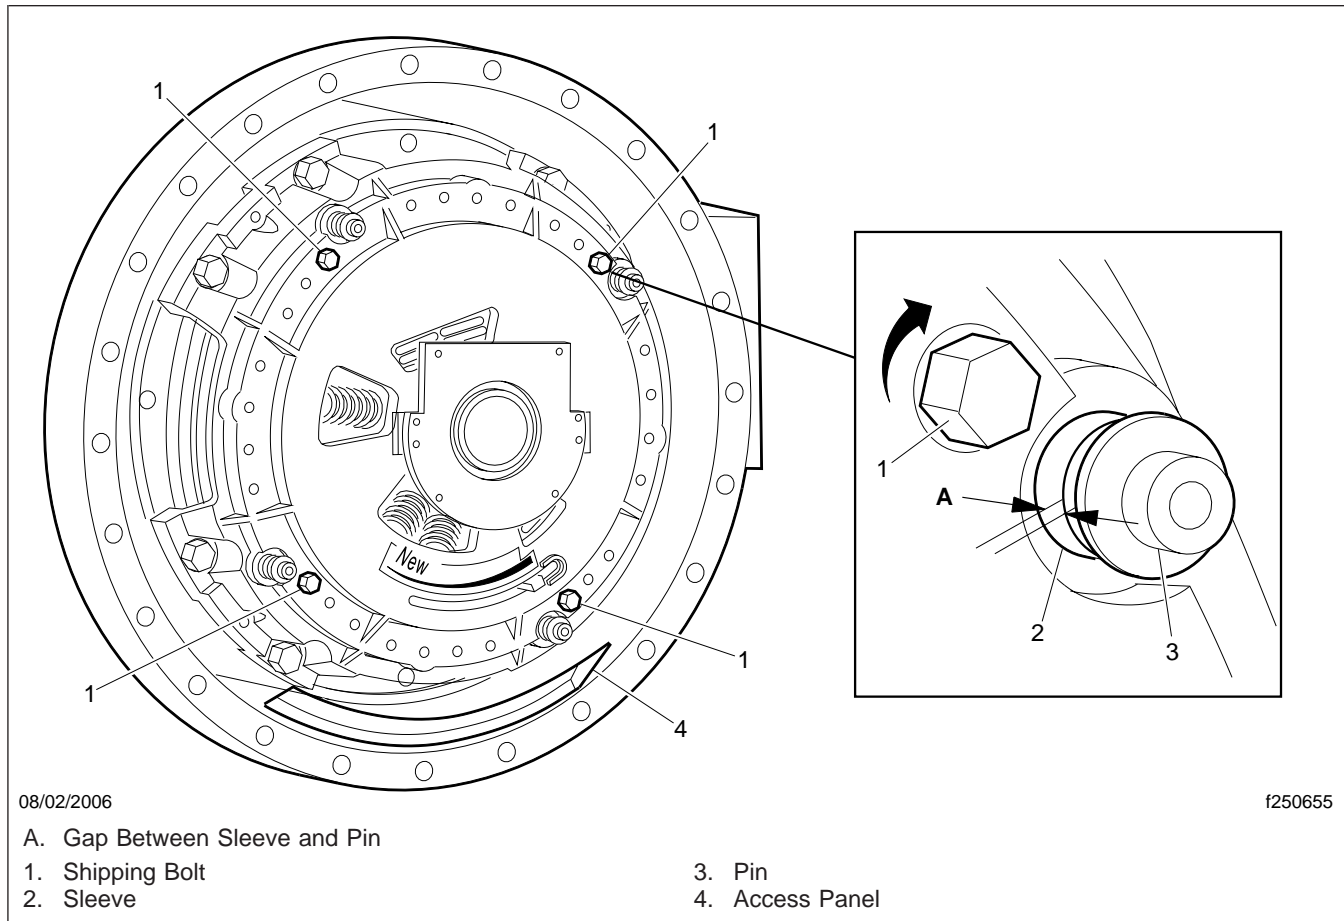
**Fig. 8, Removing the Gap Between Sleeve and Pin**

**IMPORTANT:** To prevent the clutch from returning to an over-adjusted position, the gaps between the sleeves and pins have to be eliminated, as detailed below.

5. Install four shipping bolts (7/16-14 x 1-3/4 UNC) next to the sleeves and pins, as shown in **Fig. 8**. Tighten the bolts so that the gaps between the sleeves and pins are eliminated.
