Freightliner
Service Bulletin

Description of Revisions: This bulletin replaces the version dated June 2012. Photo evidence of outgassing is no longer required when submitting warranty claims.

General Information

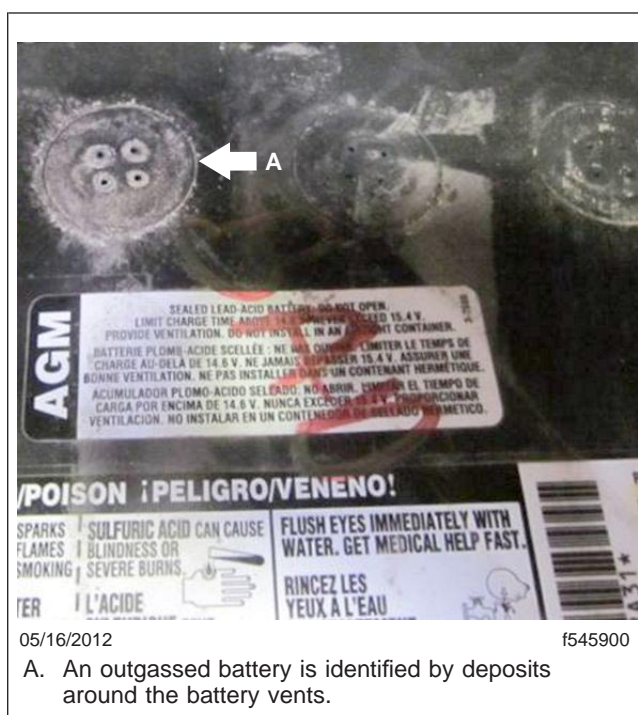
Fig. 1, Battery Outgassing

On Century Class S/T and Cascadia sleeper cabs with under-cab battery boxes built prior to February 13, 2012, 8A31 AGM batteries used for starting are failing with loss of electrolyte. While electrolyte loss is a function of normal battery use, high temperatures under the cab can accelerate electrolyte loss in 8A31 AGM batteries, which may result in early failure of the batteries. Batteries experiencing this condition frequently have bulged cases caused by outgassing (electrolyte loss), and measure well below the normal CCA (cold cranking amps). These symptoms can result in a no-start condition. See [Fig. 1](#) and [Fig. 2](#).

On affected vehicles **not** equipped with ParkSmart, an APU, or an inverter, the recommended replacement for the 8A31 is a 7T31, or equivalent flooded cell battery. On vehicles equipped with ParkSmart, an APU, or an inverter, the recommended replacement for the 8A31 is an AGM 9A31, or equivalent AGM battery.

IMPORTANT: When replacing primary batteries, all four (4) batteries must be replaced at the same time, and they must all be the same battery type. Do not combine 7T31 (flooded) and 9A31 (AGM) batteries in the same system. The difference in charge and discharge rates between different types of batteries can shorten battery life.

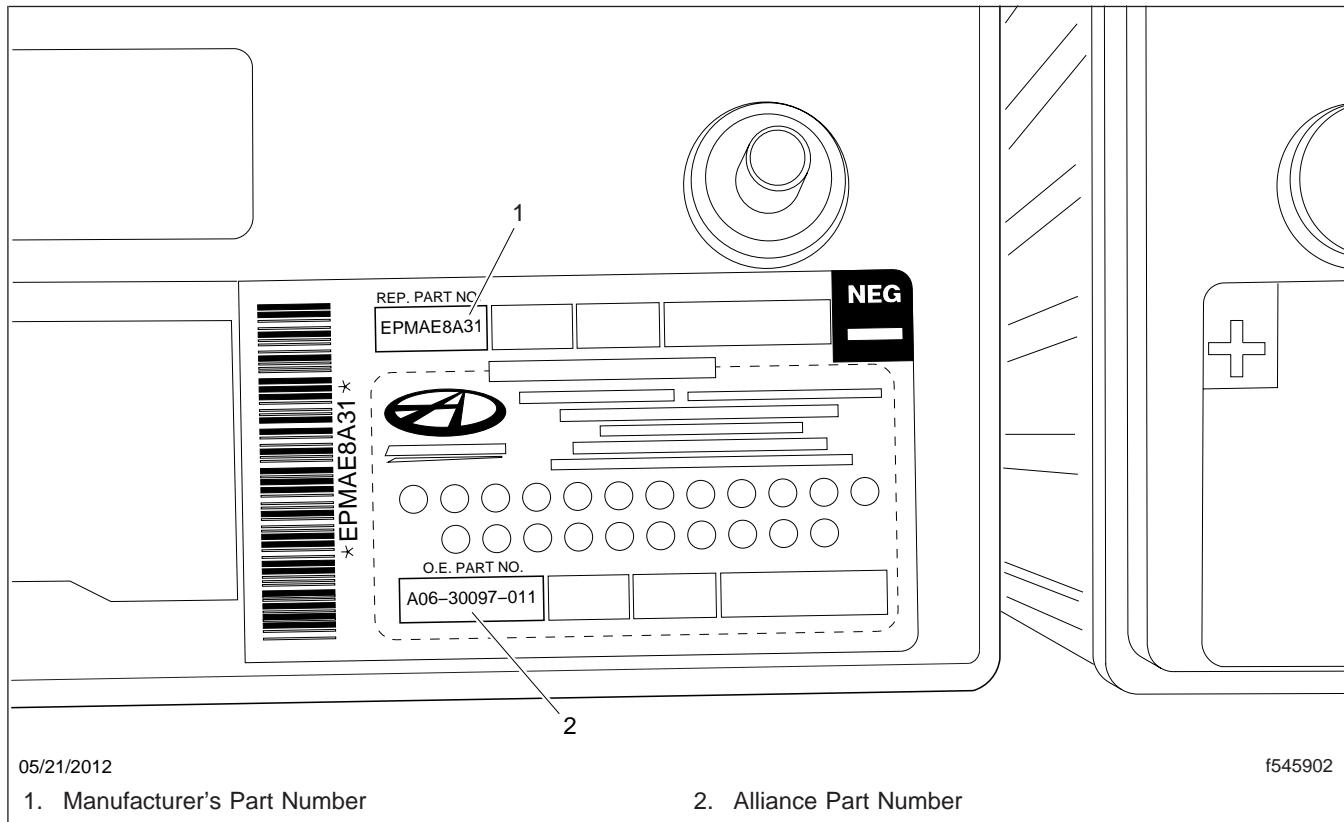
Fig. 3, Battery Label

The manufacturer's battery part number is shown on the top left-hand side of the battery label. See [Fig. 3](#). The full part number of the 8A31 is shown as EPM AE8A31. The Alliance part number (A06-30097-011) can also be used if the manufacturer's part number is worn away or obscured.
