Coronado  
Business Class M2  
> Cascadia  
108SD/114SD

**Freightliner  
Service Bulletin**

**Description of Revisions:** *This bulletin replaces the version dated June 2013. [Table 1](#) has an additional fault code.*

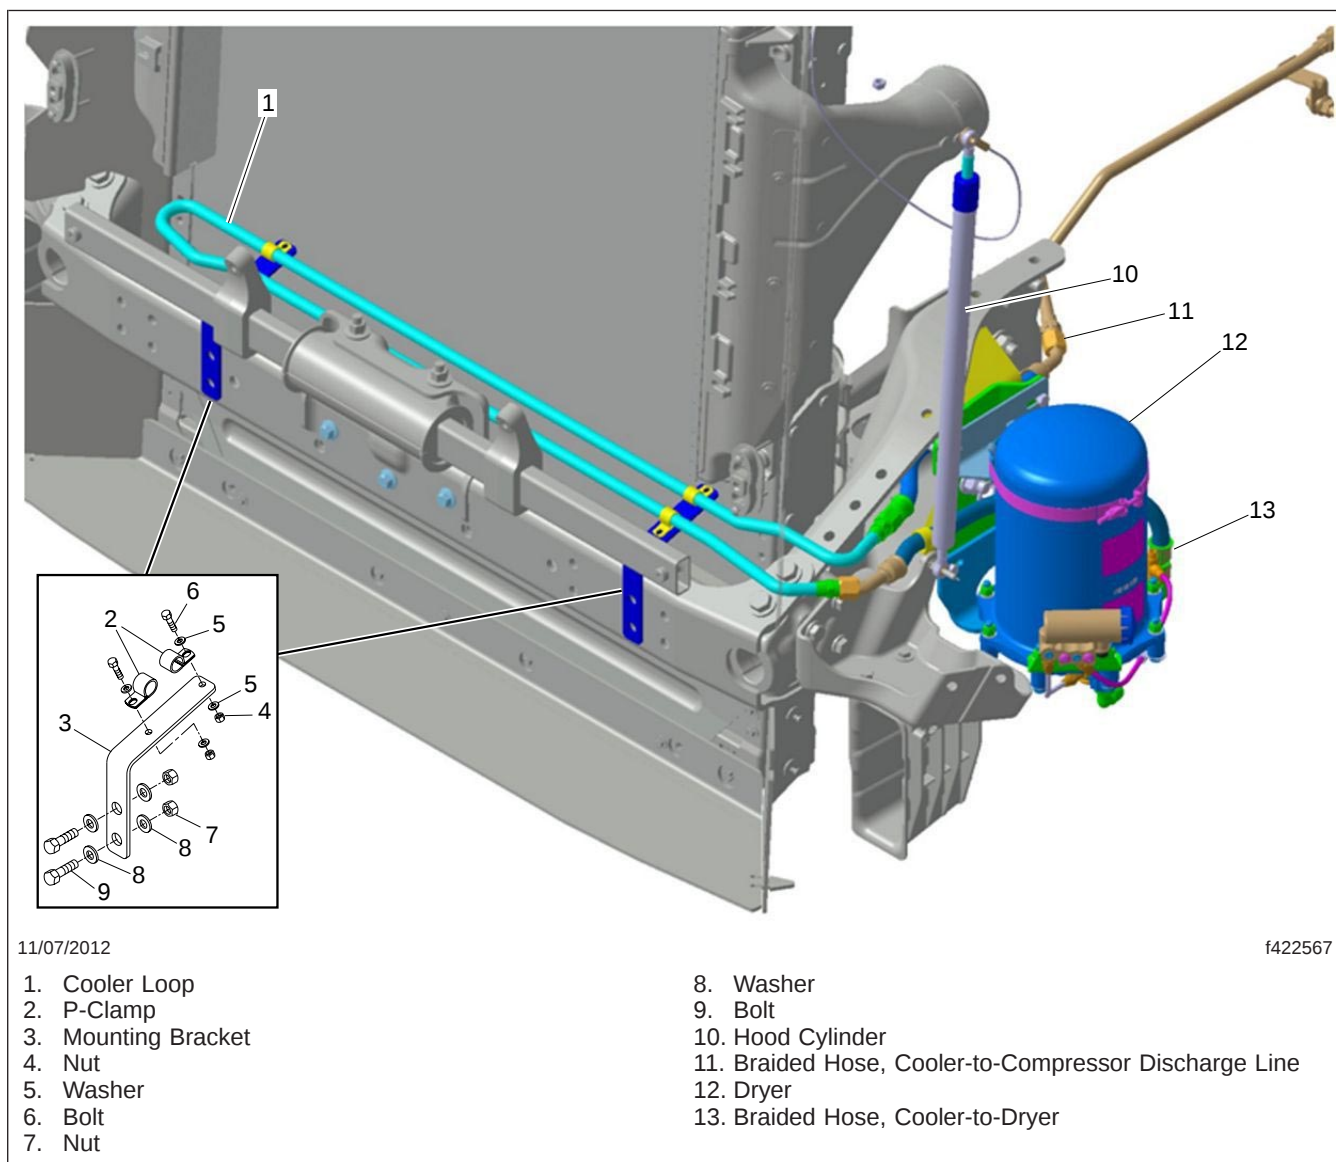
**Fig. 1, Cooler Loop Installation (AD-9/AD-IP dryer shown)**

If the issue persists, the air dryer inlet air temperature may be excessive, resulting in reduced dryer performance. Install an in-line air cooler loop, or a longer air line, depending on the vehicle configuration.

1. Park the vehicle on a level surface, shut down the engine, and set the parking brakes. Chock the wheels securely.
2. Disconnect the batteries at the negative post.
3. Drain the air from the air system.
4. Remove the grille. See [Section 88.00, Subject 110](#) of the *Cascadia Workshop Manual*.
5. Open the hood.
6. Remove the bumper. See [Group 31](#) of the *Cascadia Workshop Manual*.
7. Relocate the air temperature sensor on the right side of the frame closing crossmember down one hole.
8. Remove the rock screen from the lower face of the radiator.
9. Install the cooler-loop mounting brackets. See [Fig. 1](#).
10. Position the P-clamps on the cooler loop and install the cooler loop on the brackets. Do not tighten the P-clamp fasteners at this time. See [Fig. 1](#).
