Freightliner
Service Bulletin

49-27

Exhaust Stack Clamp Failure, EPA07 Vertical ATD

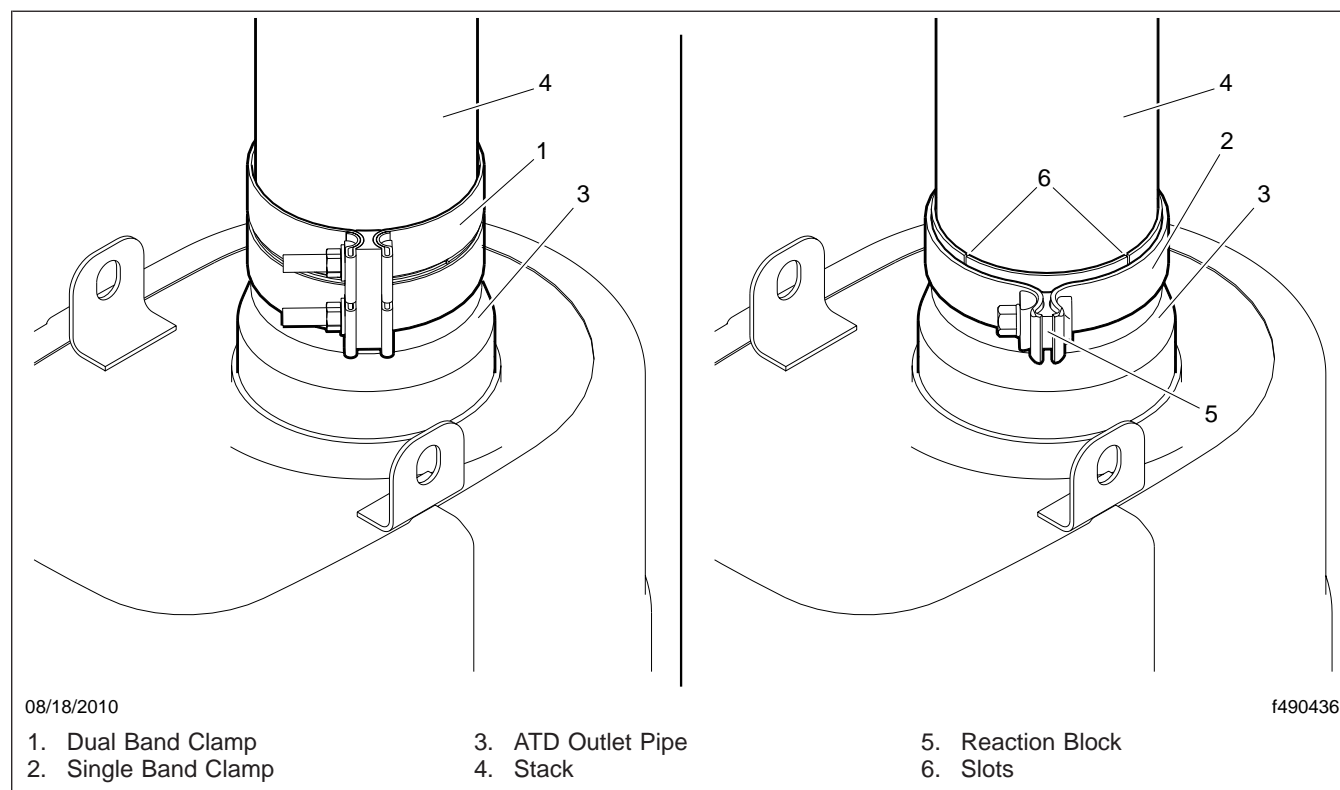
Fig. 1, Exhaust Clamp Installation

If a dual band exhaust stack clamp, part number 04-20289-000, fails on an EPA07 vehicle with a vertical ATD, replace it with single band clamp part number 04-29313-500. See [Fig. 1](#).

1. Remove the failed clamp.
2. Verify that the exhaust stack is clocked to 45 degrees.
3. Install the new clamp flush with the top of the ATD outlet pipe and with the reaction block centered between the slots in the outlet pipe. Tighten 35 to 47 lbf·ft (47 to 64 N·m).
