Columbia  
Coronado  
Business Class M2  
> Cascadia

Freightliner  
Service Bulletin

This bulletin applies only to Cascadia vehicles built before December 14, 2009. Vehicles equipped with a Cummins ISX engine may have the aftertreatment device (ATD) pressure sensor in the same circuit as the accelerator, causing fault code 1993. An overlay harness should be installed to correct this problem.

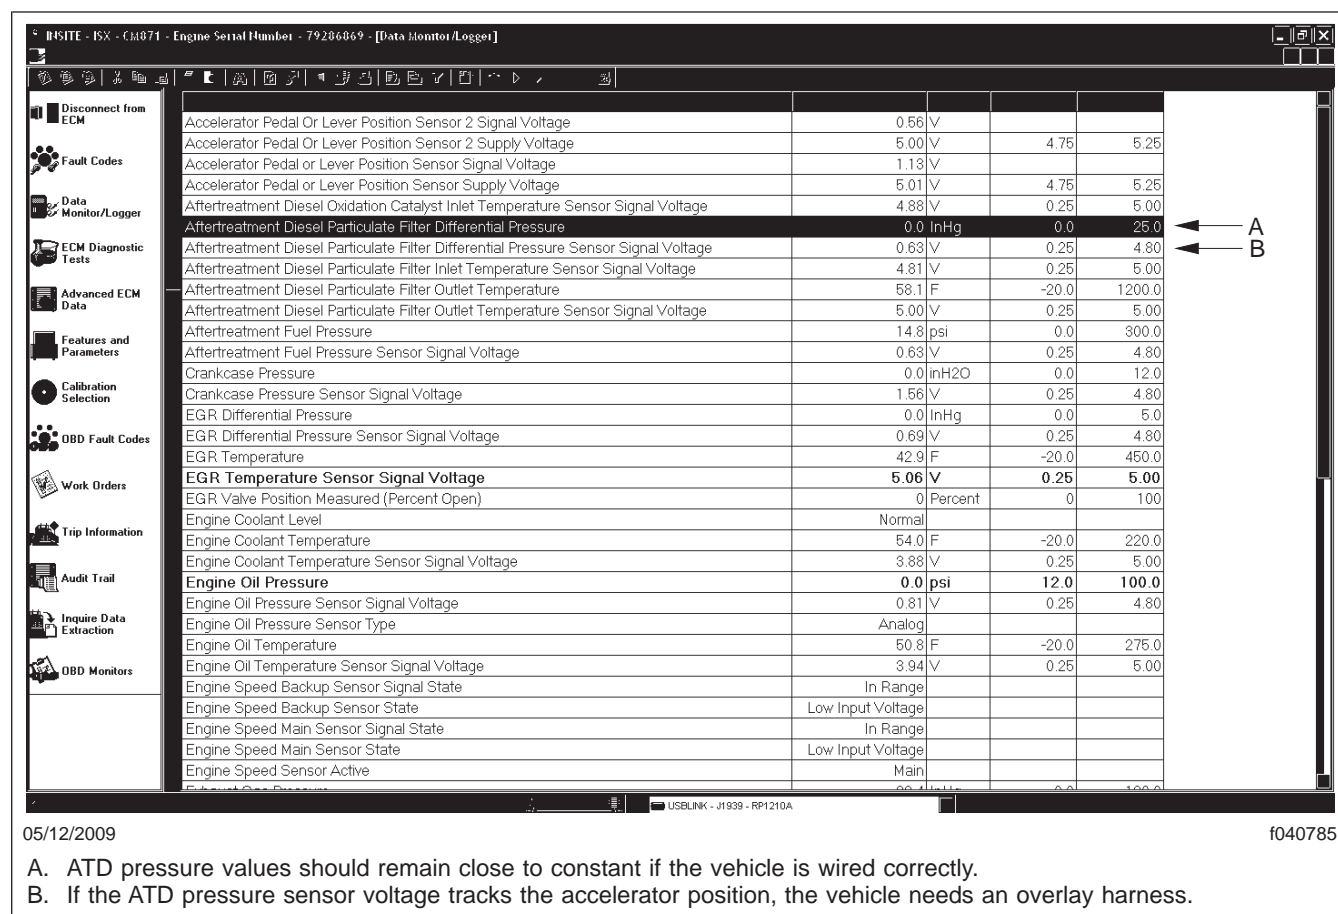
**Fig. 1, Checking Signals Using Cummins INSITE**

1. Set the parking brake, shutdown the engine, chock the tires.
2. Turn the keyswitch to the run position without starting the engine and connect Cummins INSITE®.
3. With INSITE connected to the ECM, select "Data Monitor/Logger" from the left column.
4. Expand all parameters, and monitor the voltage and the value in InHg for the Aftertreatment Diesel Particulate Filter Differential Pressure. See [Fig. 1](#).
