FLA COE
FLB COE
FLD Conventional
Business Class
FLC 112 Conventional

**Freightliner
Service Bulletin**

General Information

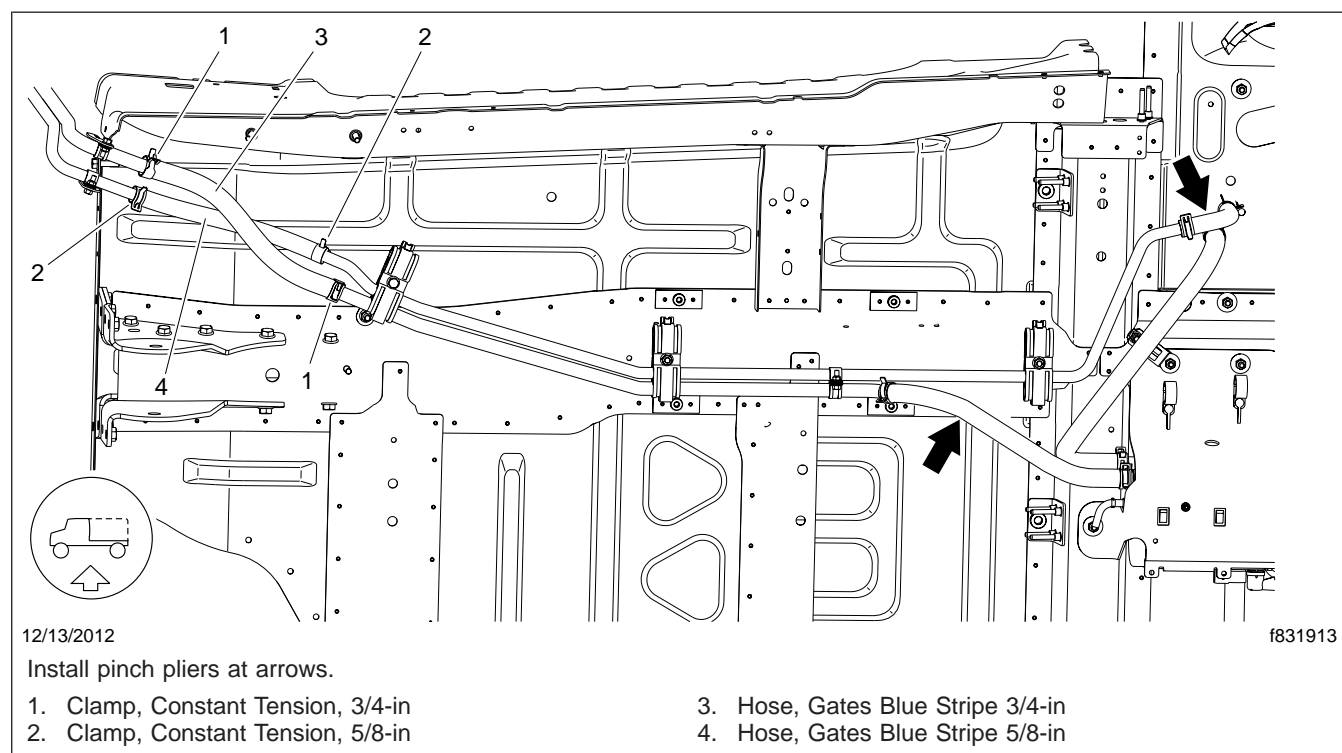
To repair a truck with Goodyear hoses that have failed on the under-cab cassette, the entire cassette does not need to be replaced. Replace only the heater hose(s) with Gates Blue Stripe of like size. See [Table 1](#) under "Parts" for replacement part numbers.

Fig. 1, Under-Cab Coolant Line Installation (ParkSmart installation shown, others similar)

2. Allow the cooling system sufficient time to cool.
3. Remove left inner fender.
4. Using hose pinch pliers, pinch off heater hoses at the right side of the engine, and at the back of the under-cab cassette. See [Fig. 1](#).
5. Place a catch pan under the hoses.

6. If heat-shrink clamps are installed, use a razor knife to cut them.
7. Remove the old hoses.
8. Install new hose clamps and Gates Blue Stripe hoses. See [Table 1](#) for a list of approved replacement parts.
9. Start the engine and check for leaks. Repair as needed.
10. Add coolant as needed.
