FLA COE
FLB COE
> FLD Conventional
Business Class

Freightliner
Service Bulletin

General Information

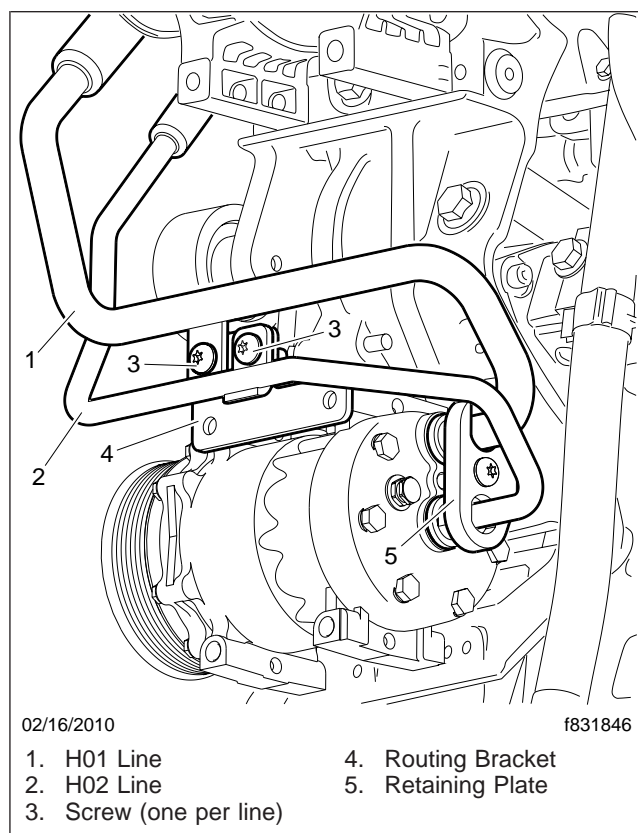
Fig. 1, Bracket Installation

Improved H01 and H02 lines have been introduced for EPA07 MBE4000 engine installations in vehicles manufactured prior to 8/17/09. The new lines supersede all old ones. If either the H01 or H02 line fails, both lines must be replaced at the same time.

A new routing bracket and hardware are required to upgrade to the new lines. [Figure 1](#) shows the bracket installation. [Table 1](#) lists the routing bracket information.

1. Remove the original lines.
2. Install the new bracket on the compressor mounting bosses, as shown in [Fig. 1](#). Tighten the fasteners 15 to 19 lbf-ft (21 to 26 N·m).

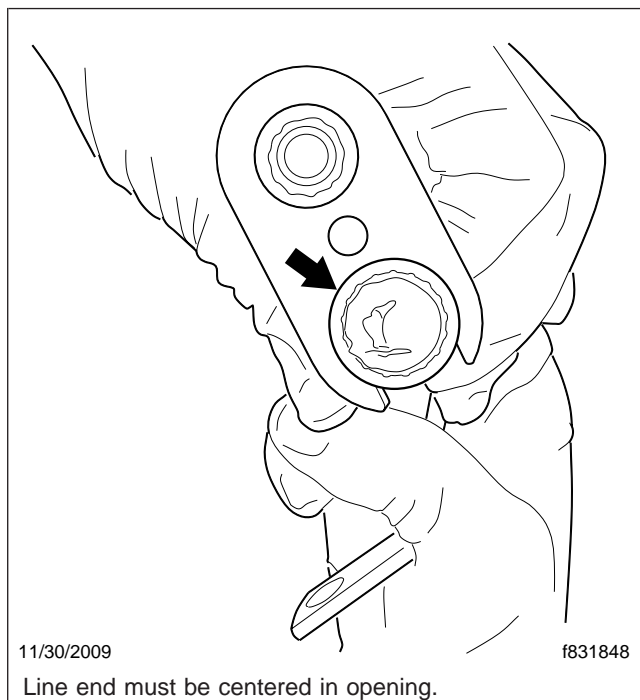
Fig. 2, Checking the Fit

NOTE: If you are replacing the H01 line, but not the H04 line, the retaining plate on the H04 line may need to be modified.

3. Check the fit of the H01 line in the retaining plate on the H04 line. See [Fig. 2](#). If it fits properly, no modification is needed. If it does not fit, modify the retaining plate as described in "H04 Line Retaining Plate Modification" below.

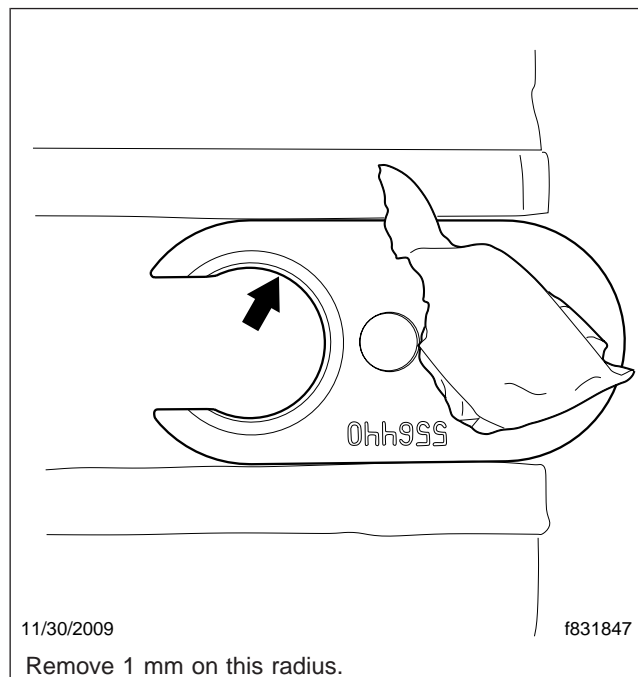
Fig. 3, Retaining Plate Modification

Do not take too much material off of the retaining plate. Make sure that material is removed equally around the radius. Improper modification of the part may cause the line to seat incorrectly leading to a leak in the A/C system.

3. Using a suitable tool, enlarge the radius of the part of the retaining plate that surrounds the H01 line end by 0.039 inch (1mm). See [Fig. 3](#). This is approximately the same as the chamfered edge on the inside radius of the retaining plate.
4. It must be centered to form a proper seal when installed.
