Intermittent Communication Between the TrailerTRACS Transmitter and the Qualcomm Unit

54-279

Coronado
Business Class M2
> Cascadia
108SD/114SD

**Freightliner
Service Bulletin**

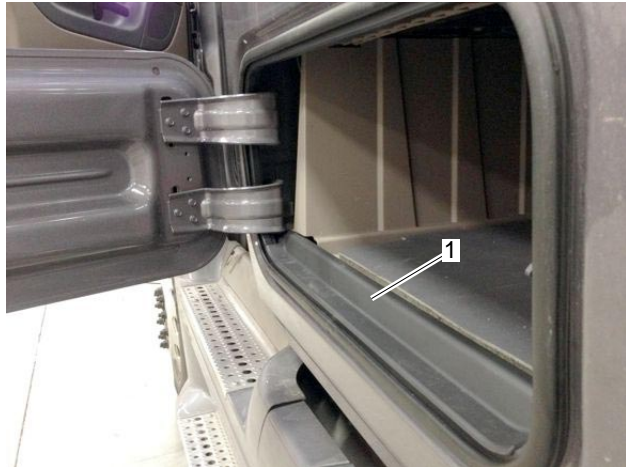
Fig. 1, Driver-Side Luggage Compartment without Auxiliary Heater Option (Sleepercab)

NOTE: There are three possible installations. On vehicles equipped with a driver-side luggage door, the wiring harness cover is located at the front edge of the luggage compartment. See [Fig. 1](#). On vehicles without a driver-side luggage compartment, the harness is under the side panel located beneath the lower bunk. On daycabs, the harness is located behind the rear upholstery panel.

- On Sleepercabs with a driver-side luggage compartment, open the compartment and remove all stored items. Remove the fasteners from the harness cover, then remove the cover.

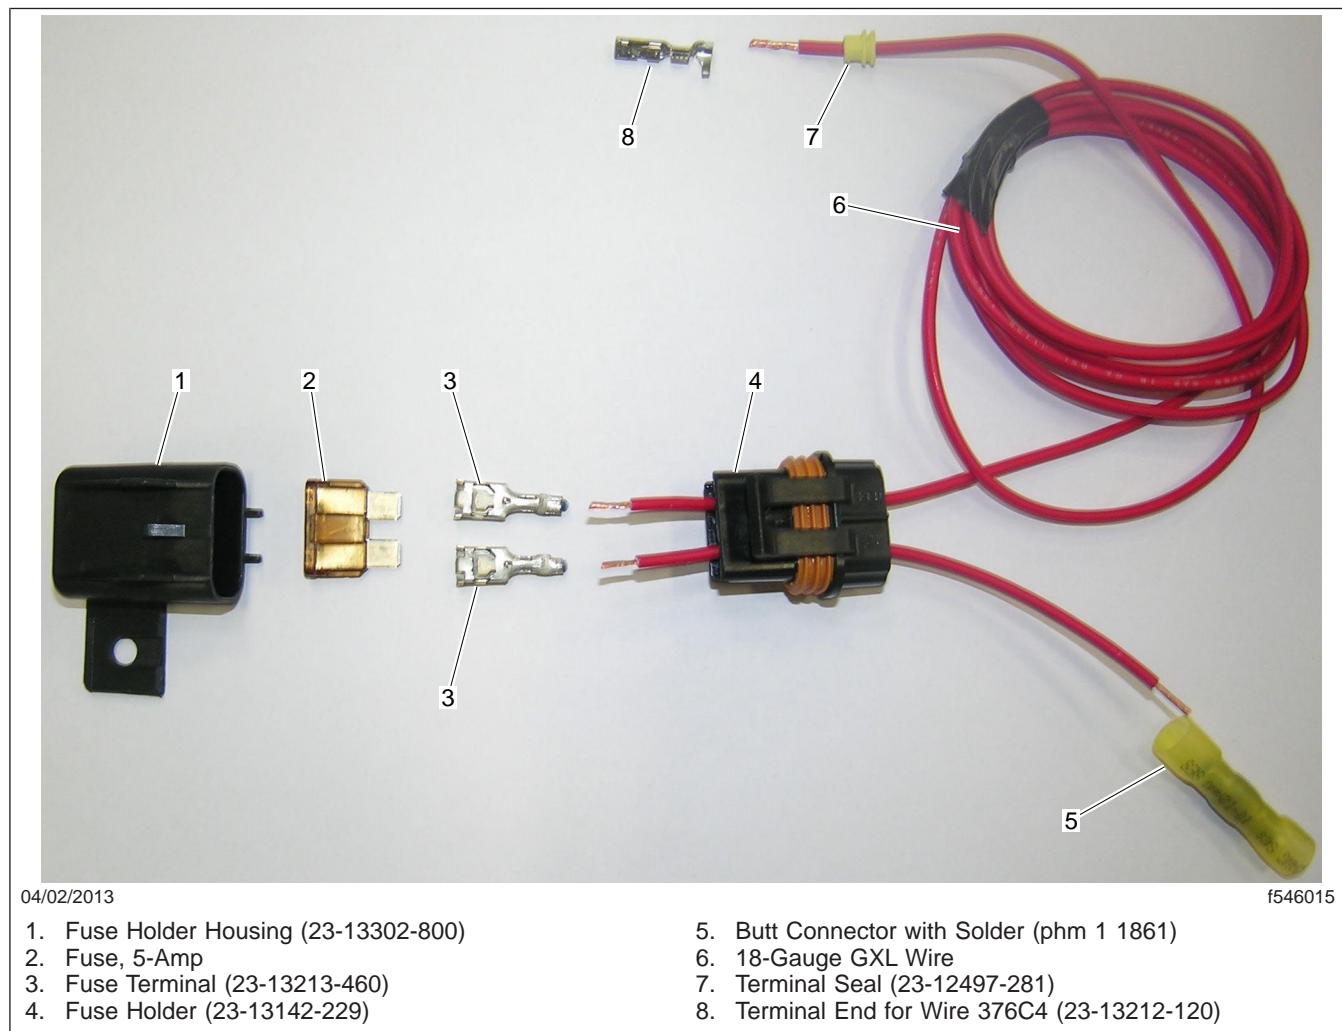
**Fig. 5, Wiring Modification Parts**

3. Inspect circuit 45 to make sure that the wiring modification has not already been completed. If the procedure was already performed, circuit 45 will be spliced with an 18-gauge wire and routed as shown in [Fig. 5](#). If the procedure has not been performed, continue with the next step.

NOTE: See [Fig. 5](#) for the parts required for the wire splice.
