FLA COE
FLB COE
FLD Conventional
Business Class
FLC 112 Conventional

**Freightliner
Service Bulletin**

General Information

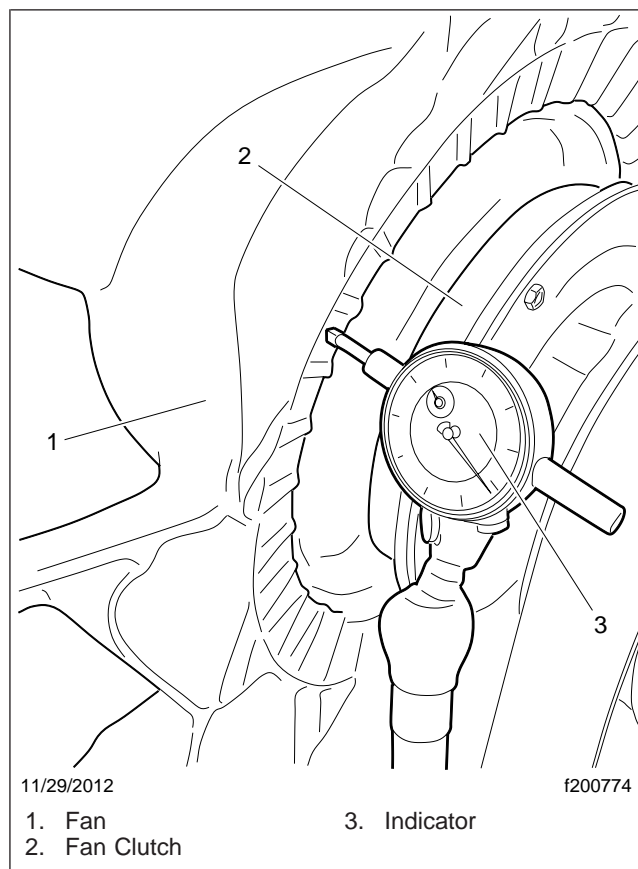
Fig. 1, Positioning the Indicator

1. Park the vehicle on a level surface, shut down the engine, and set parking brake. Chock the tires.
2. Position the indicator on a flat surface near the outside diameter (OD) of the clutch hub section of the fan as shown in **Fig. 1**.

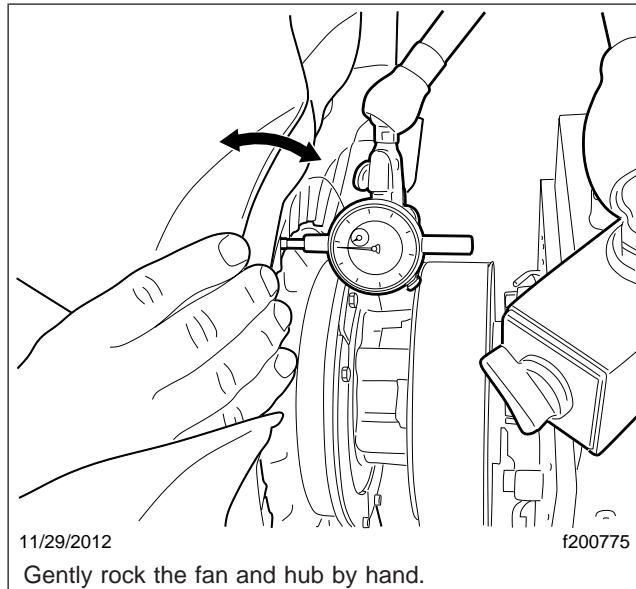
Fig. 2, Checking the Rock Runout Measurement

6. Grasp the fan at the hub and gently rock the fan fore and aft. See **Fig. 2**.

The total indicator reading should not exceed 0.050 in (1.27 mm).

If reading is greater than 0.050 in (1.27 mm), replace the fan clutch. For instructions, refer to **Group 47** of the vehicle's workshop manual.
