Freightliner  
Service Bulletin

# 83-143

## Refrigerant Leaks Due to Improperly Tightened Fasteners

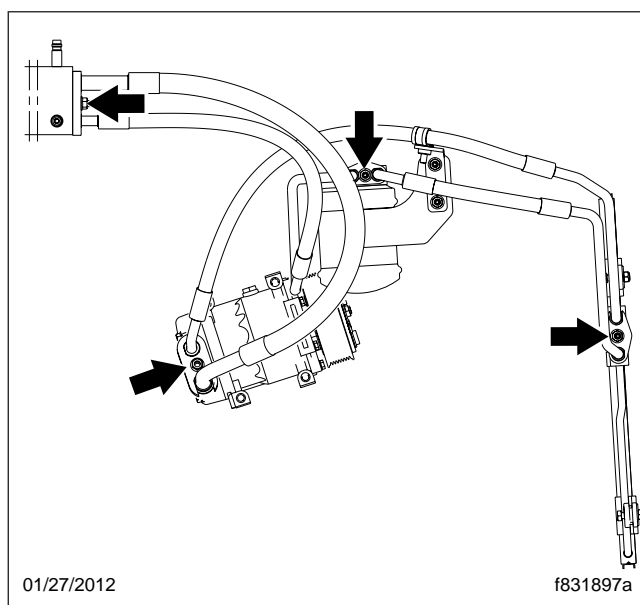
**Fig. 1, Potential Leak Points in an A/C System**

On some EPA10 vehicles built prior to February 3, 2012, some refrigerant lines were not adequately tightened during installation at the factory, resulting in a slow leak. It is not necessarily an indication of a damaged component. Using approved electronic leak detection tools, as directed in the vehicle's workshop or troubleshooting manual, check the system for leaks. If a leak is discovered, the fastener at the connection may need tightening.

Refer to [Fig. 1](#) for some of the typical locations of potential leaks at port-block connections in the refrigerant system. The exact configuration may vary from one vehicle to the next, and some vehicles may have more connections than shown.

2. Verify that the refrigerant system is charged with enough refrigerant to test for leaks. If it is not, add a small charge of refrigerant for diagnosing the system.
3. Using approved electronic leak detection tools, check all of the refrigerant lines and connections for leaks.
