Coronado
Business Class M2
> Cascadia
108SD/114SD

Freightliner
Service Bulletin

Reinforcement Plates for Cab Shock Brackets

60-151

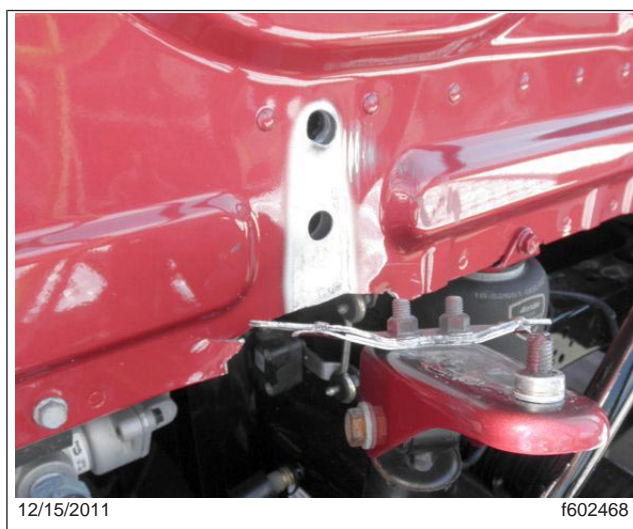
A set of reinforcement plates have been developed to repair a Cascadia cab back wall damaged by a shock mount bracket that has torn loose ([Fig. 1](#)) or started to separate. Follow the procedure in this bulletin to repair the cab back wall.

Fig. 1, Torn-Out Shock Mount Bracket, Back Wall of Cab
