Sealing the Lower Pinion Cover, Model 4 Freightliner Rear Axles

35-25

**Freightliner
Service Bulletin**

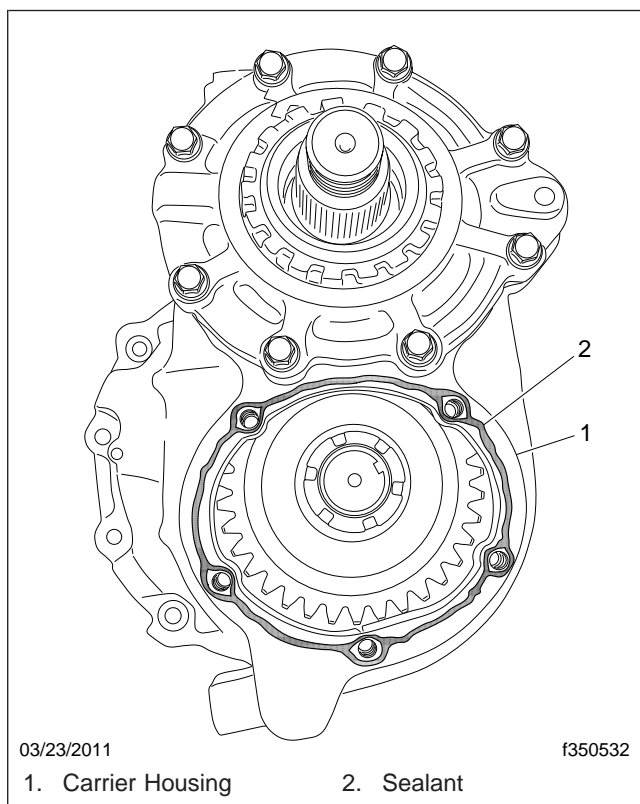
Fig. 1, Sealant Applied to Carrier Housing

Model 4 Freightliner rear axles have a lower pinion cover that may need to be removed to inspect for damage or to reseal it to prevent water intrusion. When installing the lower pinion cover, seal it per the following instructions.

1. Clean the bond surfaces of the cover and housing. Use a putty knife to remove any residual sealant.
2. Apply Loctite 5900® sealant to the bond surface of the *carrier housing* as shown in **Fig. 1**. Do not apply sealant to the cover.
3. Install the lower pinion cover. Tighten the capscrews 65 lbf-ft (85 N·m).
4. Apply Loctite 5900 to the area at the top of the cover as shown in **Fig. 2**. This seal prevents water from collecting and seeping behind the cover and into the housing.
