# Authorized Field Change

**AFC 13916**

**Subject:** MaxxForce® 15 Powertrain Harness Chafing

Model: ProStar®+  
Start Date: 14 January 2011 End Date: 14 August 2012  
Engine Family: MaxxForce® 15

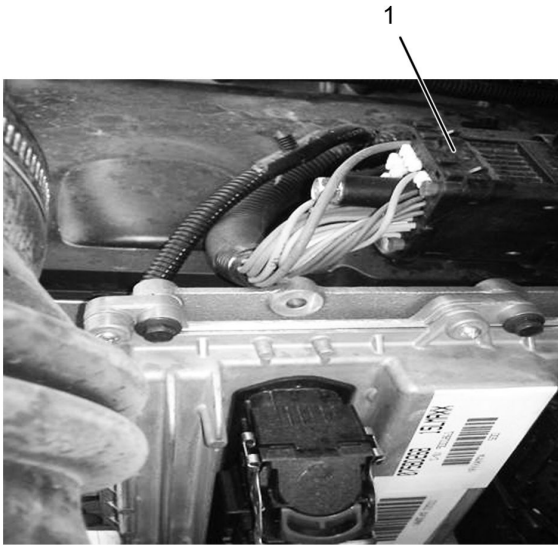
**Figure 1. Powertrain Harness 42-Way Connector without Backshell.**

In certain ProStar®+ trucks with MaxxForce® 15 engines built 14 January 2011 through 14 August 2012, the connector backshell designed to hold the powertrain harness away from the Engine Control Module (ECM) bracket was not installed. Because the backshell is missing, the powertrain harness may rub on the ECM bracket and damage the wires, causing them to short circuit. Shorts in the powertrain harness may lead to the following problems:

1. Powertrain harness 42-way connector

4. Inspect powertrain harness 42-way connector (Figure 1, Item 1) for backshell (Figure 2, Item 1).

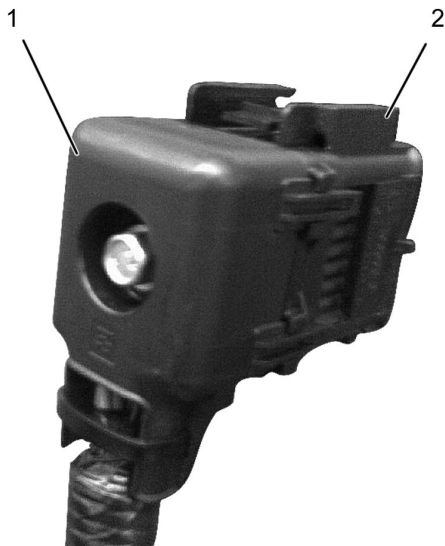
**Figure 2. 42-Way Connector.**

1. Backshell
2. 42-way connector

- a. If backshell (Figure 2, Item 1) is present, proceed to Step 17.
  - b. If backshell is missing (Figure 1), proceed to Step 5.
5. Disconnect negative battery cable.

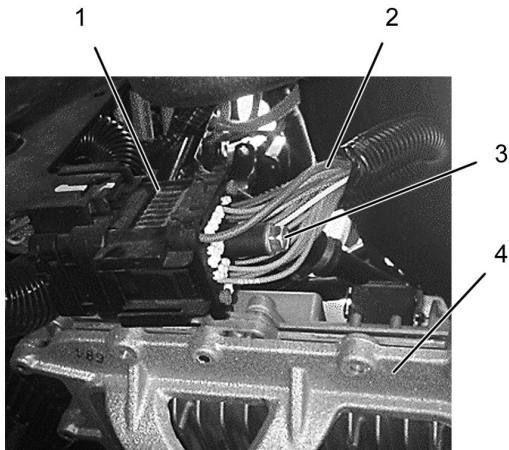
**Figure 3. Powertrain Harness Connection.**

1. Powertrain harness 42-way connector
  2. Powertrain harness circuit wires
  3. Center post bolt
  4. ECM
6. Inspect powertrain harness circuit wires (Figure 3, Item 2) for signs of chafing at ECM (Figure 3, Item 4).
- a. If no chafing is found, proceed to Step 7.
  - b. If wires are chafed but copper is not exposed, install heat shrink over damaged circuit wires.
  - c. If wires are chafed and copper is exposed, follow steps below.
    1. Splice in new circuit wires.
    2. Install heat shrink over splices.
7. Disconnect powertrain harness 42-way connector (Figure 3, Item 1).
8. Remove center post bolt (Figure 3, Item 3).
9. Install backshell (Figure 2, Item 1).
10. Install center post bolt. Using torque wrench, tighten post bolt to 31 lb-in (2.6 N•m).

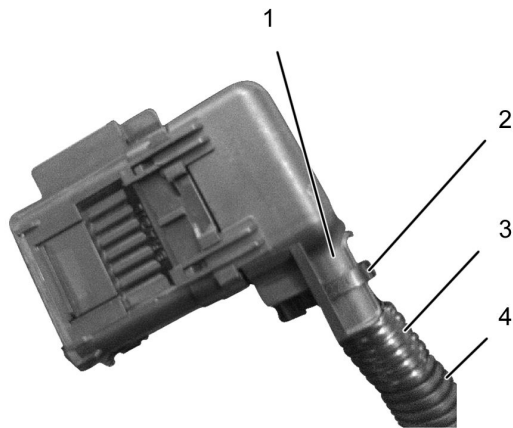
**Figure 4. Repaired Powertrain Harness 42-Way Connector.**

1. Backshell body extension
2. Tie-wrap
3. Taped end
4. Convoluted tubing

11. If needed, add convoluted tubing (Figure 4, Item 4) to cover exposed harness wires up to backshell body extension (Figure 4, Item 1).
12. Tape joints and ends (Figure 4, Item 3) of convoluted tubing, if installed.
13. Tie-wrap (Figure 4, Item 2) backshell extension.

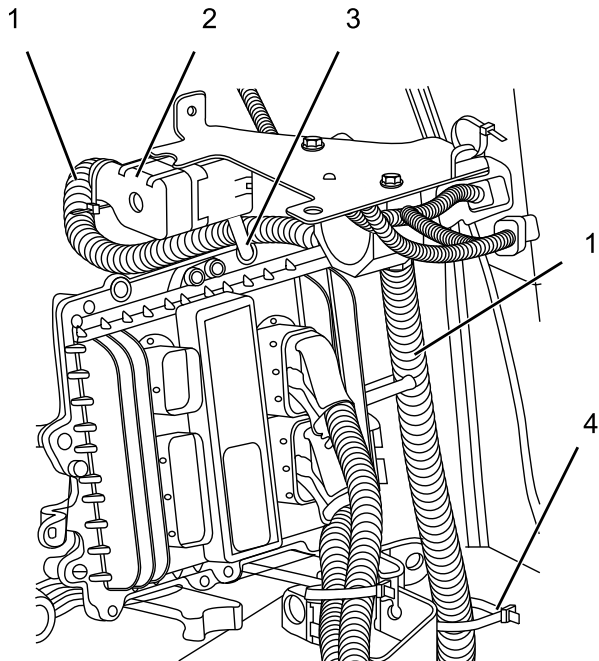
**Figure 5. Powertrain Harness.**

- 1. Powertrain harness 42-way connector
- 2. Powertrain harness
- 3. Fir tree strap
- 4. Cable tie strap

- 14. Connect powertrain harness 42-way connector (Figure 5, Item 1).
- 15. Route powertrain harness (Figure 5, Item 2) toward cab and behind ECM as shown in Figure 5, and secure powertrain harness (Figure 5, Item 2) with fir tree strap (Figure 5, Item 3) and cable tie strap (Figure 5, Item 4).
- 16. Connect negative battery cable.
- 17. Close and latch hood.
- 18. Remove wheel chocks.
