## Eaton® Fuller® Clutches

Diagnostic Procedure for Solo Seized Cam

Troubleshooting Guide CLMT-1308 October 2001

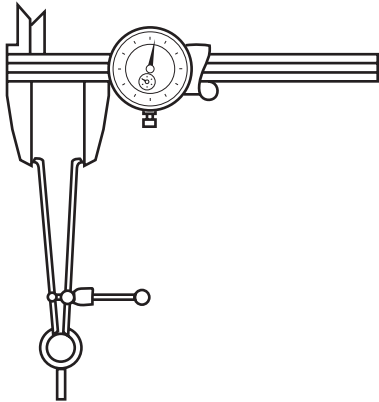
1. Remove inspection cover (replace it when procedure is completed).
2. Tug on the release bearing to ensure it is stretched toward transmission.
3. Use inside caliper to gauge the distance between the release bearing and the clutch brake. Do not force the bearing toward the engine or you will get an incorrect "false" measurement.

4. Measure the calipers.

The correct measurement should be between .490" and .560":

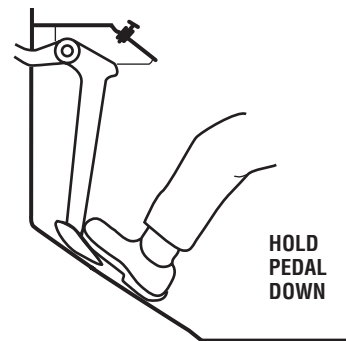
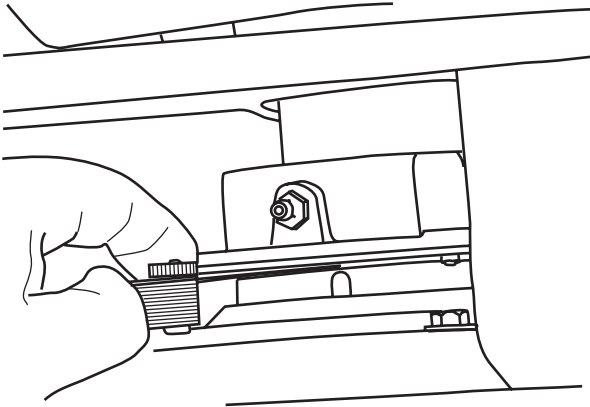
- A. Push pedal down and hold. Verify that bearing moves against clutch brake and will squeeze .010" feeler gauge. Let up on the pedal.

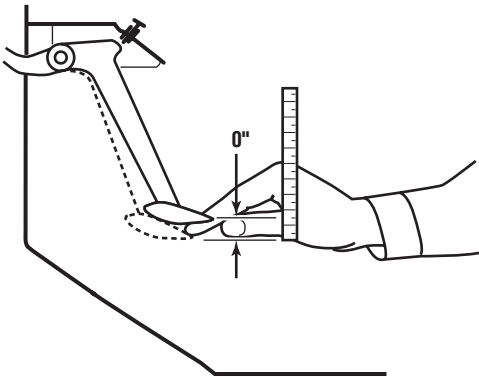
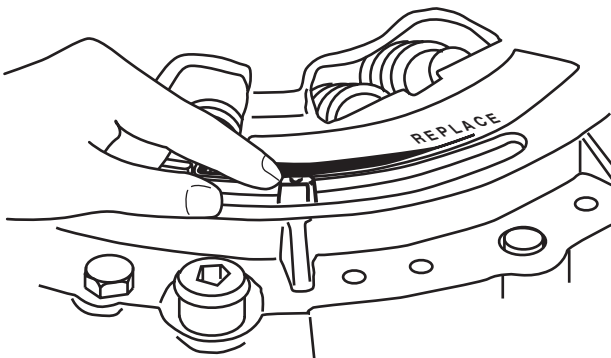
- B. If there is no free pedal and the bearing is still more than .560" from brake, verify that truck linkage moves bearing approximately .600". Then push the pedal down and move the wear indicator to the right toward the "Replace" position. (If the tab moves, then the release bearing should move slightly closer to the brake when the pedal is up.)

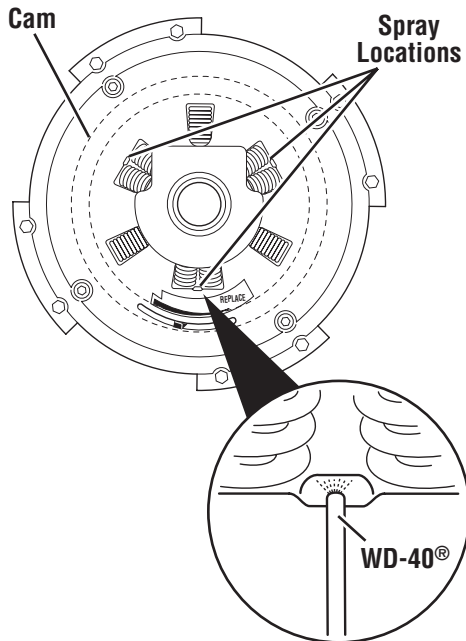
- The cam is a ring 11 inches in diameter.
- A seized cam is caused by grease, dust or other debris building up around the outer perimeter of the cam.
- To free a seized cam, spray generous amounts of WD-40® on to the small lip at each of the three spring perches and into the cam slot.
- Allow the WD-40 to penetrate around the entire cam perimeter.
- Use the tool to help jiggle the cam free.
- Do not use heavy force on the tool; heavy force could break the cam.

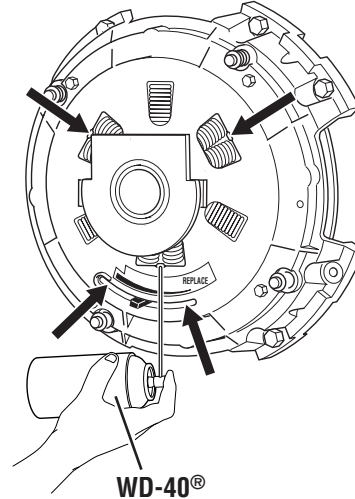
1. Spray WD-40 into cam slot and all three spring perches.
  - Do not substitute another penetrant for WD-40. WD-40 is safe to use with cam material.
  - Make sure there is full penetration of liquid into cam.
  - Rotate engine to access all three locations.

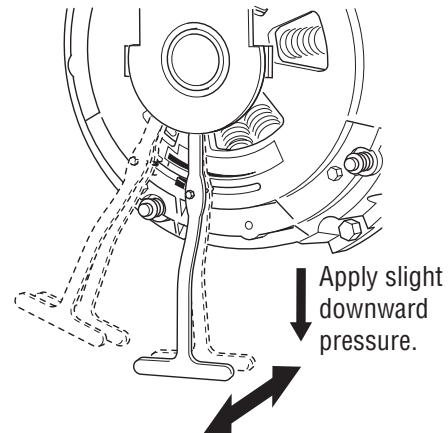
3. Have an assistant hold clutch pedal down.
4. Insert end of tool under bearing.
5. Position tool so that threaded bolt extends down into slot in the cam.

6. Push tool to move cam toward engine. Spray WD-40 into cam slot. Jiggle the tool to free cam. Use finesse, not force.

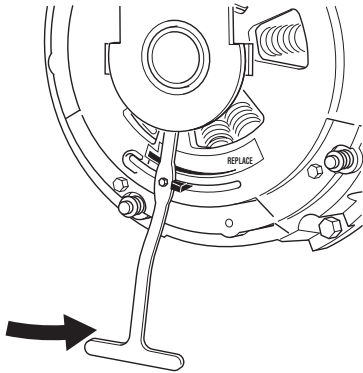
8. Use the tool to move the cam toward the “Replace” position.

Do not force the cam down into the clutch. Instead, use sideways pressure so the cam can rotate.

When the cam moves to the right of the original marked position, the release bearing should have moved closer to the clutch brake, increasing the free pedal in the cab.
