Columbia
Coronado
Business Class M2
> Cascadia

**Freightliner
Service Bulletin**

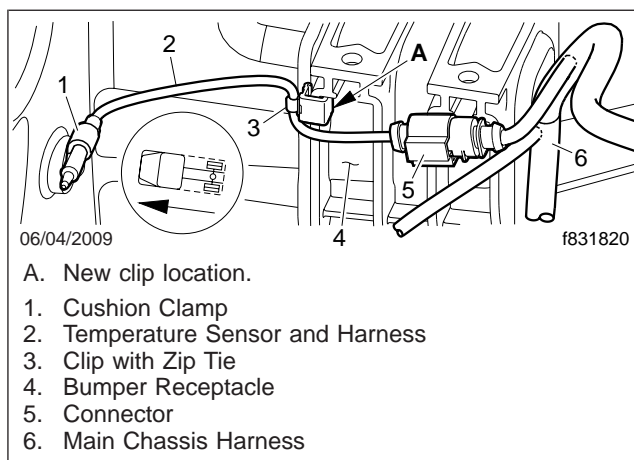
Fig. 1, Ambient Temperature Sensor and Harness Installation

Some Cascadia vehicles built prior to 5/26/09 may have the ambient air temperature sensor harness routed such that it can be chaffed on a radiator baffle. If the harness is rubbed through, the AC may not function. If a failure occurs, install a new sensor and harness per D06-54930-001, detail B. The part and part number have not changed. Only the sensor harness routing has been changed. The new installation can be viewed in EZWiring.

Refer to **Fig. 1** for the new ambient air temperature sensor harness installation.

1. Set the brakes and chock the tires.
2. Open the hood.
3. Disconnect the ambient air temperature sensor harness from the main chassis harness.
4. Pry the clip from the rib on the bumper receptacle, and cut the zip tie.
5. Remove the ambient air temperature sensor from the cushion clamp.
6. Install the new ambient air temperature sensor in the cushion clamp, and connect the sensor harness to the main chassis harness.

NOTE: In the new location, the clip and zip tie will secure the ambient air temperature sensor harness rather than the main chassis harness.

7. Using the original clip and a new zip tie, secure the ambient air temperature sensor harness in the new location on the bumper receptacle, as shown in **Fig. 1**.
8. Close the hood.
