# Cascadia Radiator Strut Rod Rubbing on Upper Radiator Hose

# 20-78

**Freightliner  
Service Bulletin**

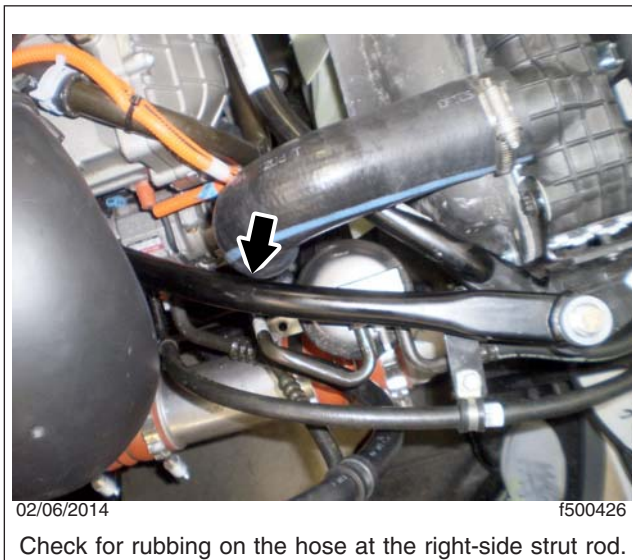
**Fig. 1, Hose Rubbing Area, DD13 Engines**

On vehicles with DD13 engines, rubbing will show near the right-side strut rod. See [Fig. 1](#).

If there is evidence of rubbing, replace the hose and install a new strut rod. Refer to [Table 1](#) under "Parts" for replacement strut rods by vehicle configuration.

2. Remove the strut rod and discard.
3. Remove the damaged radiator hose.
4. Install the new radiator hose.
5. Install the new strut rod.

For DDC engines, tighten the radiator strut rod fasteners at the radiator 55 to 65 lbf-ft (75 to 90 N·m), and at the engine block 125 to 139 lbf-ft (171 to 188 N·m).

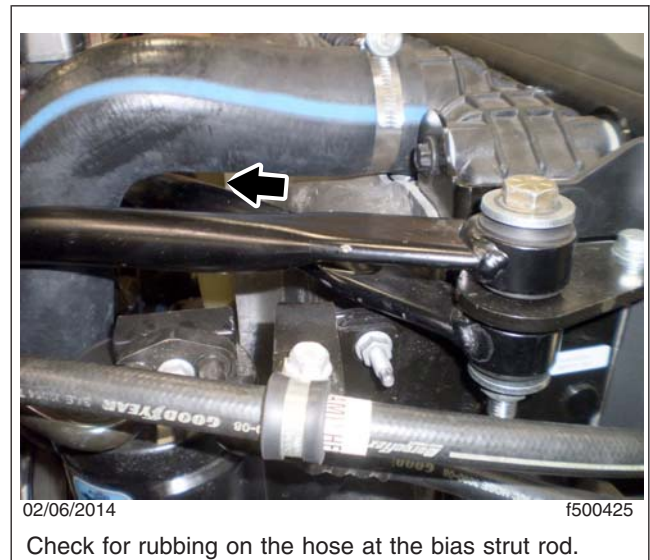
**Fig. 2, Hose Rubbing Area, Cummins ISX Engines**

On vehicles with Cummins ISX engines, rubbing will show near the bias strut rod. See [Fig. 2](#).

For Cummins engines, tighten the radiator strut rod fasteners at the radiator and the engine block 55 to 65 lbf-ft (75 to 90 N·m).
