Freightliner  
Service Bulletin

**Description of Revisions:** *This bulletin replaces the version dated February 2014. Valve cleaning and O-ring installation have been clarified.*

# DEF Tank Coolant Valve O-Ring Kit

# 49-34

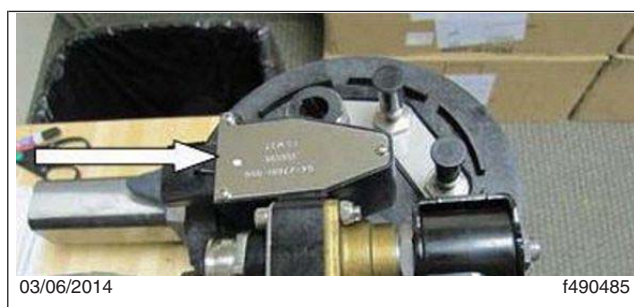
Fig. 1, Adding a White Dot

**IMPORTANT:** Units that are manufactured with the new O-rings will have a yellow dot on the ID plate. Units that have had the O-rings replaced should have a white dot on the ID plate. In the event of a leaking solenoid valve, check the unit for a white or yellow dot on the ID plate. See [Fig. 1](#). If the unit being serviced already has one of these, replace the unit with a new one. If the unit does not have a yellow or white dot on the ID plate, replace the O-rings following the instructions in "Replacement" below.

9. Add a white dot to the ID plate to indicate that the valve is reworked. See [Fig. 1](#).
