Exhaust manifold leakage

Troubleshooting information for leakage or soot buildup around MX-13 exhaust manifold

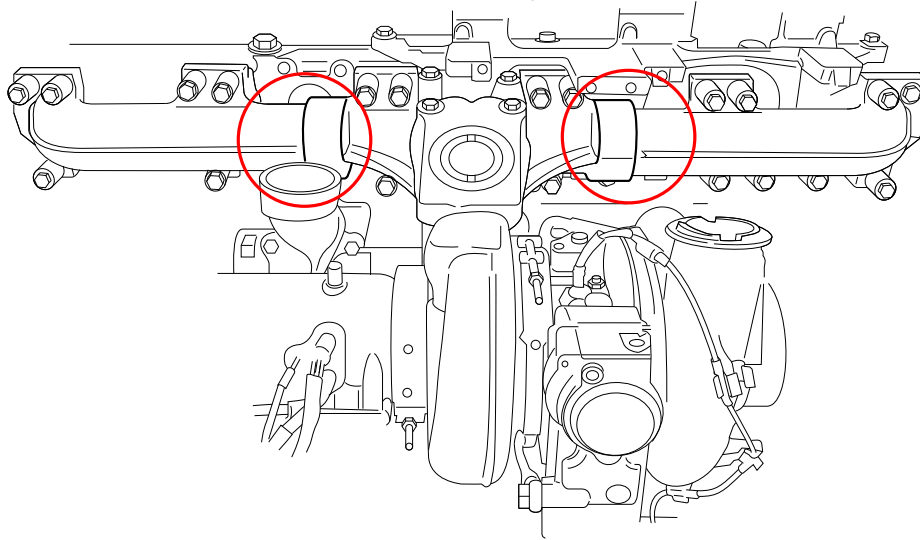
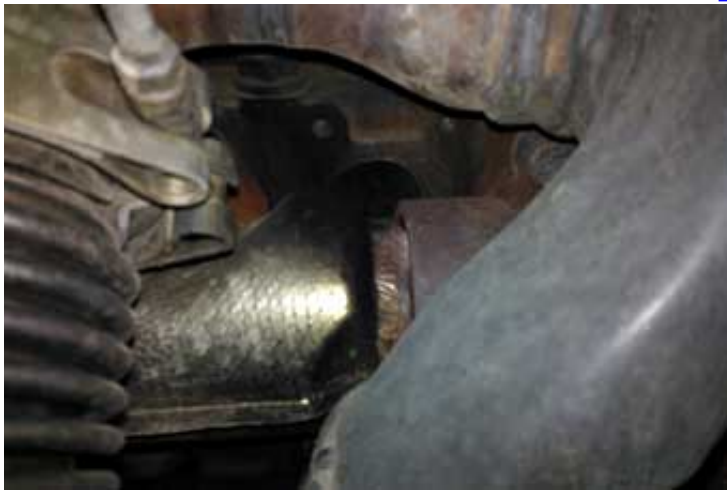
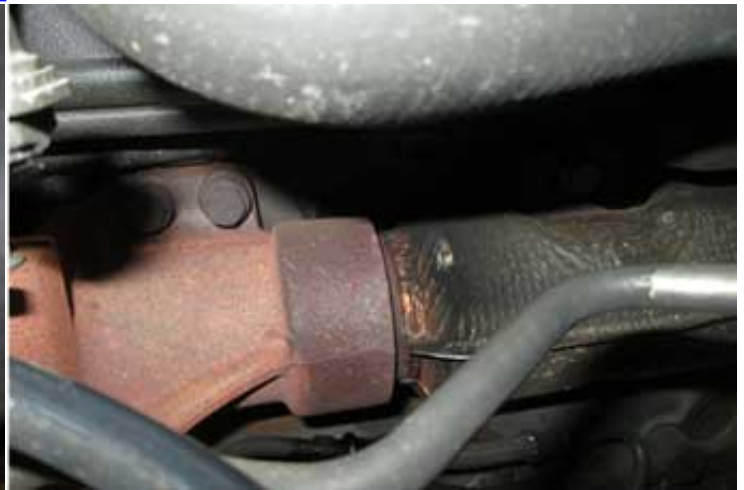
Exhaust manifold sliding connections

Soot accumulation observed at the exhaust manifold sliding connections can be misinterpreted as an indication of exhaust system leakage.

This is mainly observed during the initial engine run-in period, but it can also be observed after an exhaust manifold is dismantled or renewed.

The exhaust manifolds rely on the effects of thermal expansion as well as a small amount of particulate (soot) accumulation to seal minor leak pathways between the manifold sliding connections. A small amount of exhaust leakage and corresponding soot buildup around the exhaust manifold sliding connections is expected during the engine run-in period. This is not necessarily an indication of exhaust system failure or a problem with the related parts. These conditions improve throughout the run-in period when the system self-seals.

However, a small amount of leakage may occur under cold engine conditions, even after the run-in period, because the manifold sliding connections must have relative movement under thermal expansion.

- Allow adequate cooling time before approaching or working on or near any part of the exhaust system or surrounding components.
1. Clean any small amounts of soot accumulation from the manifold insulation.
 2. Warm up the engine to operating temperature, and check this area for further signs of excessive or continued leakages.
