AirLiner™ Suspension Air-Spring Bag Misalignment Troubleshooting

32-40

**Freightliner
Service Bulletin**

Description of Revisions: *This bulletin replaces the version dated May 2010. The part numbers in [Table 2](#) have been revised.*

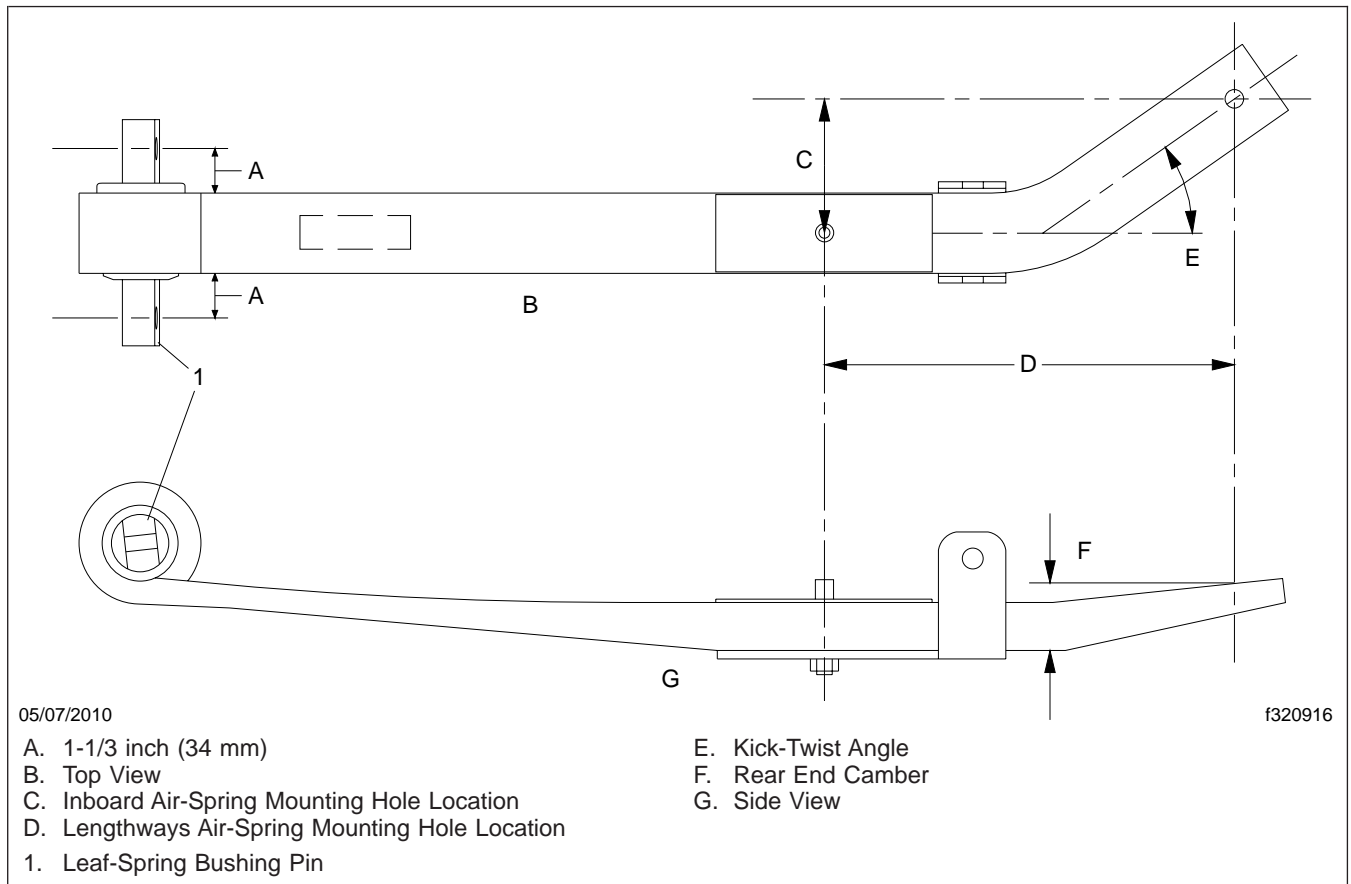
Fig. 3, AirLiner Leaf Spring Critical Dimensions

Dimensions "B" and "C" must not vary from dimension "A" by more than 1/4 inch (6 mm).

- 6.3 If dimensions "B" and "C" vary from dimension "A" by more than 1/4 inch (6 mm), loosen the lateral torque rods at the frame rail and add or subtract shims as necessary, following the instructions in the section titled Freightliner Airliner Rear Suspension, in **Group 32**, of the applicable workshop/service manual.
7. Check that the axle clamps are correctly aligned on the axle housing and not shifted inboard or outboard. See **Fig. 6**. The distance from the brake spider flange to the outside surface of the leaf spring should be 4-7/8 to 5-1/4 inches (124 to 133 mm). The upper axle clamps should align with the dowels on the top surface of the axle housing.
- If the axle clamps are not correctly aligned, raise the vehicle and support the frame rails with safety stands. With the axle supported, loosen the U-bolts then install the axle clamps correctly.

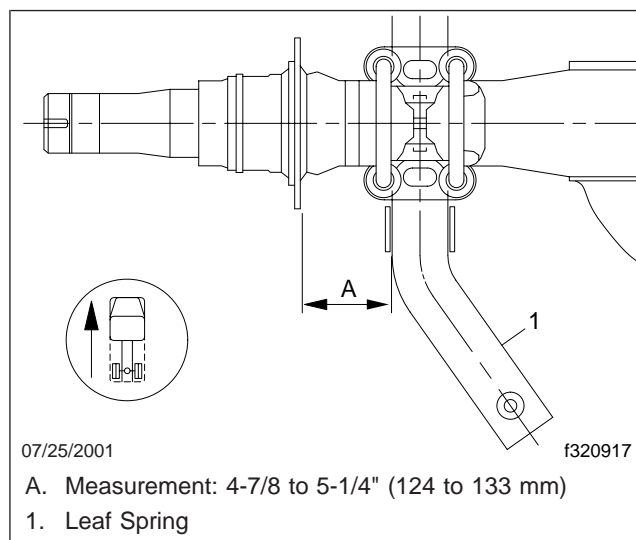
Fig. 6, Axle Clamp/Axle Alignment Measurement

If the difference between these two measurements is more than 3/8 inch (9.5 mm), the leaf spring is out of tolerance. Replace it following the instructions in the section titled Freightliner Airliner Rear Suspension, in **Group 32**, of the applicable workshop/service manual.

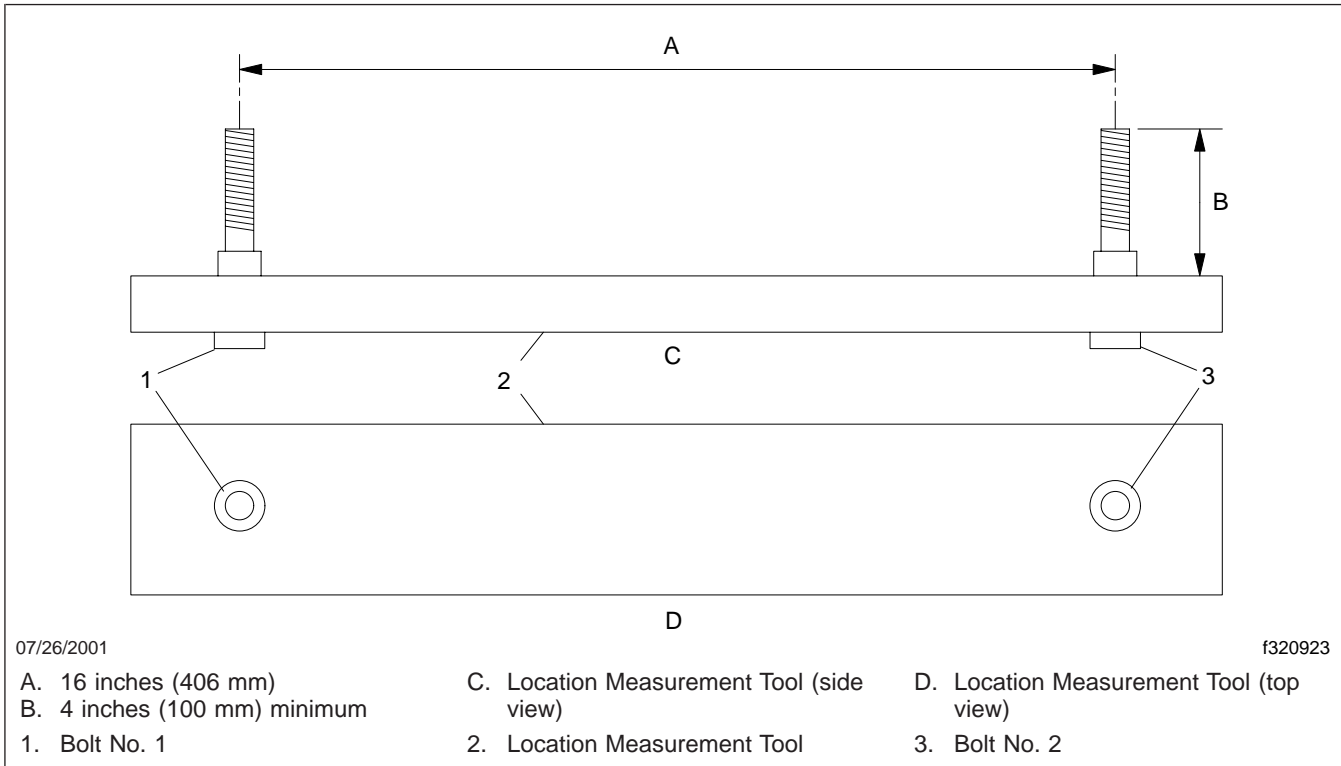
Fig. 9, Air-Spring Mounting Hole Location Measurement Tool

3. Measure the distance between the center of the bolts to ensure that they are exactly 16 inches (406 mm). Correct as necessary until this distance is accurate. See [Fig. 9](#).
4. From under the vehicle, align the center of one of the bolts on the measurement tool with the center-bolt in the lower U-bolt retainer. See [Fig. 10](#).
5. Pivot the measurement tool around to align the second bolt on the measurement tool with the air-spring mounting bolt and nut. Make sure the first bolt is still aligned with the center-bolt in the lower U-bolt retainer. See [Fig. 10](#).
6. If the second bolt aligns with the air-spring mounting bolt and nut, the leaf spring is within this tolerance. No further modification is necessary.

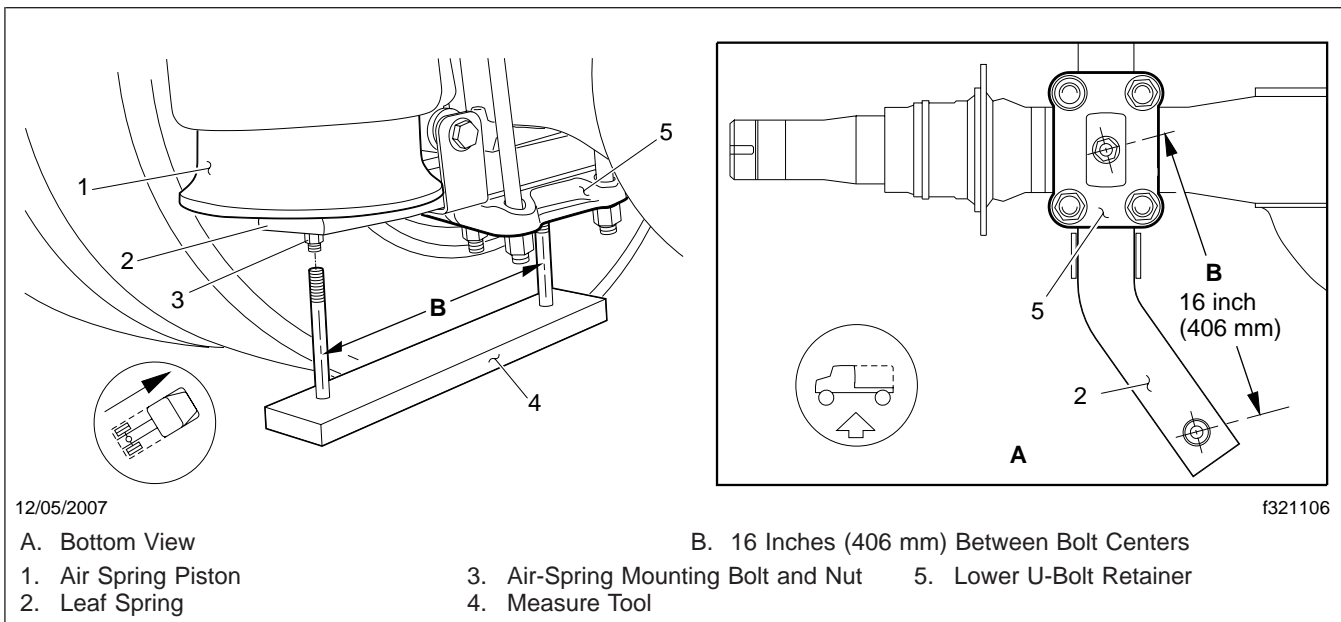
Fig. 10, Measuring the Air-Spring Mounting Hole Location

If the second bolt does not align with the air-spring mounting bolt and nut, the leaf spring is out of tolerance. Replace it, following the instructions in the section titled Freightliner Airliner Rear Suspension, in **Group 32**, of the applicable workshop/service manual.
