Freightliner  
Service Bulletin

**Description of Revisions:** *This bulletin replaces the version dated September 2013. Step 3 of "Resetting the Clutch" has been revised.*

# Clutch-Related No-Start Diagnostics, Cascadia

# 25-34

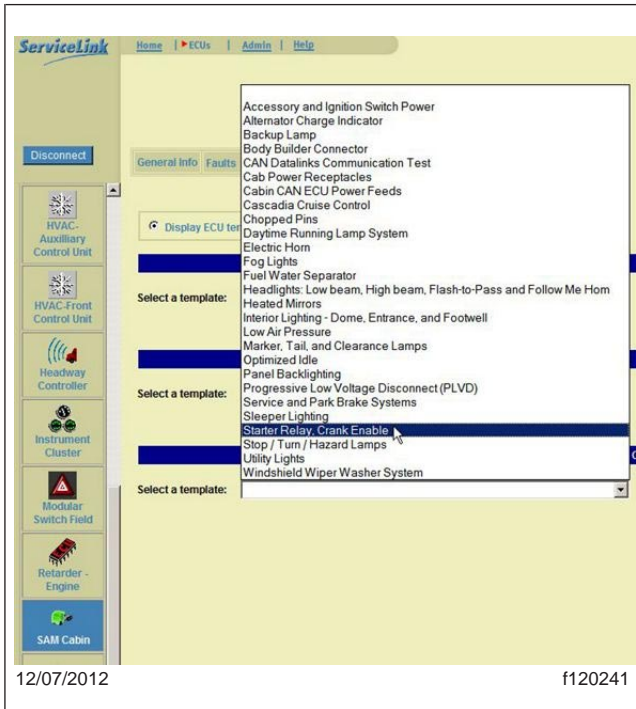
**Fig. 1, ServiceLink Template Menu**

1. Park the vehicle on a level surface, shut down the engine, and set the parking brake. Chock the tires.
2. Make sure the batteries are charged. Turn the ignition key ON.
3. Connect the vehicle to the ServiceLink diagnostic tool. Select the SAM Cab ECU, then go to the "Templates" tab and select "Starter Relay, Crank Enable." See [Fig. 1](#).
4. While pushing the pedal to the point of clutch brake squeeze ([Fig. 2](#)), check the SAM Cab Template. Does the actuation of the pedal switch register? The actuation of the pedal is registered when the "Bottom of Clutch Circuit" indicator turns green and reads "At Bottom," as shown in [Fig. 3](#).
