Eaton UltraShift PLUS[®], UltraShift[®] and AutoShift[®] Transmissions TRTS0930

March 2012

Transmission Models Included

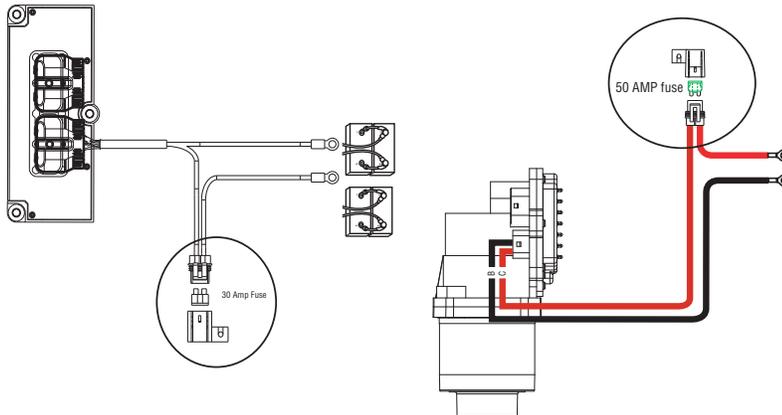
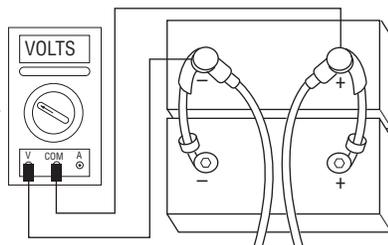
Procedure	Condition	Action
1. Key off.		
2. Remove and clean all battery and battery to frame connections.		
3. Remove and clean ground supply to engine ECU.		
4. Inspect starter/battery and inline 30 amp fuse holder connections for corrosion or damaged contacts.

5. Measure voltage across batteries.

If voltage is 11 to 13 volts on a 12 volt system or 22 to 26 on a 24 volt system

Proceed with battery load test. Repair or replace batteries as required. Go To **STEP B**

Procedure	Condition	Action
1. Key off.		
2. Remove and clean all battery and battery to frame connections.		
3. Remove and clean ground supply to engine ECU.		
4. Inspect starter/battery and inline 30 amp fuse holder connections for corrosion or damaged contacts. Also inspect the 50 amp fuse holder on vehicles equipped with an Electronic Clutch Actuator (ECA).

Refer to OEM guidelines for battery load test. Repair or replace batteries as required. Go to **STEP B**

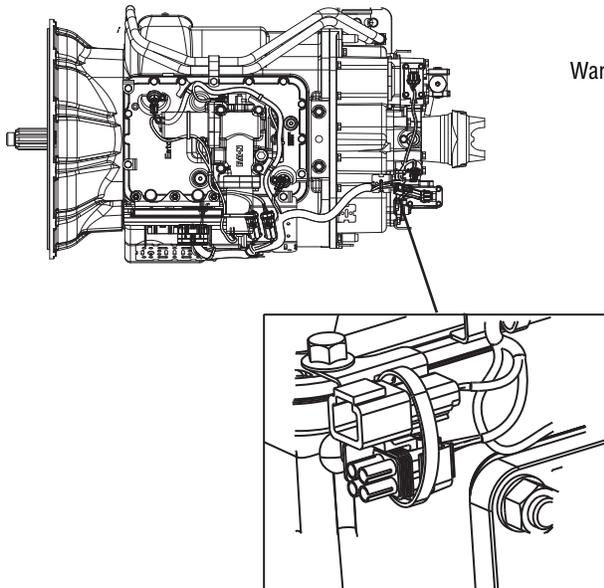
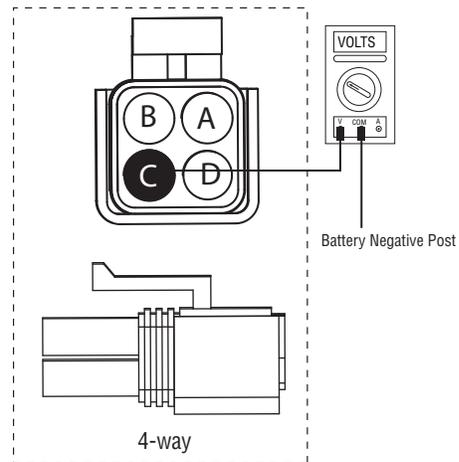
4-Pin Diagnostic Port
(Located at the left rear corner of the transmission.)

Procedure	→	Condition	→	Action
1. Locate diagnostic port on Transmission Harness.				
2. Key on.				
3. Measure voltage between pins C and the battery negative post.		If voltage between pin C and the battery negative post is 0.70 volts or less		Go to STEP C
		If voltage is outside of range		Repair battery ground supply to Transmission ECU. Repeat test.

Warning! - Do Not Load Test at Diagnostic Port
4-Pin Diagnostics Port

B - Service Bat. +
C - Service Bat. -
A - Service Ignition +

Procedure	Condition	Action
1. Locate diagnostic port on Transmission Harness.		
2. Key on.		
3. Measure voltage between pins C and the battery negative post.	If voltage between pin C and the battery negative post is 0.70 volts or less	Go to STEP C
	If voltage is outside of range	Repair battery ground supply to Transmission ECU. Repeat test.

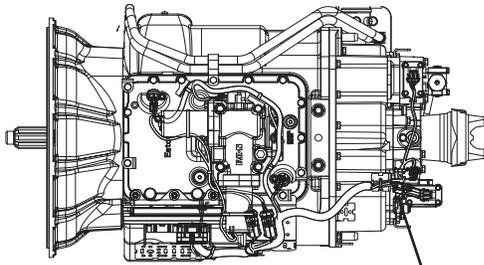
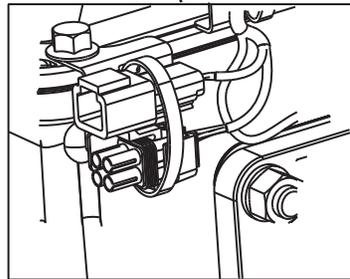
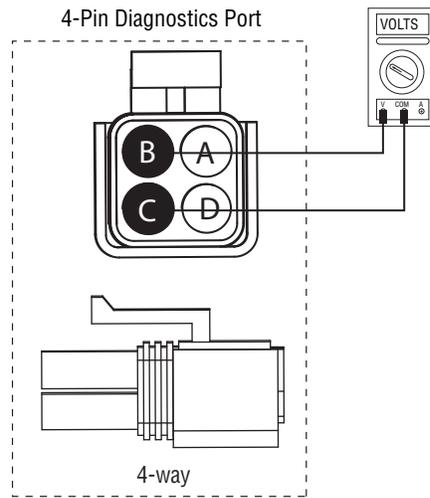
4-Pin Diagnostic Port
(Located at the left rear corner of the transmission.)

Procedure	→	Condition	→	Action
1. Locate diagnostic port on Transmission Harness.				
2. Key on.				
3. Measure voltage between pins B and pin C.		If voltage between pins B and C is within 0.6 volts of battery voltage		Go to STEP D
		If voltage is outside of range		Repair battery power supply to Transmission ECU. Fuse may be blown. Repeat test.

Warning! - Do Not Load Test at Diagnostic Port

B - Service Bat. +
C - Service Bat. -
A - Service Ignition +

Procedure	→	Condition	→	Action
1. Locate diagnostic port on Transmission Harness.				
2. Key on.				
3. Measure voltage between pins B and pin C.		If voltage between pins B and C is within 0.6 volts of battery voltage		Go to STEP D
		If voltage is outside of range		Repair battery power supply to Transmission ECU. Fuse may be blown. Repeat test.

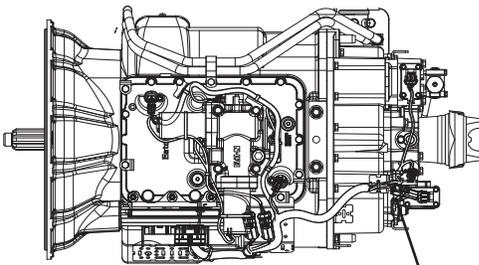
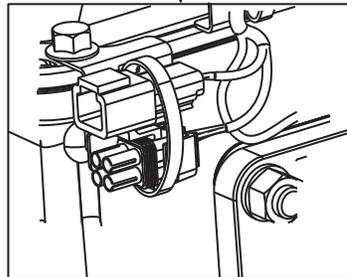
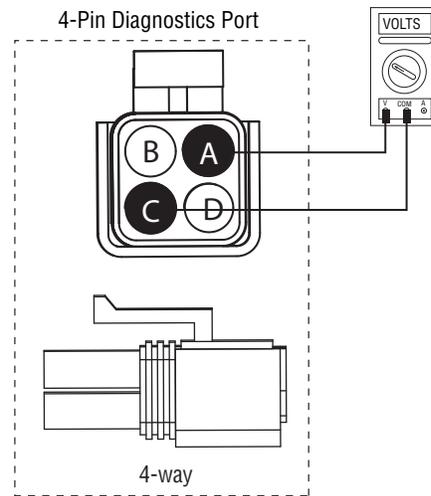
4-Pin Diagnostic Port
(Located at the left rear corner of the transmission.)

Procedure	Condition	Action
1. Key on.		
2. Measure voltage between pin A and pin C.	If voltage between pins A and C is within 0.6 volts of battery voltage	Go to STEP E
	If voltage is outside of range	Repair Ignition power supply to ECU. Fuse may be blown. Repeat test.

Warning! - Do Not Load Test at Diagnostic Port

B - Service Bat. +
C - Service Bat. -
A - Service Ignition +

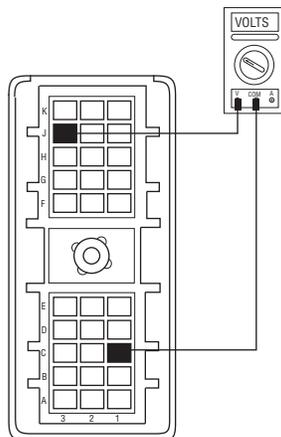
Procedure	→	Condition	→	Action
1. Key off.				
2. Disconnect Shift Control 30-way connector.				
3. Key on.				
4. Measure voltage between Shift Control 30-way pins C1 and J3.		If voltage is within 1 volt of battery voltage		Replace Shift Control. Go to STEP V
		If voltage is outside of range		Go to STEP I

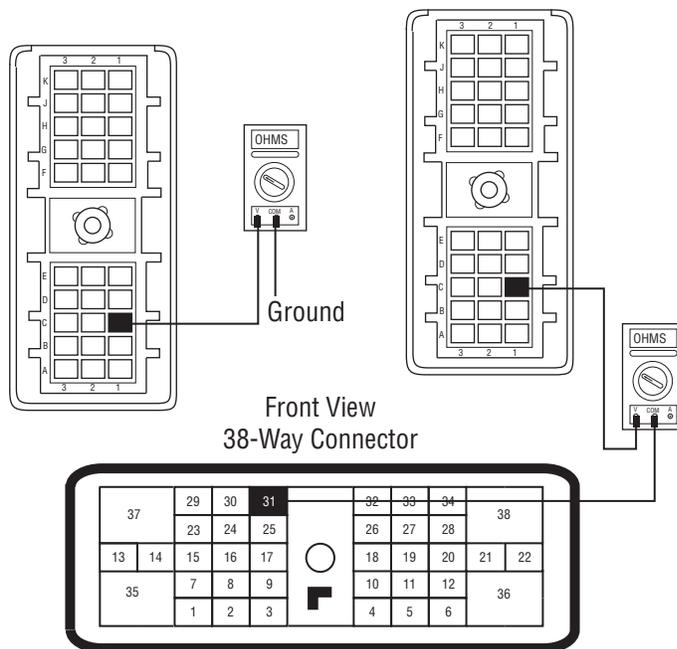
Procedure	Condition	Action
1. Measure resistance between Transmission ECU pin 31 and Shift Control connector pin C1 and then from pin C1 to ground.	If resistance from pin 31 to C1 is 0 to 0.3 ohms and resistance from C1 to ground is 10K or OL	Replace the Transmission ECU. Go to STEP V
	If resistance is outside of range	Repair the OEM harness. Go to STEP V

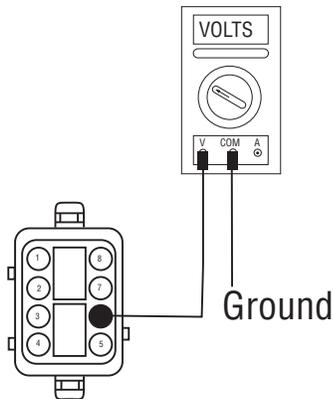
Procedure	Condition	Action
1. Disconnect Shift Lever 8-way connector.		
2. Key on.		
3. Measure voltage at pin 6 and ground.	If voltage is within 2 volts of battery voltage for one second, then 0 volts	Replace the Eaton Shift Lever. Go to STEP V
	If voltage is constant	Go to STEP O

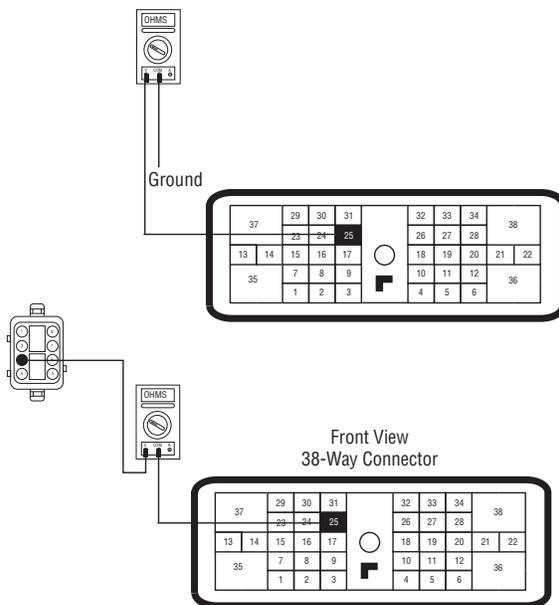
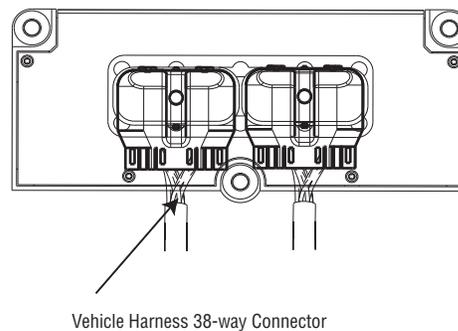
Procedure	→	Condition	→	Action
1. Key off				
2. Disconnect 38-way Vehicle Harness connector on Transmission ECU.				
Note: On Peterbilt disconnect Gear Display				
3. Measure resistance between pin 3 on the 8-way connector and pin 25 on the 38-way connector and from pin 25 to ground.		If resistance between pin 3 and 25 is 0 to 0.3 ohms and resistance from pin 25 to ground is OL.		Go to STEP R
		If resistance is outside of range		Repair harness between Vehicle Harness 38-way connector pin 25 and Vehicle Harness 8-way connector pin 3. Go to STEP V

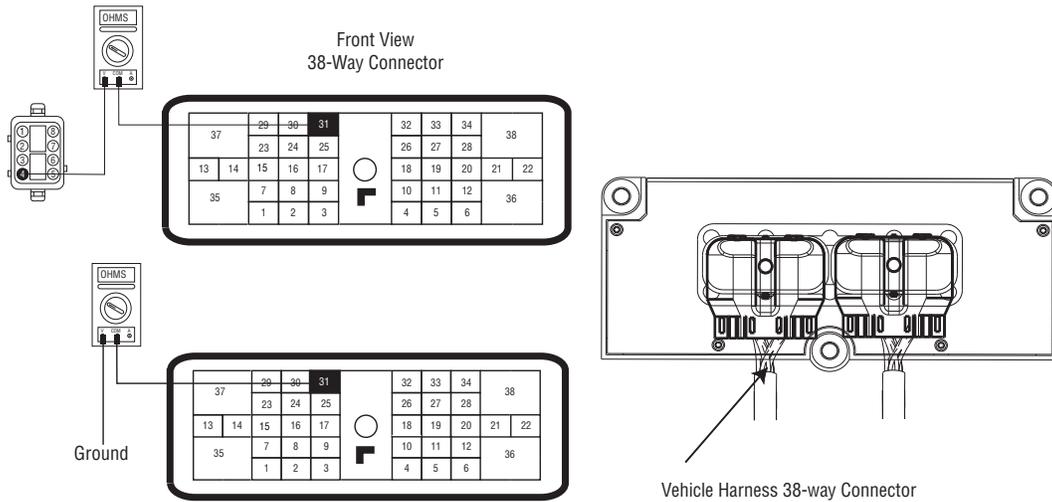
Procedure	→	Condition	→	Action
1. Key off.				
2. Measure resistance between:		If resistance between pins 31 and 4 is 0 to 0.3 ohms and if resistance between pin 31 and ground is OL.		Replace Transmission ECU. Go to STEP V
<ul style="list-style-type: none"> Vehicle Harness 38-way connector pin 31 and Vehicle Harness 8-way connector pin 4 Vehicle Harness 38-way connector pin 31 and ground 		If any of the above conditions are not met		Repair harness between Vehicle Harness 38-way connector pin 31 and Vehicle Harness 8-way connector pin 4. Go to STEP V

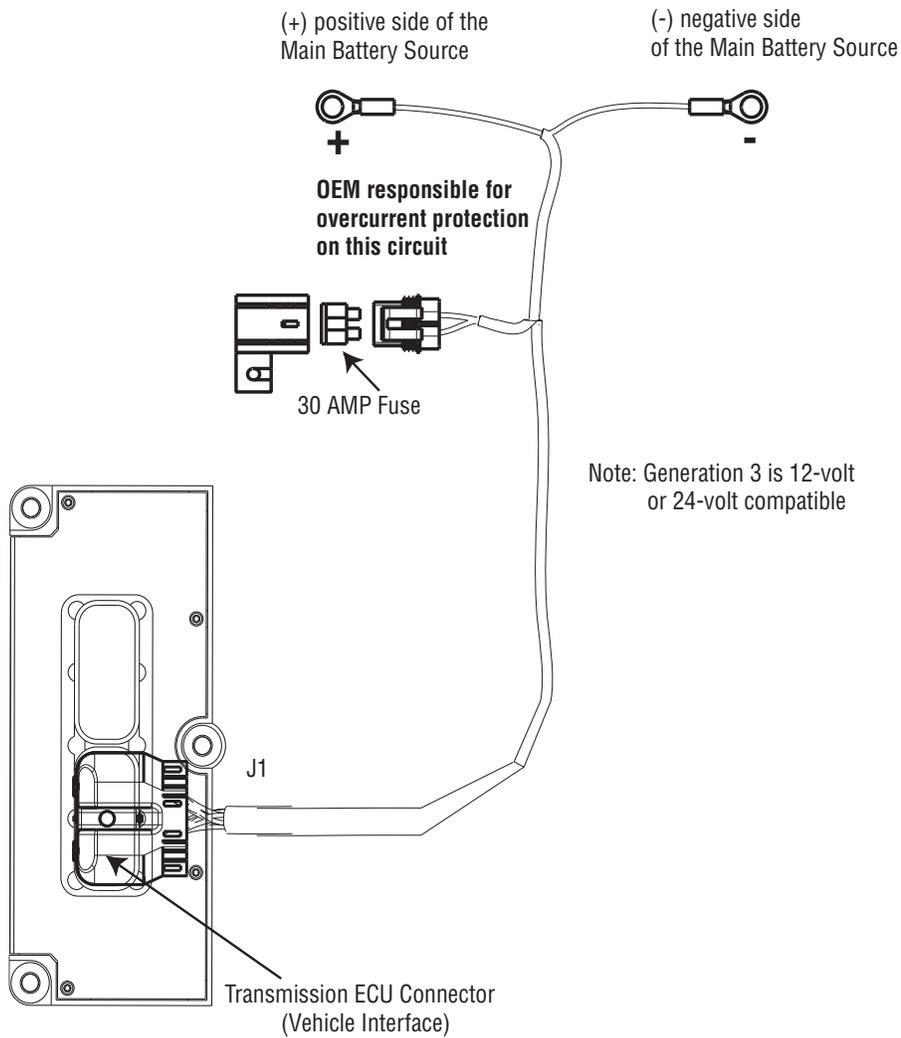
Transmission ECU Power Harness

<p>The Transmission ECU and ECA must be wired to a non-switched power source at the battery. IF a disconnect switch is required, the recommended practice is to wait a minimum of three minutes before using the disconnect switch.</p>
<p>It is the OEM responsibility to provide power and ground to the Transmission Controller (TECU) and Electric Clutch Actuator (ECA) from a reliable battery source from the battery which supplies the starter. The power (+) connection must include overload protection per Federal Motor Carrier Safety Regulations, Section 393.31. The TECU Main Power and Ground must be a direct connection from the battery posts to the TECU connector. At 120° C, these conductors must be able to carry 30 amps @ 9 volts with no more than 0.05 ohms per wire (0.1 ohms total) for a total voltage drop from the battery posts to the TECU connector not to exceed 3.0 volts. ECA Main Power and Ground must be able to carry 50 amps @ 9 volts with no more than 0.025 ohms per wire (.05 ohms total) at 120° C. Duration of the 50 amp current draw will not exceed 20 milliseconds.</p>

<p>The Main Power 30 amp fuse connection for the Transmission ECU must be identified with a tag at the battery.</p>
<p>The Main Power 50 amp fuse connection for the Electric Clutch Actuator (ECA) must be identified with a tag at the battery.</p>
<p>Battery Positive and Negative must be disconnected PRIOR to any type of welding on any Fuller Automated transmission-equipped vehicles.</p>
<p>Removal of fuses is not recommended as the method of disconnecting power from the ECU. Making and breaking a circuit through tin plated terminals (e.g. ring terminals, fuses, most connectors) will destroy the plating on the terminal. Opening a switch contact or the main power link is the recommended method of interrupting power.</p>
<p>Application of more than 36 volts to the system (such as jump-starting) will cause system shutdown and possible electrical component damage.</p>
<p>Battery and Ignition power and ground to the TECU must not be switched off during the engine start process.</p>

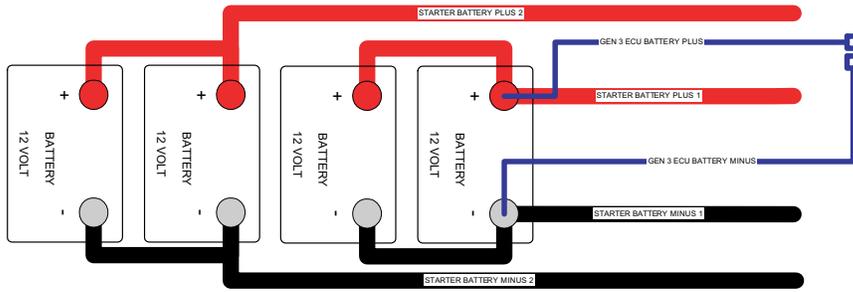
TWO BATTERY BANKS - TWO BATTERIES PER BANK - DUAL JUMPERS TO STARTER
 BATTERIES ARE CONNECTED IN PARALLEL BY PAIRS. GEN 3 POWER SUPPLIED BY BATTERY CLOSEST TO STARTER (BOTH PLUS AND MINUS)

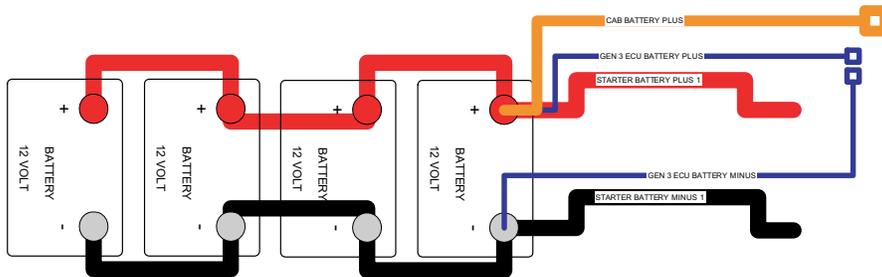
ONE BATTERY BANK - FOUR BATTERIES
 BATTERIES ARE CONNECTED IN PARALLEL. GEN 3 POWER SUPPLIED FROM BATTERY CLOSEST TO STARTER WITH CAB POWER. (BOTH PLUS AND MINUS)

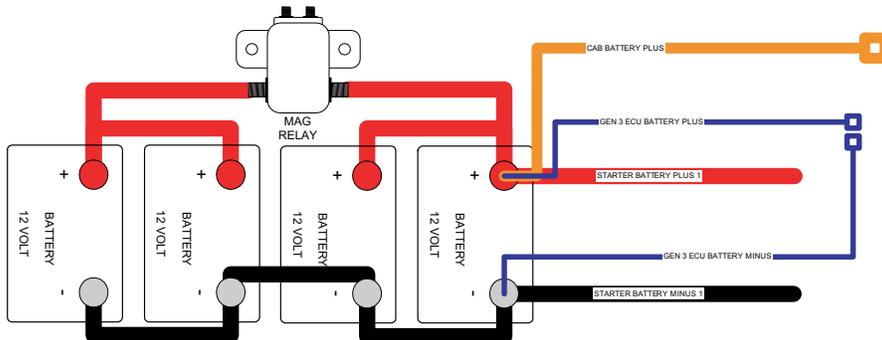
TWO BATTERY BANKS - TWO BATTERIES PER BANK WITH DISCONNECT
 BATTERIES ARE CONNECTED IN PARALLEL BY PAIRS - DISCONNECT FOR CAB AND VEHICLE START - DISCONNECTED PAIR PROVIDES "DEEP DISCHARGE" CAB COMFORT AND ENTERTAINMENT CAPABILITY. GEN 3 POWER SUPPLIED FROM BATTERY SET CLOSEST TO STARTER AND COMMON TO CAB POWER

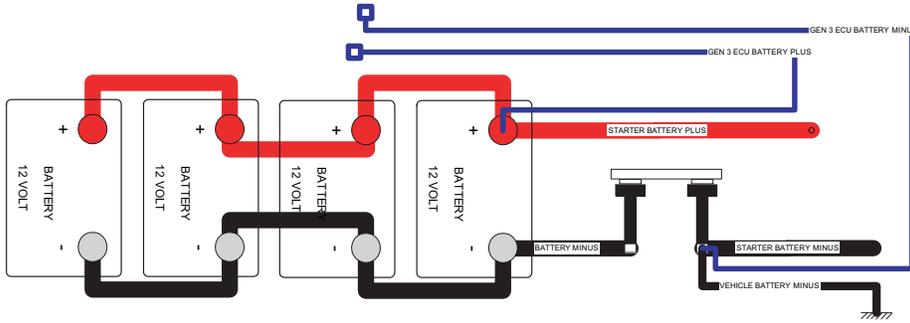
TWO BATTERY BANKS - BATTERY NEGATIVE DISCONNECT SWITCH
 BATTERIES ARE DISCONNECTED AT POWER DOWN WHEN VEHICLE STORED INSIDE. GEN 3 POWER SUPPLIED FROM BATTERY CLOSEST TO THE STARTER. NEGATIVE CONNECTION AT POINT OF VEHICLE CABLE CONNECTION TO DISCONNECT SWITCH

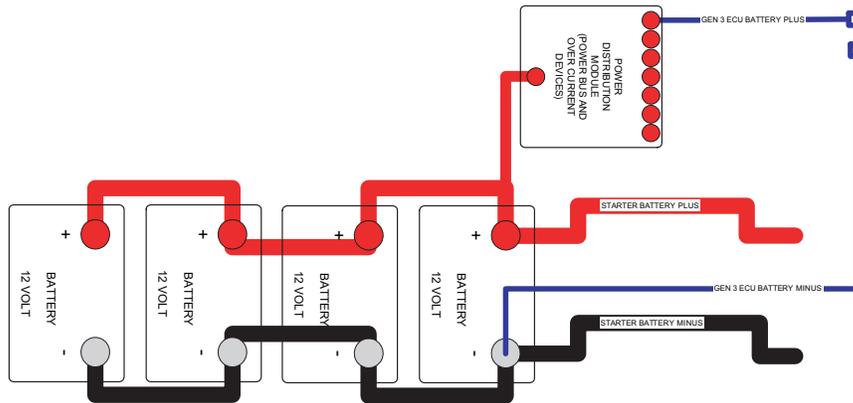
POWER DISTRIBUTION MODULE
 BATTERIES ARE CONNECTED IN PARALLEL, POWER PLUS AND MINUS CONNECTED ON BATTERY CLOSEST TO THE STARTER. CABLES SIZE AND LENGTH OPTIMIZED FOR LOW VOLTAGE DROP

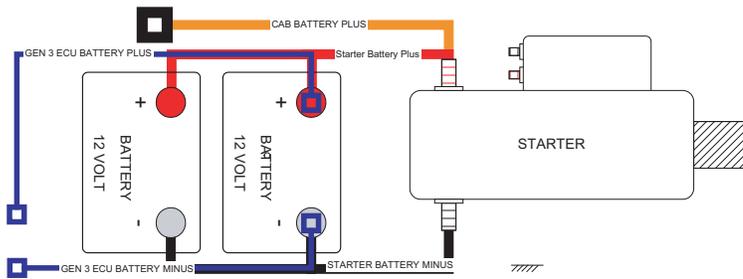
STARTER BATTERY CONNECTION
 GEN 3 POWER PLUS AND MINUS CONNECTED ON BATTERY CLOSEST TO THE STARTER.

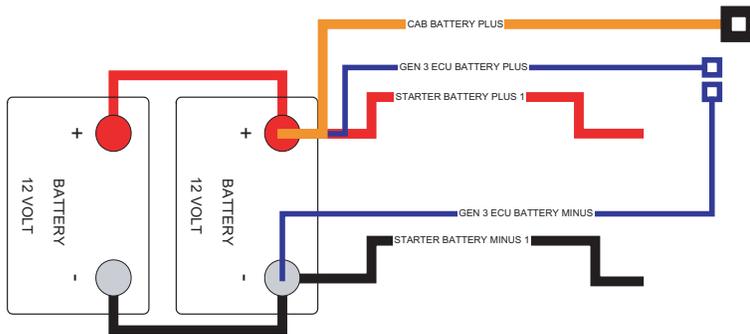
ONE BATTERY BANK - TWO BATTERIES
 BATTERIES ARE CONNECTED IN PARALLEL. GEN 3 POWER SUPPLIED FROM BATTERY CLOSEST TO STARTER WITH CAB POWER. (BOTH PLUS AND MINUS)

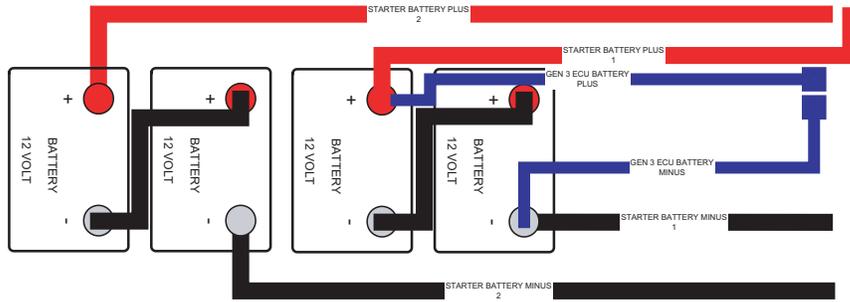
TWO BATTERY BANKS - TWO BATTERIES IN SERIES PER BANK - DUAL JUMPERS TO STARTER
 BATTERIES ARE CONNECTED IN SERIES/PARALLEL BY PAIRS. GEN 3 POWER SUPPLIED BY BATTERY CLOSEST TO STARTER (BOTH PLUS AND MINUS)

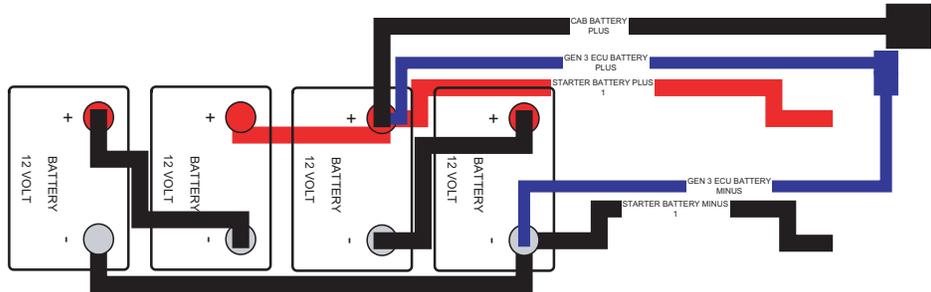
ONE BATTERY BANK - FOUR BATTERIES - ONE CABLE PAIR TO STARTER
 BATTERIES ARE CONNECTED IN SERIES/PARALLEL BY PAIRS. GEN 3 POWER SUPPLIED FROM BATTERY CLOSEST TO STARTER WITH CAB POWER. (BOTH PLUS AND MINUS)

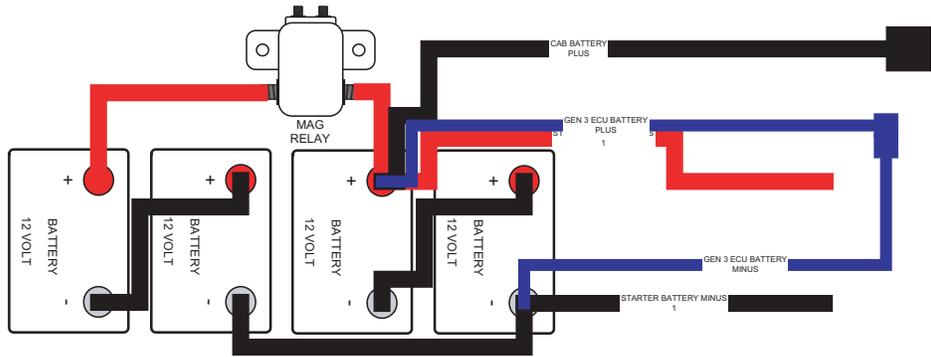
TWO BATTERY BANKS - TWO BATTERIES PER BANK WITH DISCONNECT
 BATTERIES ARE CONNECTED IN SERIES/PARALLEL BY PAIRS - DISCONNECT FOR CAB AND VEHICLE START - DISCONNECTED PAIR PROVIDES "DEEP DISCHARGE" CAB COMFORT AND ENTERTAINMENT CAPABILITY. GEN 3 POWER SUPPLIED FROM BATTERY SET CLOSEST TO STARTER AND COMMON TO CAB POWER

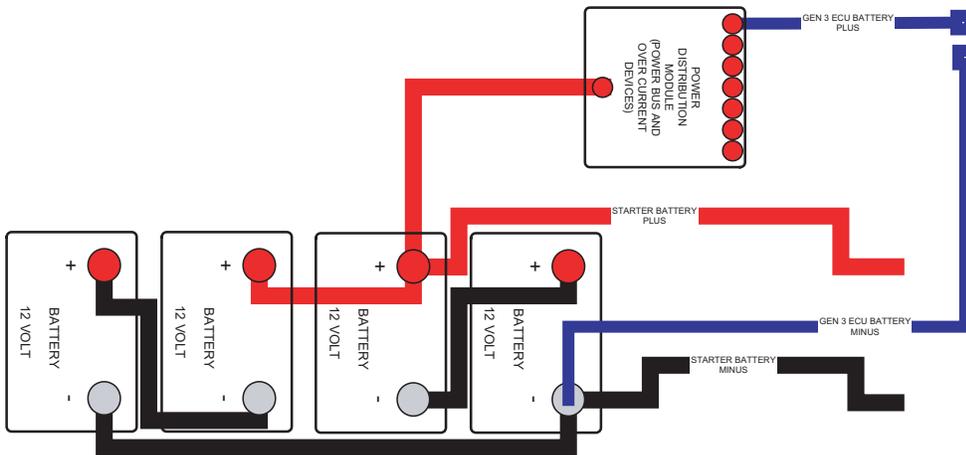
TWO BATTERY BANKS - BATTERY NEGATIVE DISCONNECT SWITCH
 BATTERIES ARE DISCONNECTED AT POWER DOWN WHEN VEHICLE STORED INSIDE. GEN 3 POWER SUPPLIED FROM BATTERY CLOSEST TO THE STARTER. NEGATIVE CONNECTION AT POINT OF VEHICLE CABLE CONNECTION TO DISCONNECT SWITCH

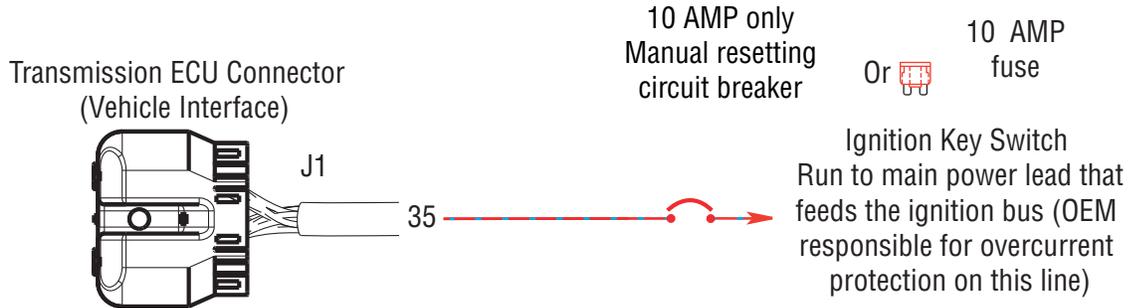
Transmission ECU Ignition Circuit

Ignition Circuit Detail

Battery and Ignition power and ground to the TECU must not be switched off during the engine start process.

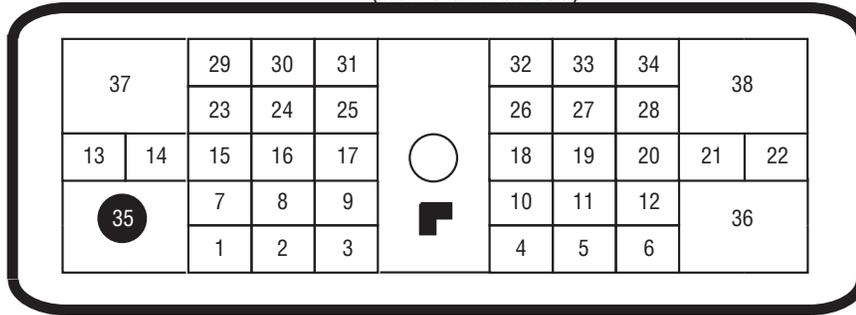
Front View
Transmission ECU Connector
(Vehicle Interface)

FROM	TO
J1-35	VIGN

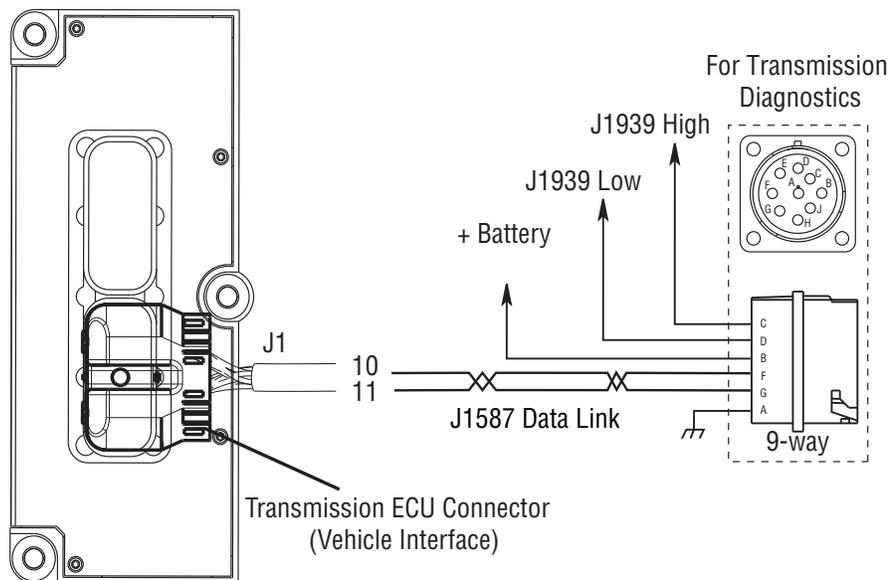
J1939 Data Link

- Check the resistance of the J1939 Data Link.
- With the Key-OFF, measure resistance between the 9-pin diagnostic connector pins C and D and record the reading. The reading should be 60 ohms of resistance (between 50 and 70.)
- Check resistance between pins C and A and D and A. These two readings should be 10K ohms or greater (open circuit).

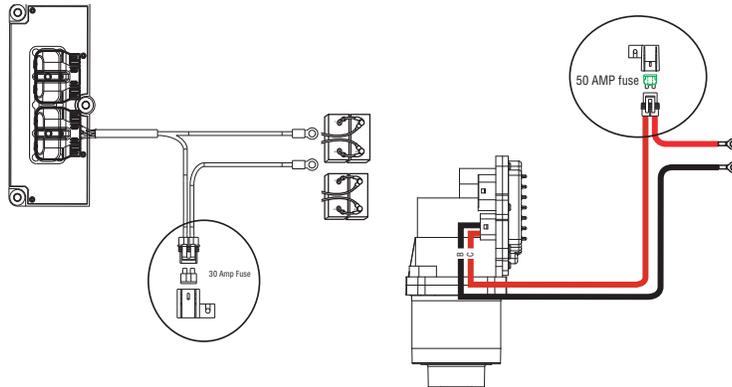
5. Measure voltage across batteries.

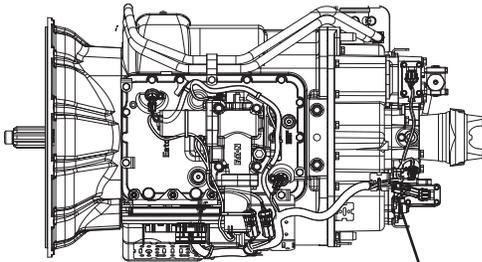
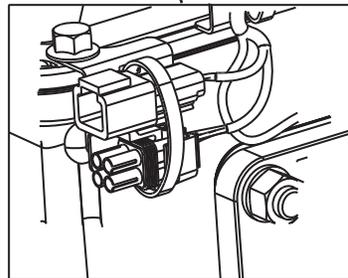
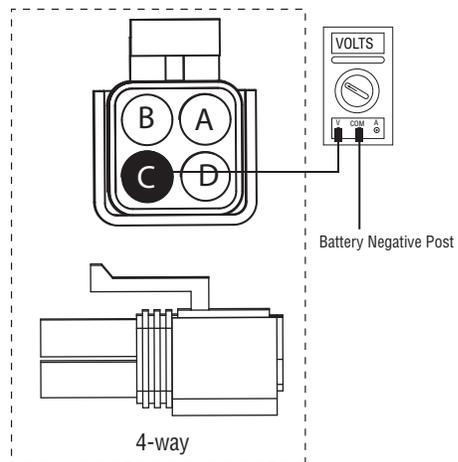
4-Pin Diagnostic Port
(Located at the left rear corner of the transmission.)

Warning! - Do Not Load Test at Diagnostic Port
4-Pin Diagnostics Port

B - Service Bat. +
C - Service Bat. -
A - Service Ignition +

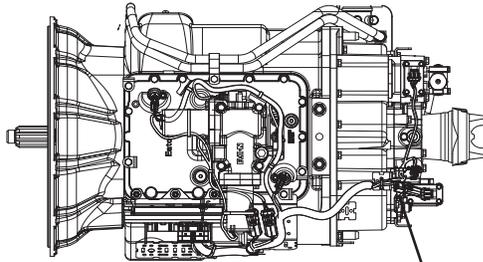
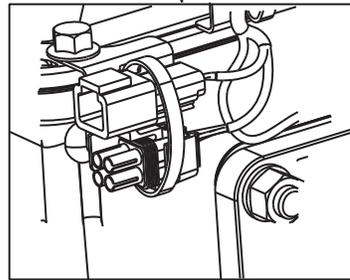
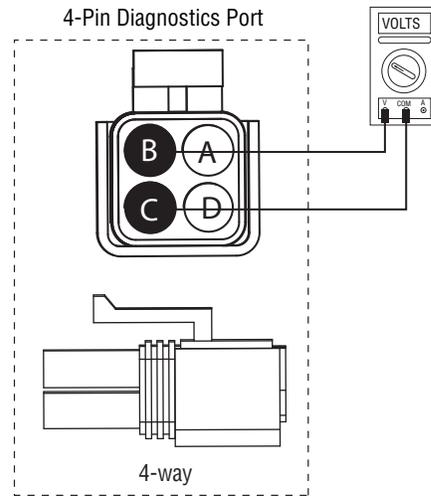
4-Pin Diagnostic Port
(Located at the left rear corner of the transmission.)

Warning! - Do Not Load Test at Diagnostic Port

B - Service Bat. +
C - Service Bat. -
A - Service Ignition +

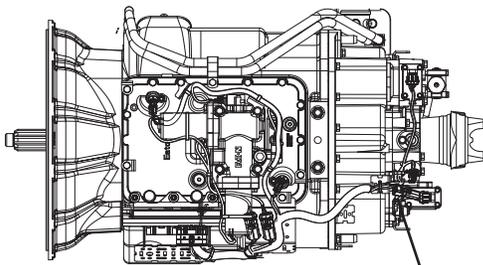
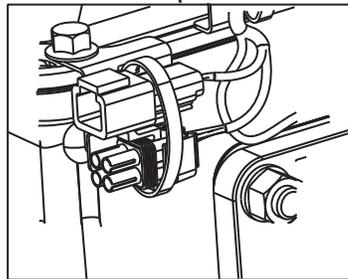
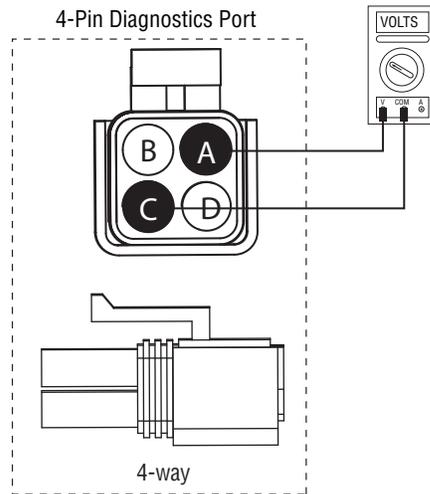
4-Pin Diagnostic Port
(Located at the left rear corner of the transmission.)

Procedure	Condition	Action
1. Key on.		
2. Measure voltage between pin A and pin C.	If voltage between pins A and C is within 0.6 volts of battery voltage	For non-ECA products, test complete. Return to diagnostic procedure. For ECA products, go to STEP E
	If voltage is outside of range	Repair Ignition power supply to ECU. Fuse may be blown. Repeat test.

Warning! - Do Not Load Test at Diagnostic Port

- B - Service Bat. +
- C - Service Bat. -
- A - Service Ignition +

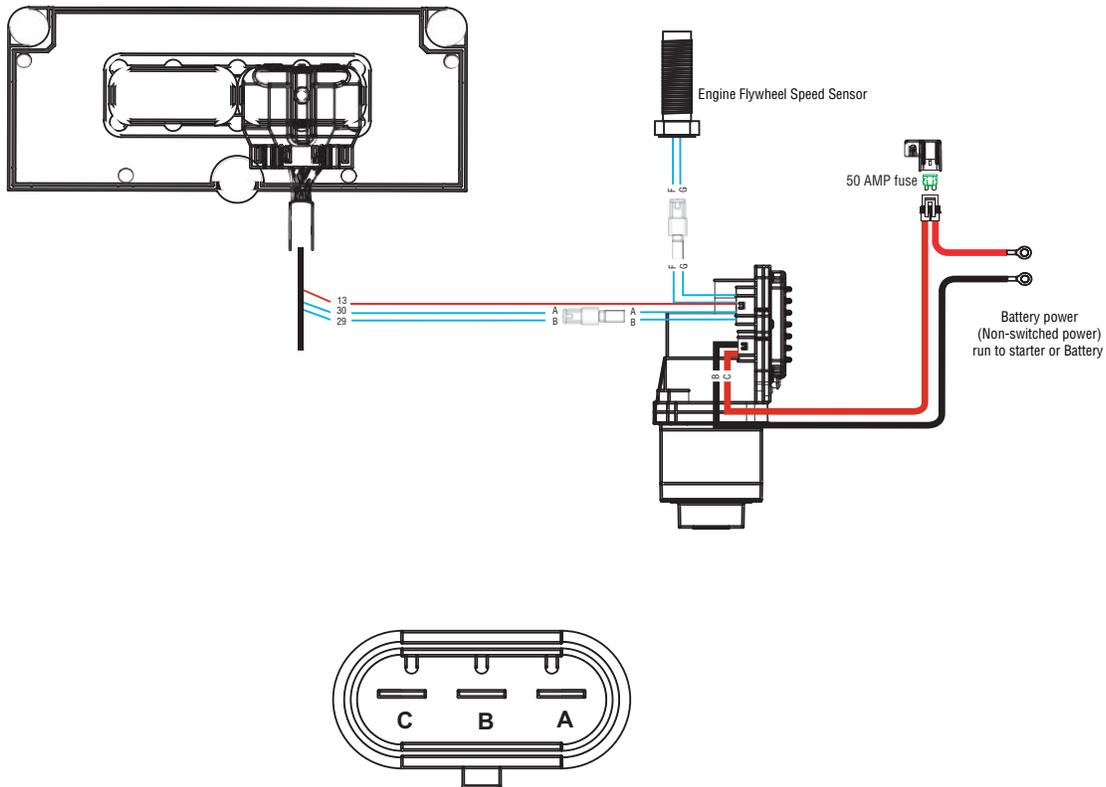
Procedure	→	Condition	→	Action
1. Key off.				
2. Disconnect battery negative.				
3. Disconnect ECA 3-way connector.				
4. Reconnect battery negative.				
5. Measure voltage between pin B and pin C of 3-way connector.		If voltage between pin B and pin C of 3-way connector is within 0.6 volts of battery voltage:		Test complete. Return to diagnostic procedure.
		If voltage is outside of range		Repair battery power supply to ECA. Fuse may be blown. Repeat test.

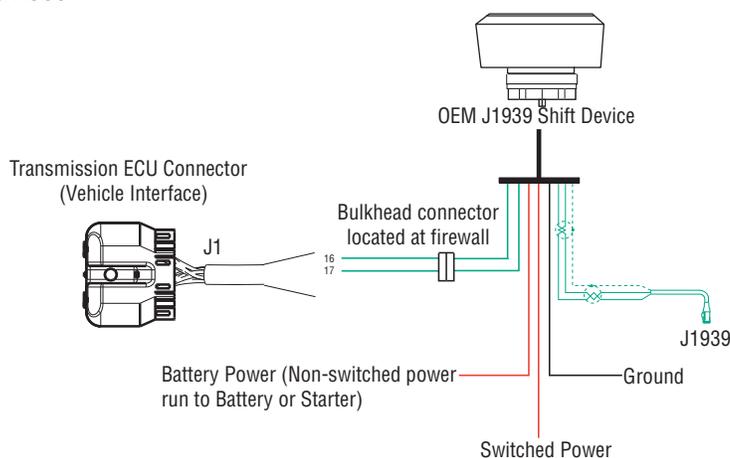
- OEM J1939 Shift Control Device
- Vehicle Harness

Procedure	Condition	Action
1. Key off.		
2. Disconnect negative battery cable.		
3. Disconnect Vehicle Harness 38-way connector.		
4. Measure resistance between 38-way connector pin 16 and corresponding OEM pin at J1939 Shift Device and pin 16 and ground (see OEM wiring for correct pin location)	<p>If resistance is 0 to 0.3 ohms between pin 16 and the corresponding OEM pin and resistance to ground is 10K ohms or greater</p> <p>If resistance is out of range</p>	<p>Go to STEP B</p> <p>Repair wiring between Transmission ECU and J1939 Shift Device. Go to STEP V</p>

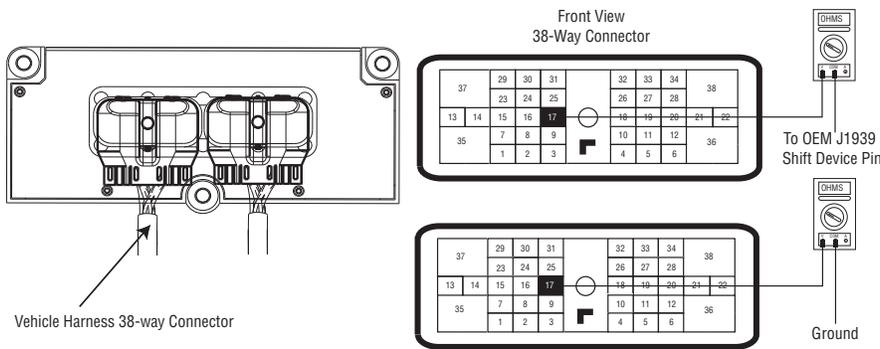
Procedure	Condition	Action
1. Measure resistance between 38-way connector pin 17 and corresponding OEM pin at J1939 Shift Device and pin 17 and ground (see OEM wiring for correct pin location)	If resistance is 0 to 0.3 ohms between pin 17 and the corresponding OEM pin and resistance to ground is 10K ohms or greater	Problem exists with the J1939 Shift Device, or J1939 Shift Device power, ground or datalink wiring. Contact your OEM for repair strategy. Go to STEP V
	If resistance is out of range	Repair wiring between Transmission ECU and J1939 Shift Device. Go to STEP V

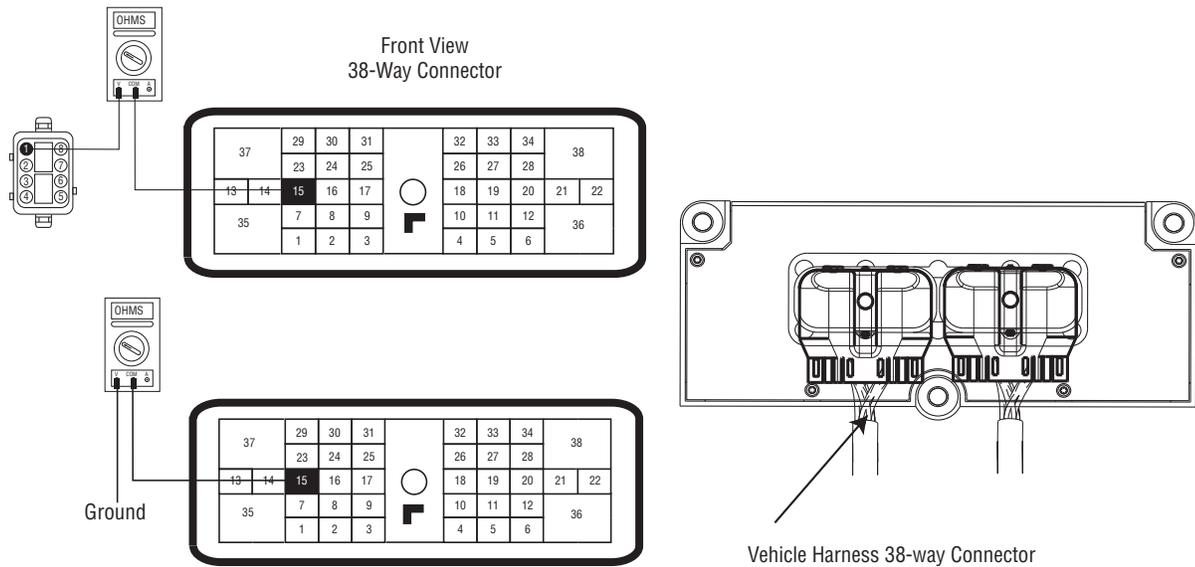
Procedure	→	Condition	→	Action
1. Key off.				
2. Disconnect negative battery cable.				
3. Disconnect Transmission ECU 38-way connector.				
4. Remove tester from Shift Lever 8-way connector.				
5. Measure resistance between:				
<ul style="list-style-type: none"> ECU 38-way pin 15 and Shift Lever 8-way connector pin 1 ECU 38-way connector pin 15 and ground 		<p>If resistance between pins 15 and 1 is 0 to 0.3 ohms and resistance between pin 15 and ground is 10K ohm or greater</p>		Go to STEP D
		<p>If any of the above conditions are not met</p>		Repair Vehicle Harness between the Transmission ECU and the Shift Lever. Go to STEP V

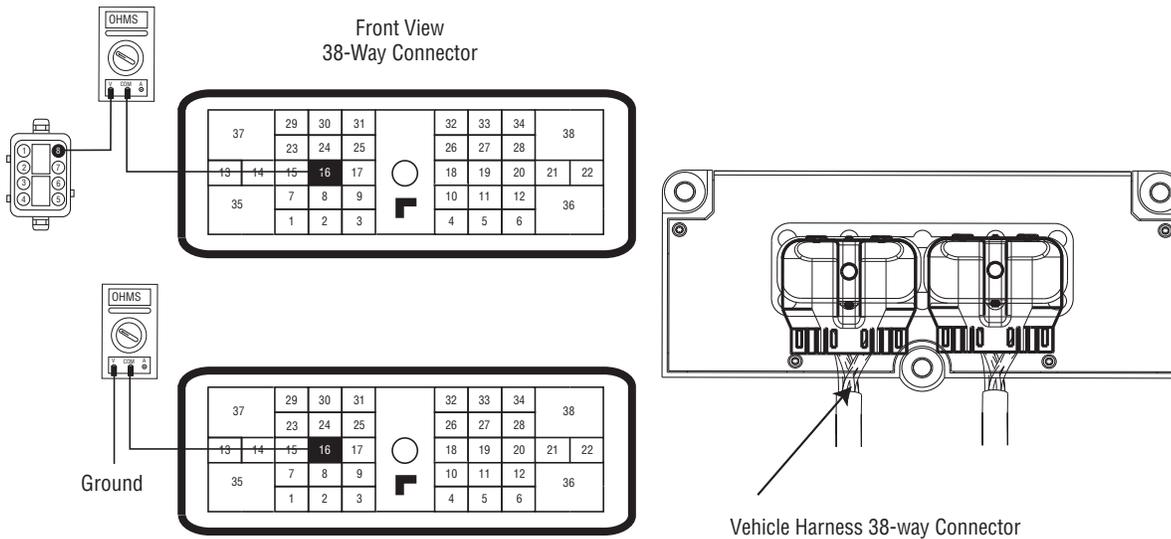
Procedure	→ Condition	→ Action
1. Key off.		
2. Measure resistance between:	If resistance between pins 16 and 8 is 0 to 0.3 ohms and resistance between pin 16 and ground is 10K ohm or greater	Go to STEP E
<ul style="list-style-type: none"> ECU 38-way pin 16 and Shift Lever 8-way connector pin 8 ECU 38-way connector pin 16 and ground 	If any of the above conditions are not met	Repair Vehicle Harness between the Shift Lever and Transmission ECU. Go to STEP V

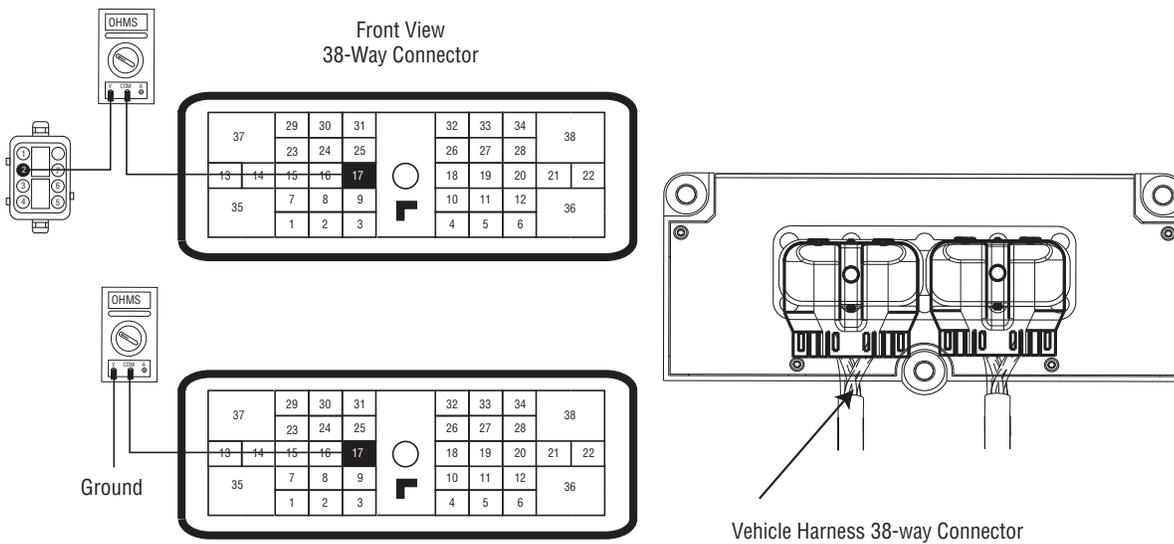
Procedure	→	Condition	→	Action
1. Key off.				
2. Measure resistance between:				
<ul style="list-style-type: none"> ECU 38-way pin 17 and Shift Lever 8-way connector pin 2 ECU 38-way connector pin 17 and ground 		If resistance between pins 17 and 2 is 0 to 0.3 ohms and resistance between pin 17 and ground is 10K ohm or greater		Go to STEP F
		If any of the above conditions are not met		Repair Vehicle Harness between Shift Lever and Transmission ECU. Go to STEP V

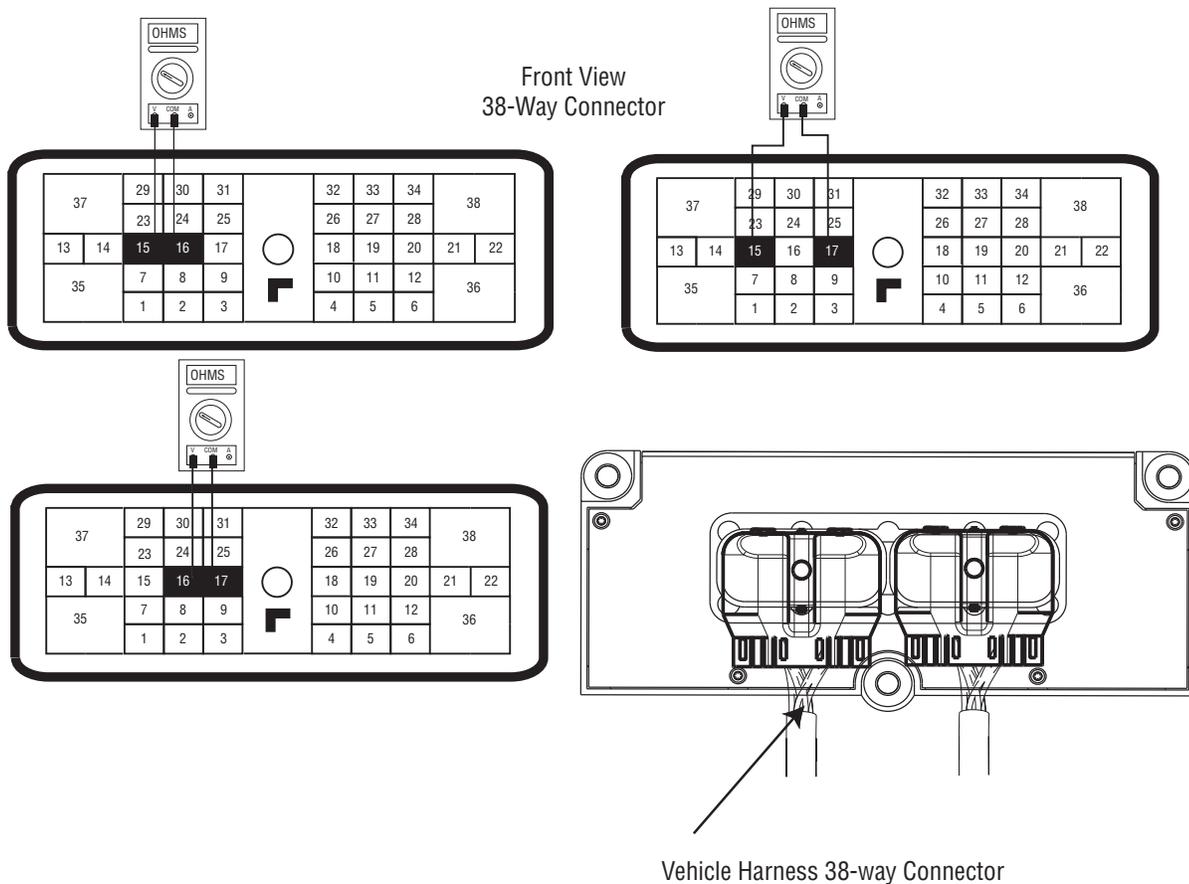
Procedure	→ Condition	→ Action
1. Key off.		
2. Measure resistance between: <ul style="list-style-type: none"> • Transmission ECU 38-way connector pin 15 and 16 and 15 and 17. Then measure resistance from pin 16 to 17. 	If resistance on all three is 10K ohm or greater	Replace Shift Lever. Go to STEP V
<ul style="list-style-type: none"> • Transmission ECU 38-way connector pin 15 and 16 and 15 and 17. Then measure resistance from pin 16 to 17. 	If any of the three readings is less than 10K ohm	Repair Vehicle Harness between Shift Lever and Transmission ECU. Go to STEP V

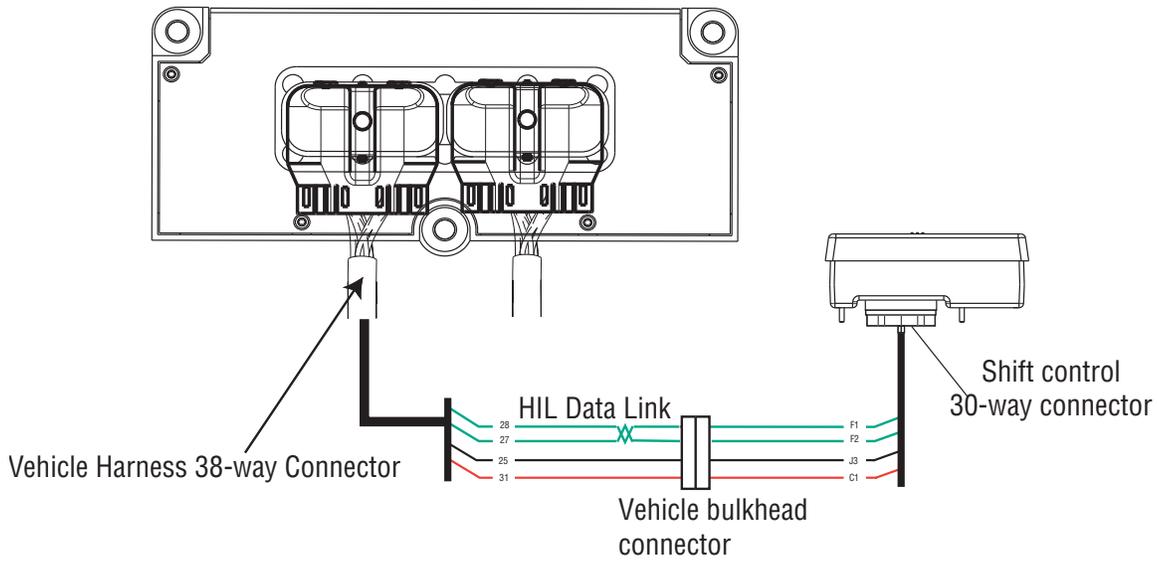
Shift Control ECU Legend
 All OEM responsible wiring shown is "typical". Consult specific application.
 (31) = +12 volt switched from TECU
 (28, 27) = Communication from and to the TECU
 (25) = Signal returns, grounds, and general OEM wiring

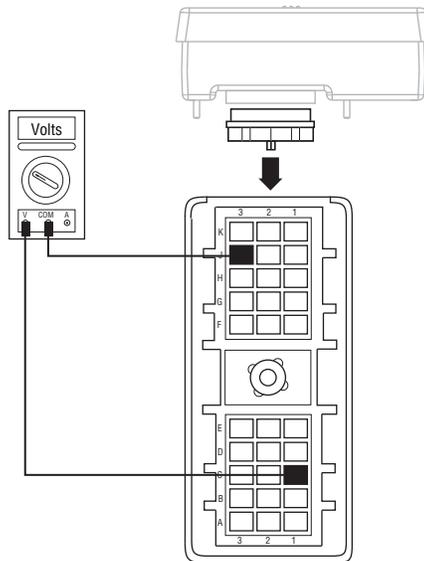
Procedure	→	Condition	→	Action
1. Disconnect Shift Control 30-way connector.				
2. Key on.				
3. Measure voltage on 30-way connector pins J3 and C1		If voltage is within 1.2 volts of battery voltage		Go to STEP D
		If out of range		Go to STEP F

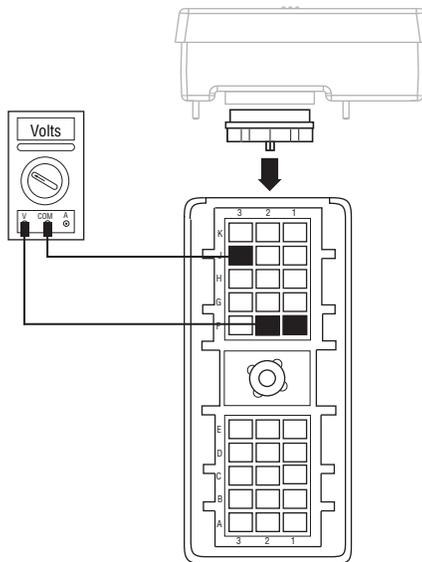
Procedure	→	Condition	→	Action
1. Disconnect Shift Control 30-way connector.				
2. Key on.				
3. Measure voltage at Shift Controller 30-way connector pins: - J3 and F1 - J3 and F2		If both readings are between 2-3 volts.		Go to STEP E
		If any of the above requirements are not met.		Go to STEP H

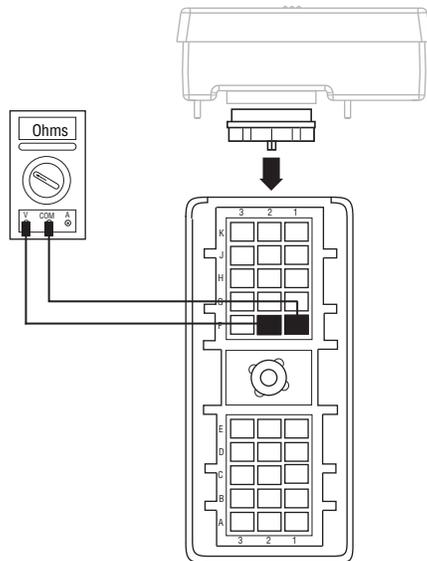
Procedure	Condition	Action
<p>1. Key off.</p> <p>Note: Ensure key is off for a minimum of two minutes before proceeding. If unsure, disconnect battery power or remove the 30-amp inline fuse.</p>		
<p>2. Measure resistance at Shift Controller 30-way connector pins F1 and F2.</p>	<p>Transmission is equipped with an ECA and resistance between pins F1 and F2 is between 50-70 ohms.</p> <p>Transmission is not equipped with an ECA and resistance between pins F1 and F2 is between 110-130 ohms.</p>	<p>Replace Push Button Shift Control (Only if Fault Code is Active.) Go to STEP V</p>
	<p>If any of the above requirements are not met.</p>	<p>Go to STEP H</p>

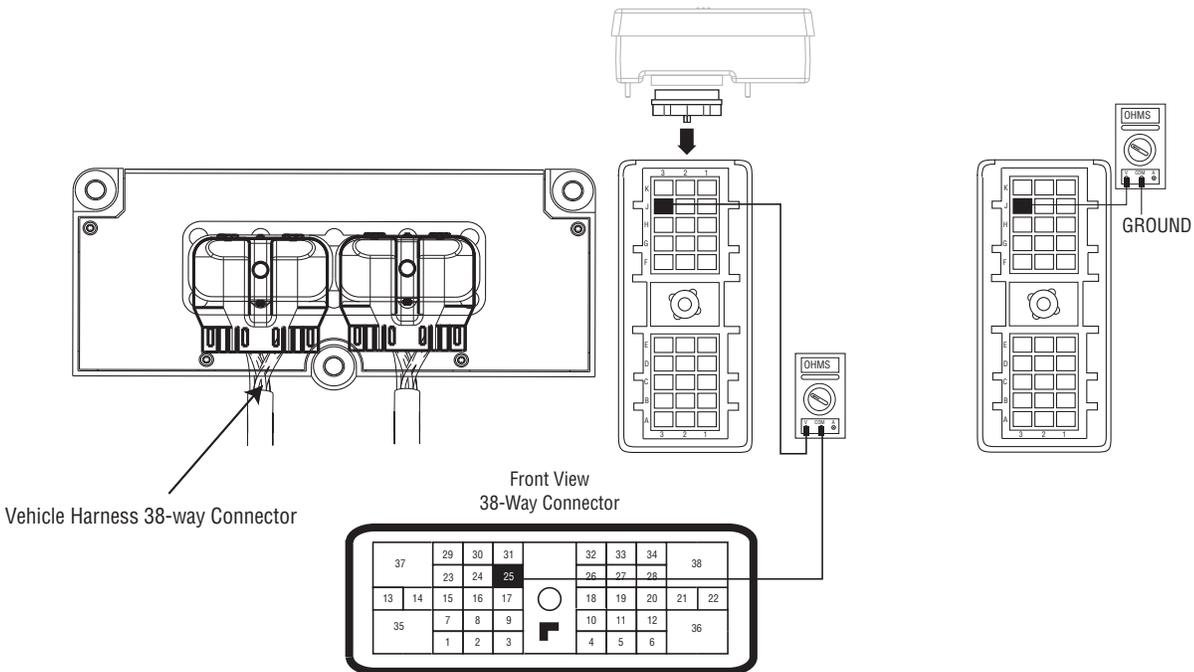
Repair harness between the Shift Control and Transmission ECU.
Go to **STEP V**

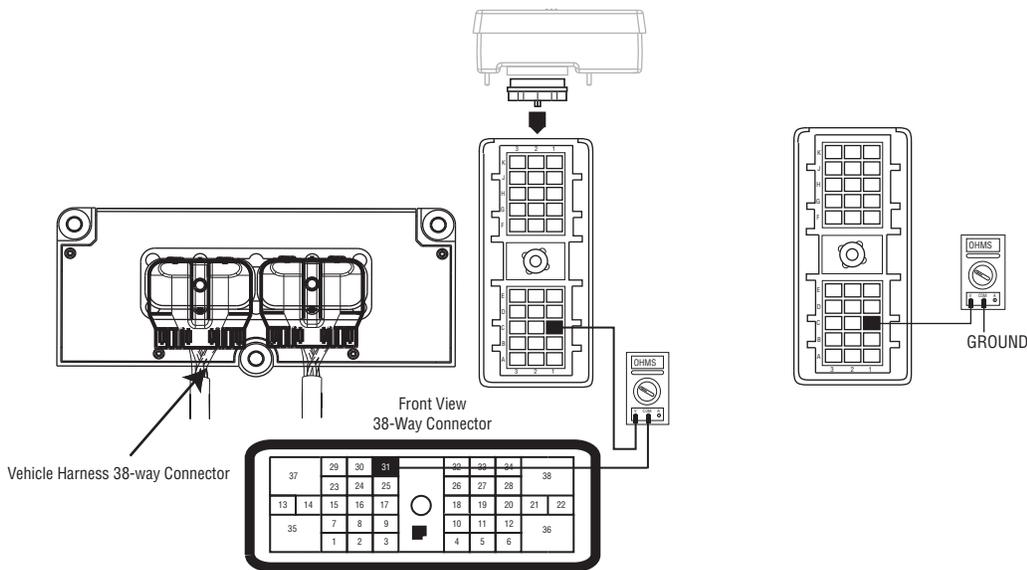
Procedure	→	Condition	→	Action
1. Key off.				
2. Measure resistance between: <ul style="list-style-type: none"> • Shift Control 30-way connector pin C1 and Vehicle Harness 38-way connector pin 31. • Shift Control 30-way connector pin C1 and ground. 		If resistance between pins C1 and 31 is 0 to 0.3 ohms and resistance between pin C1 and ground is OL		Go to STEP H
		If any of the above conditions are not met		Repair harness between the Transmission ECU and Shift Control. Go to STEP V
