Eaton UltraShift PLUS[®], UltraShift[®] and AutoShift[®] Transmissions TRTS0930

March 2012

Transmission Models Included

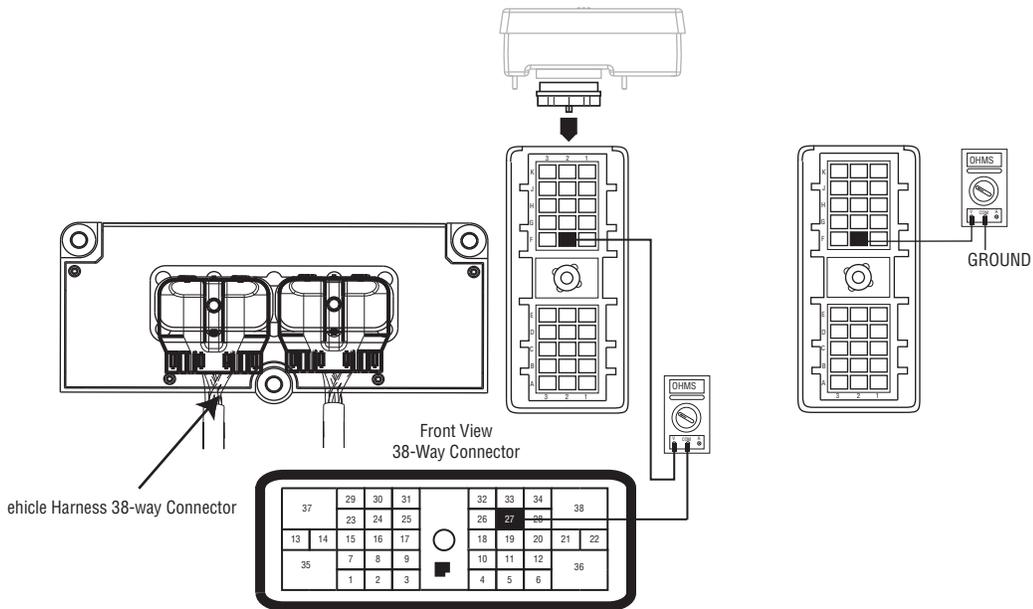
Procedure	→	Condition	→	Action
1. Key off.				
2. Measure resistance between:				
<ul style="list-style-type: none"> Shift Control 30-way connector pin F2 and Vehicle Harness 38-way connector pin 27 Shift Control 30-way connector pin F2 and ground 		If resistance between pins F2 and 27 is 0 to 0.3 ohms and resistance between pin F2 and ground is OL		For transmissions without an ECA - Replace Transmission ECU (only if Fault Code is Active). Go to STEP V
				For transmissions equipped with an ECA, go to STEP J
		If any of the above conditions are not met		Repair harness between the Shift Control and Transmission ECU. Go to STEP V

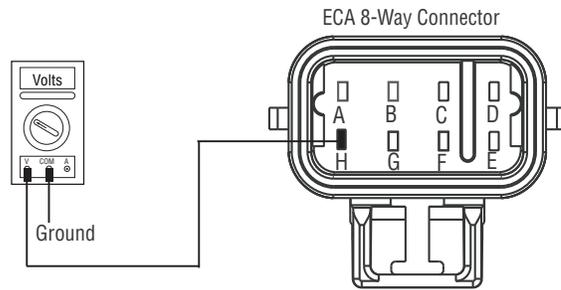
Procedure	→	Condition	→	Action
1. Key off.				
2. Disconnect the ECA 8-way harness connector.				
3. Key on.				
4. Measure voltage at ECA 8-way harness connector from pin H to ground.		Voltage is within 1.2 volts of battery voltage		Go to STEP L
		Voltage is out of range		Go to STEP K

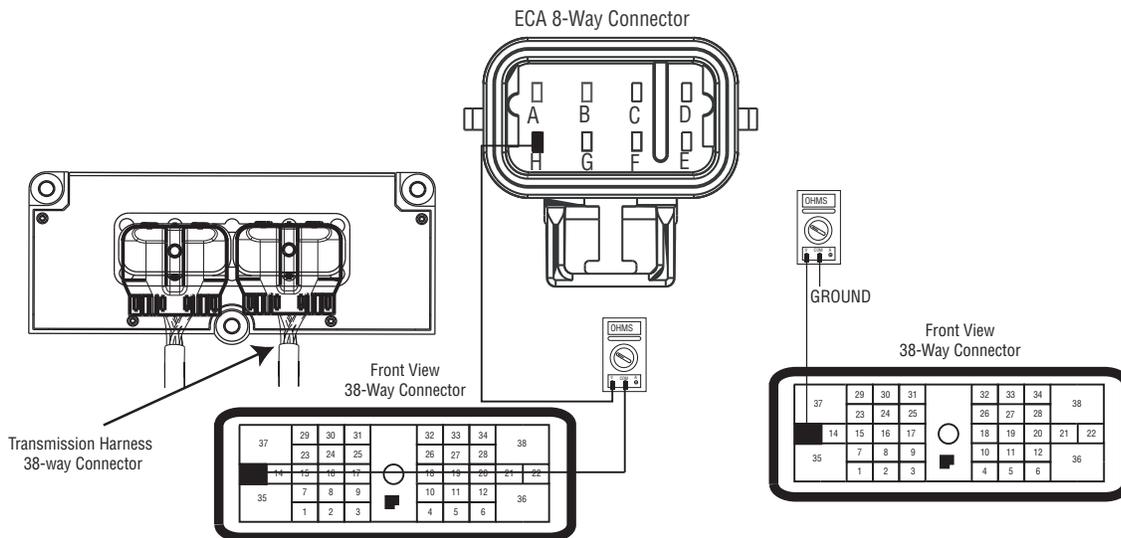
STEP K

Procedure	Condition	Action
1. Key off.		
2. Disconnect the transmission 38-way harness connector at ECU.		
3. Inspect for clean and serviceable 8-way and 38-way connectors, and measure resistance between:		
<ul style="list-style-type: none"> • Transmission 38-way harness connector pin 13 and ECA 8-way harness connector pin H. • Transmission 38-way harness connector pin 13 and ground. 	<p>If connectors are in good repair, and if resistance between pins 13 and H is 0 to 0.3 ohms, and if resistance between pin 13 and ground is OL</p>	<p>Replace ECU (Only if fault code is Active.) Go to STEP V</p>
	<p>If any of the above conditions are not met</p>	<p>Replace Transmission Harness. Go to STEP V</p>

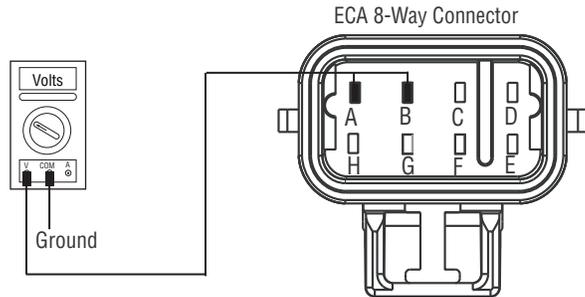
STEP L

Procedure	Condition	Action
1. Key on.		
2. Measure voltage at 8-way connector pins: <ul style="list-style-type: none">• A and ground• B and ground	<p>If voltage between pin A and ground and between pins B and ground are 2-3 volts</p> <p>If any of the above conditions are not met</p>	<p>Go to STEP M</p> <p>Go to STEP N</p>

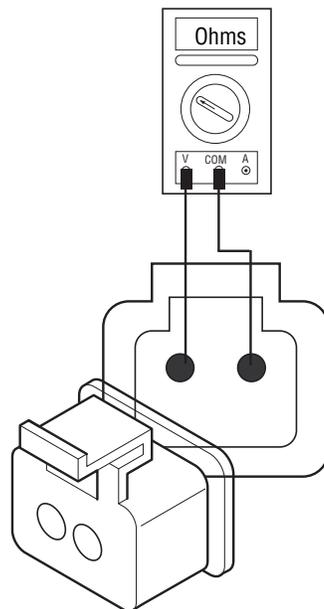
STEP M

Procedure	→ Condition	→ Action
<ol style="list-style-type: none"> 1. Key off. 2. Connect 8-way connector. 3. Locate and remove the terminating resistor that is wired into the ECA 8-way connector pins C and E. 4. Measure resistance between transmission harness connector pins 1 and 2. <p>Note: Make sure the volt/ohm meter is on the proper scale (around 200 ohm scale).</p>	<p>If equipped with a Push Button Shift Control and resistance between pins 1 and 2 is between 50-70 ohms</p> <p>If equipped with a lever or J1939 shift device and resistance between pins 1 and 2 is between 120-130 ohms</p> <p>If any of the above conditions are not met</p>	<p>Replace ECA (Only if fault code is Active). Go to STEP V</p> <p>Go to STEP N</p>

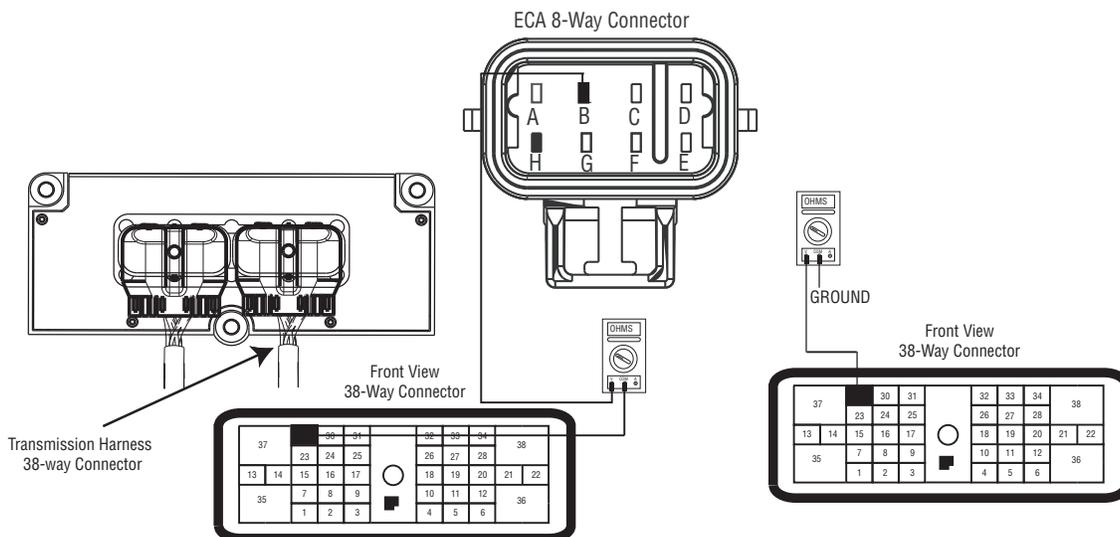
STEP N

If connectors are in good repair, and if resistance between pins 29 and B is 0 to 0.3 ohms, and if resistance between pin 29 and ground is OL

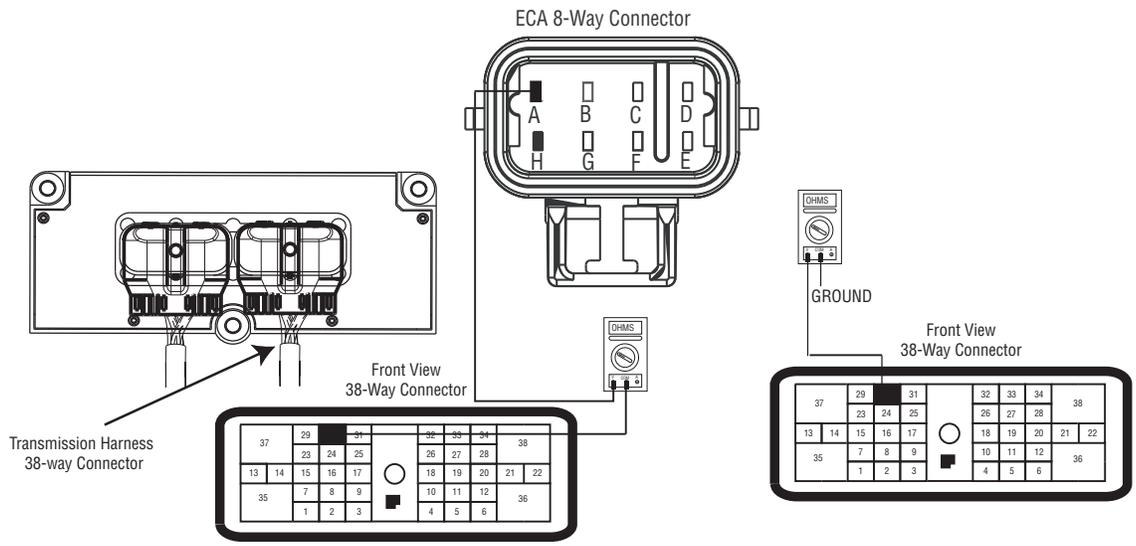
STEP O

Procedure	→	Condition	→	Action
1. Key off.				
2. Measure resistance between:				
<ul style="list-style-type: none"> Transmission 38-way harness connector pin 30 and ECA 8-way harness connector pin A. Transmission 38-way harness connector pin 30 and ground. 		<p>If resistance between pins 30 and A is 0 to 0.3 ohms, and if resistance between pin 30 and ground is OL</p>		<p>Replace ECU (Only if fault code is Active). Go to STEP V</p>
		<p>If any of the above conditions are not met.</p>		<p>Replace Transmission Harness. Go to STEP V</p>

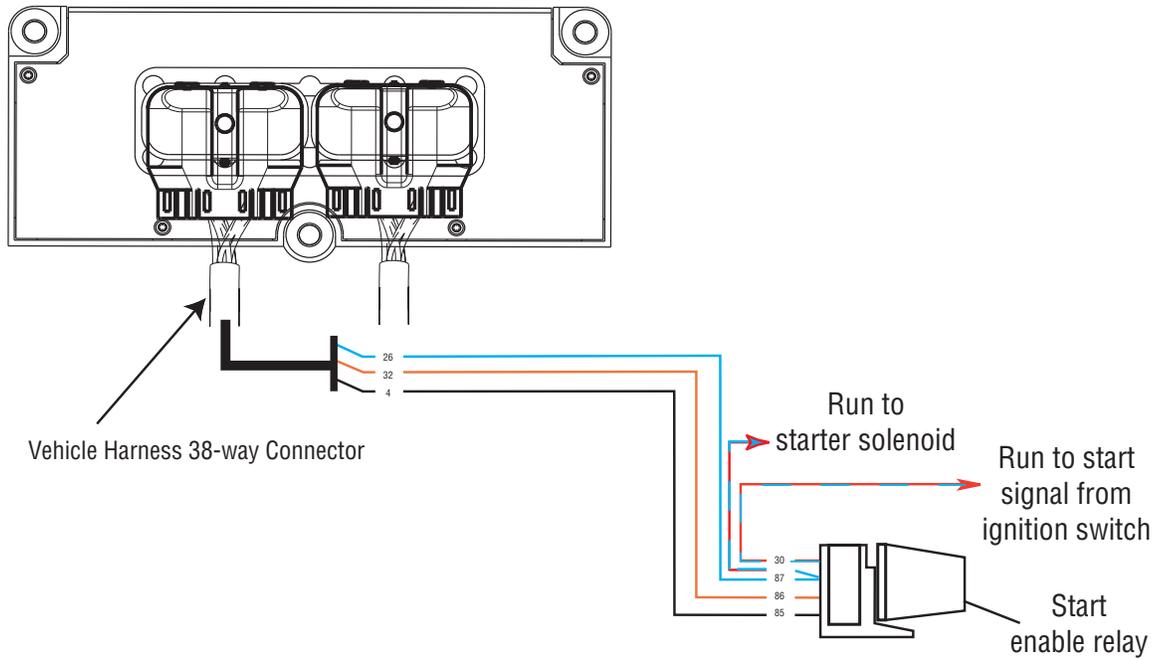
Trans ECU Legend
 All OEM responsible wiring shown is "typical". Consult specific application.
 (30, 87) = Switched ignition
 (26-87) = Latch into the ECU
 (4-85) = -12 volt relay source
 (32-86) = +12 volt relay source

Procedure	Condition	Action
1. Key on.		
Note: The Start Enable Relay must be wired according to Eaton GEN III requirements (shown on previous page) for tests to work properly. If wired differently, consult OEM for correct wiring schematic.		
2. Retrieve active fault codes and FMIs with ServiceRanger using the 9-pin diagnostic connector.		
3. What FMIs are present?	FMI 14 is present	Go to STEP B
	FMI 3 or 4 are present	Go to STEP C

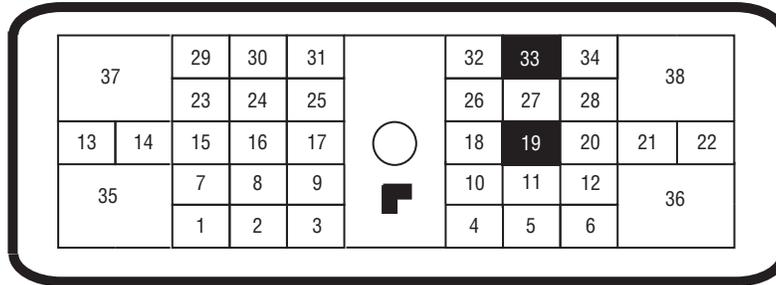
Front View
Transmission ECU Connector
(Vehicle Interface)

Description	From	To
Pressure Switch Signal Wire	Pin 19	Signal Wire
Pressure Switch Return Wire	Pin 33	Return Wire

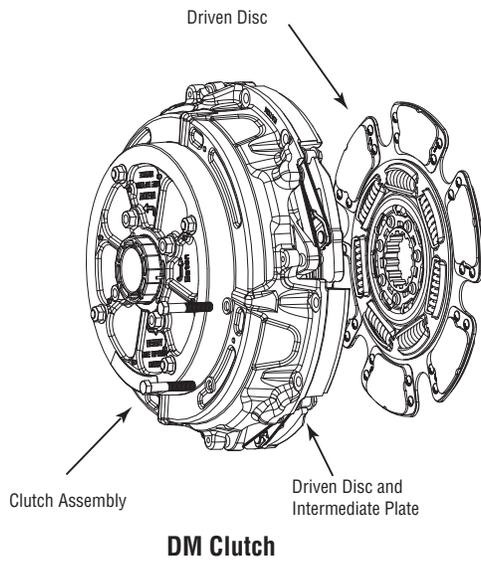
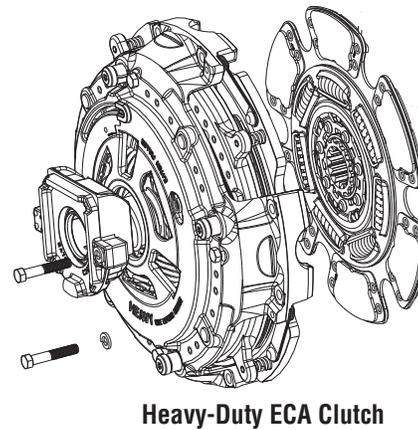
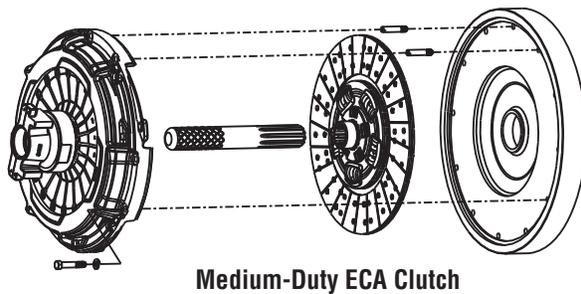
Clutch Slip Testing

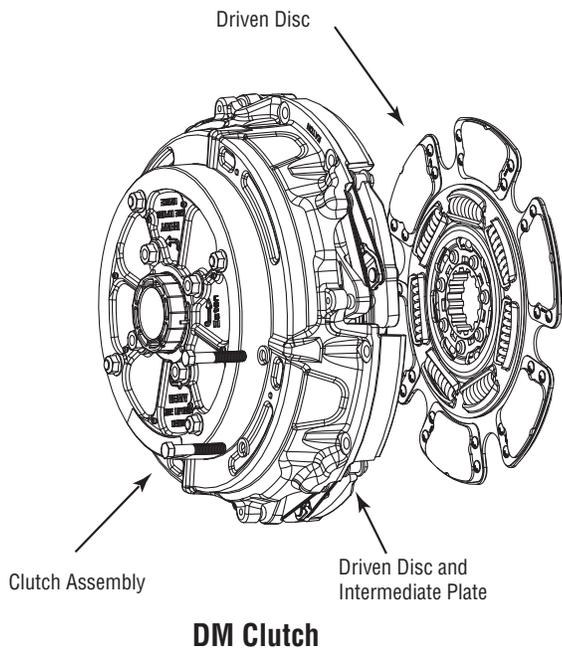
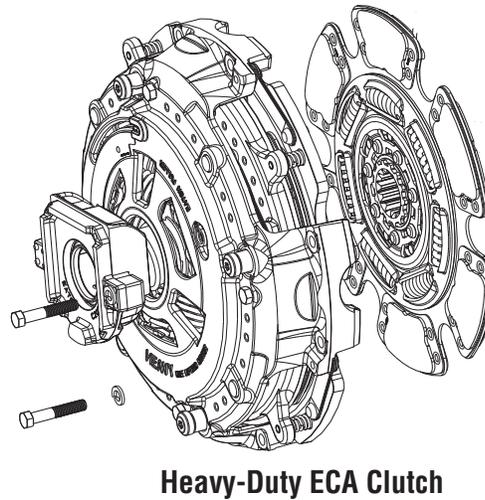
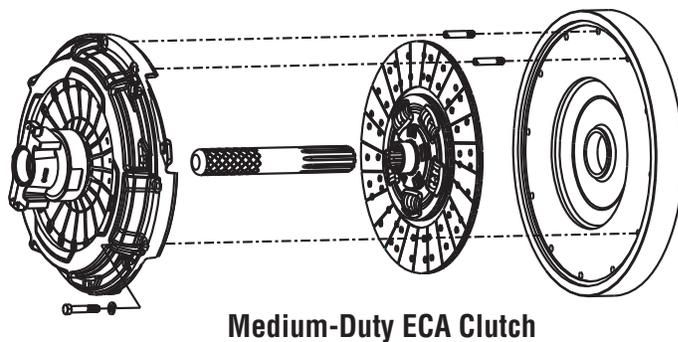
Clutch Disengagement Test

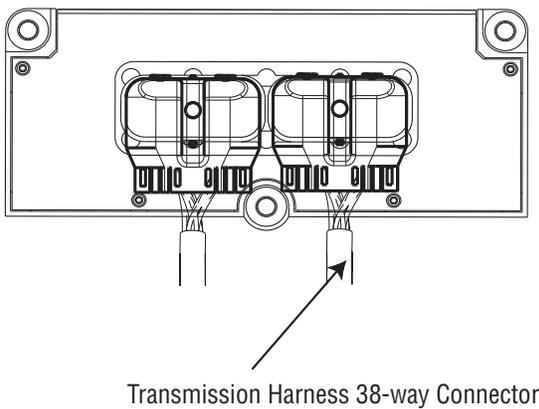
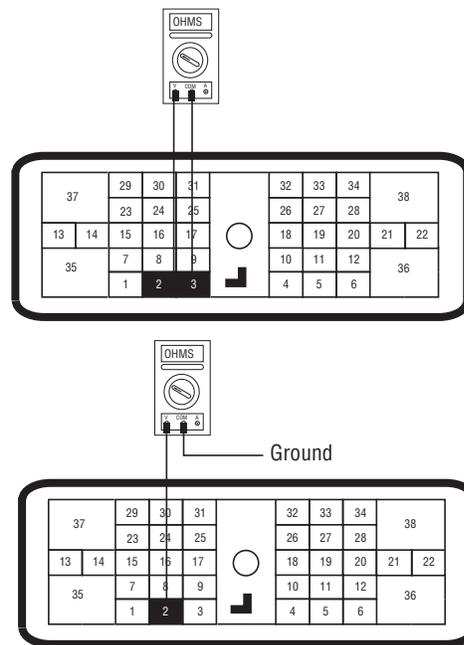
1. Key off.
2. Disconnect the negative battery cable.
3. Disconnect the Transmission ECU 30-way connector.
4. Measure resistance between the Transmission Harness 38-way connector pins 2 and 3 and 2 to ground.

If the resistance between 2 and 3 is 6.5 to 9.5 ohms and is resistance from pin 2 to ground is OL	Go to STEP C
If resistance is outside of range	Go to STEP D

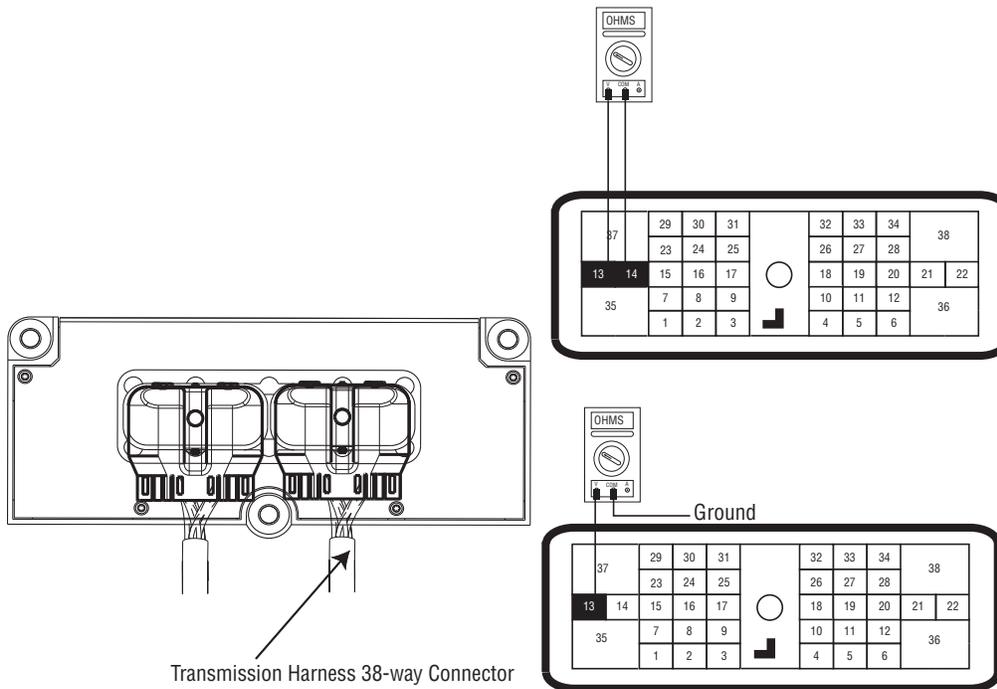
STEP C

Procedure	→ Condition	→ Action
1. Measure resistance between the Transmission Harness 38-way connector pins 13 and 14 and 13 to ground.	If resistance between 13 and 14 is 8.5 to 12 ohms and resistance from pin 13 to ground is OL	Replace Transmission (Only if Fault Code is Active). Go to STEP V
	If resistance is less than 10K ohm	Go to STEP D

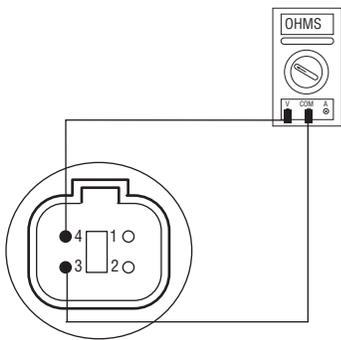
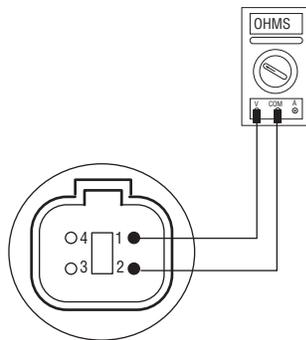
STEP D

Procedure	→	Condition	→	Action
1. Disconnect Transmission Harness located on left side of WetClutch housing.				
2. Measure resistance between WetClutch housing connector pins:				
<ul style="list-style-type: none"> • 3 and 4 • 1 and 2 		<p>If the resistance between pins 1 and 2 is 8.5 to 12 ohms and the resistance between 3 and 4 is 6.5 to 9.5 ohms</p>		Go to STEP E
		<p>If resistance is outside of range</p>		<p>Replace Transmission. Go to STEP V</p>

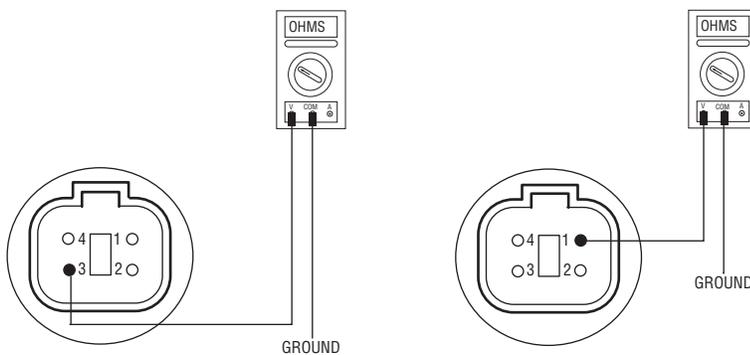
STEP E

Procedure	→	Condition	→	Action
1. Measure resistance between WetClutch housing connector pins: <ul style="list-style-type: none"> • 3 and ground • 1 and ground 		If resistance from pin 3 to ground and pin 1 to ground is 10K ohm or greater		Replace Transmission Harness. Go to STEP V
		If resistance is less than 10K ohm		Replace Transmission. Go to STEP V

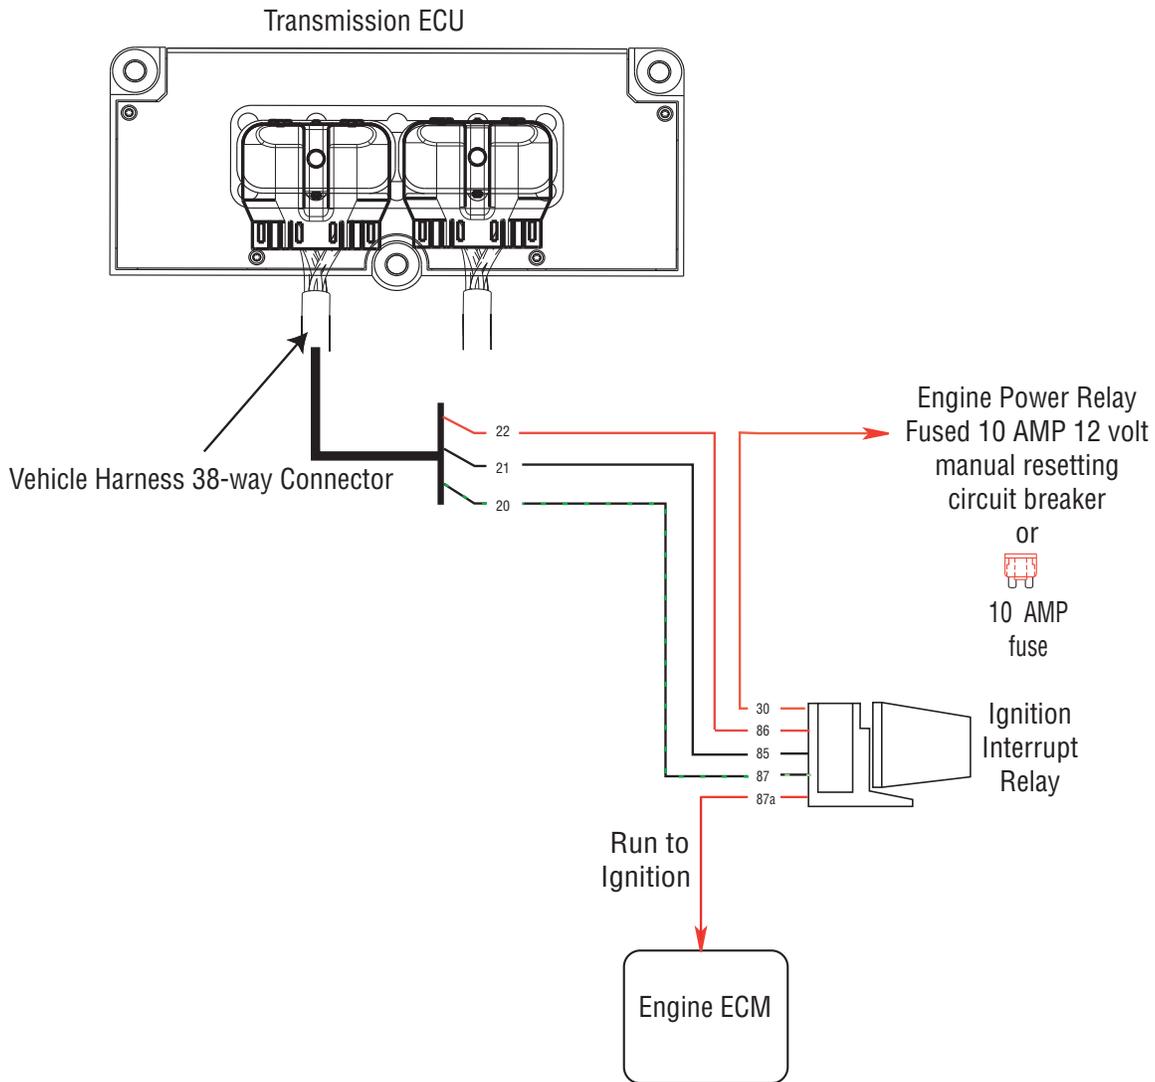
Ignition Interrupt Legend
 All OEM responsible wiring shown is "typical". Consult specific application.
 (30, 87a) = +12 volt switched
 (20-87) = Signal
 (21-85) = -12 volt relay source
 (22-86) = +12 volt relay source

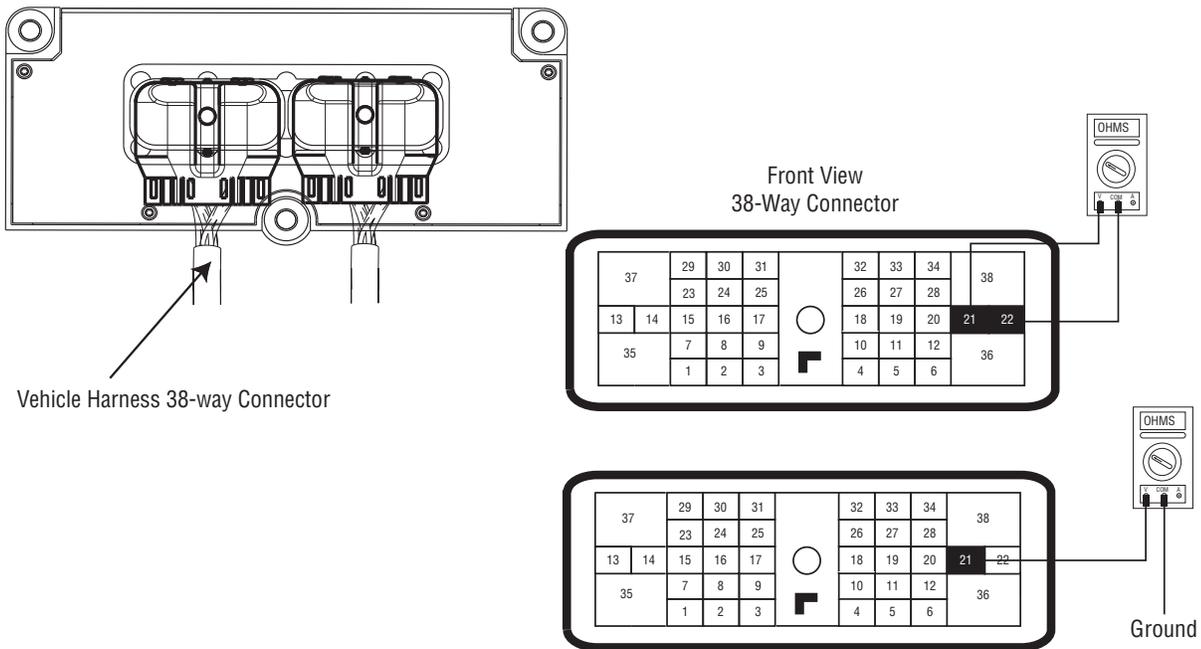
Procedure	→	Condition	→	Action
1. Key off.				
2. Disconnect negative battery cable.				
3. Disconnect Transmission ECU Vehicle Harness 38-way connector.				
4. Measure resistance between Vehicle Harness 38-way connector pins 21 and 22 and from pin 21 to ground.		If resistance between pins 21 and 22 is 40 to 120 ohms (12 volt system) or 140 to 480 ohms (24 volt system) and resistance from pin 21 to ground is OL		Go to STEP B
		If resistance is outside of range		Go to STEP D

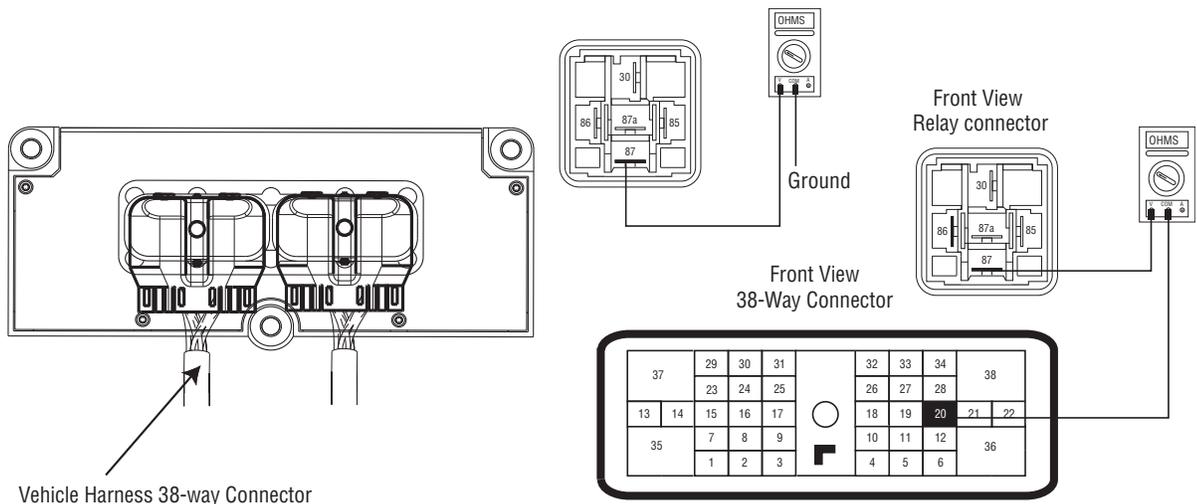
STEP B

Procedure	Condition	Action
1. Measure resistance between Transmission Vehicle Harness 38-way connector pin 20 and MEIIR relay connector pin 87 and from MEIIR relay connector pin 87 to ground.	If resistance between pin 20 and 87 is 0 to 0.3 ohms and if resistance between pin 87 and ground is OL	Go to STEP C
	If resistance is outside of the range	Repair OEM harness between the Transmission ECU and the MEIIR relay connector. Go to STEP V

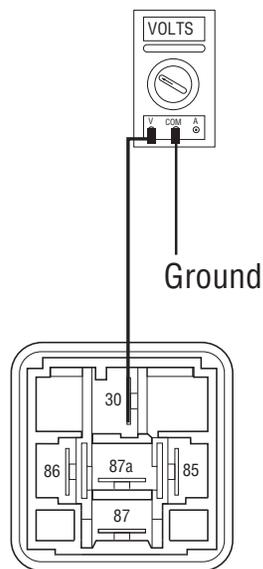
Procedure	Condition	Action
1. Disconnect MEIIR relay from connector.		
2. Key on.		
3. Measure voltage from pin 30 of the MEIIR relay connector to ground.	<p>If voltage is within 0.6 volts of battery voltage</p> <p>If voltage is outside of range</p>	<p>Replace MEIIR relay. Go to STEP E</p> <p>Repair OEM harness. Go to STEP V</p>

Front View
Relay connector

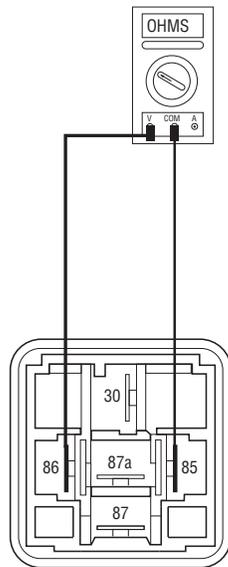
Procedure	→	Condition	→	Action
1. Remove MEIIR relay from OEM dash harness.				
2. Measure resistance between MEIIR relay pins 85 and 86.		If resistance is 40 to 120 ohms (12 volt system) or 140 to 480 ohms (24 volt system)		Repair OEM wiring from the Transmission ECU to the MEIIR relay. Go to STEP V
		If resistance is outside of range		Replace MEIIR relay. Go to STEP V

Front View
Relay connector

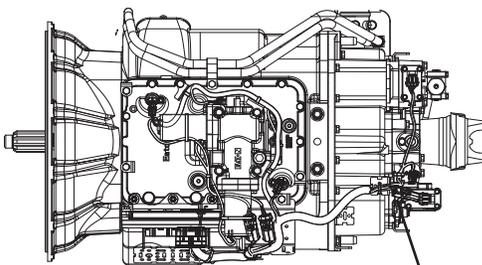
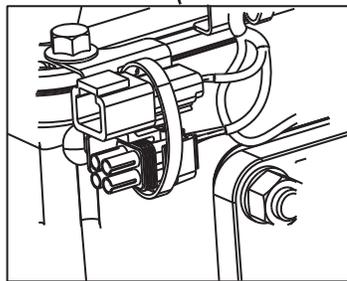
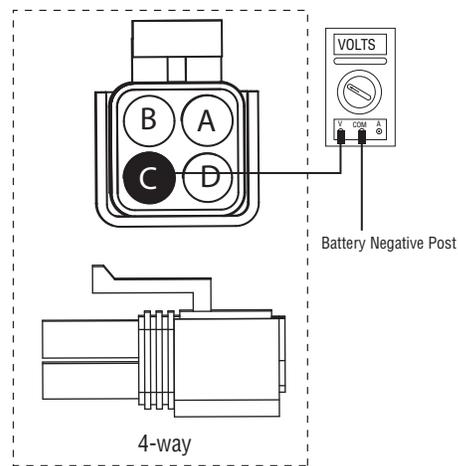
Procedure	Condition	Action
1. Locate diagnostic port on Transmission Harness.		
2. Key on.		
3. Measure voltage between pins C and the battery negative post.	If voltage between pin C and the battery negative post is 0.70 volts or less	Go to STEP C
	If voltage is outside of range	Repair battery ground supply to Transmission ECU. Repeat test.

4-Pin Diagnostic Port
(Located at the left rear corner of the transmission.)

Warning! - Do Not Load Test at Diagnostic Port
4-Pin Diagnostics Port

- B - Service Bat. +
- C - Service Bat. -
- A - Service Ignition +

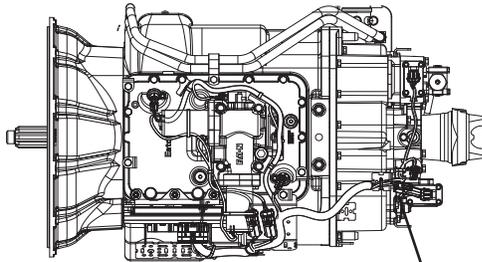
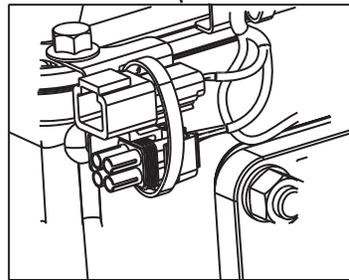
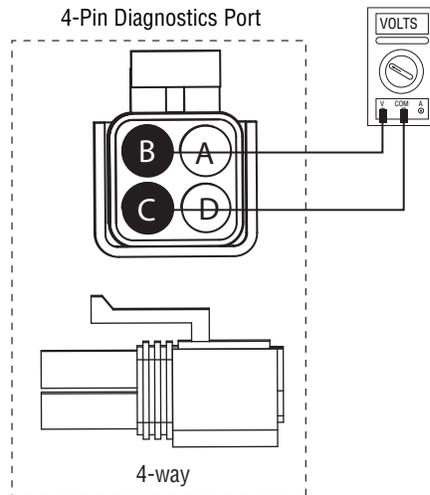
Procedure	→	Condition	→	Action
1. Locate diagnostic port on Transmission Harness.				
2. Key on.				
3. Measure voltage between pins B and pin C.		If voltage between pins B and C is within 0.6 volts of battery voltage		Go to STEP D
		If voltage is outside of range		Repair battery power supply to Transmission ECU. Fuse may be blown. Repeat test.

4-Pin Diagnostic Port
(Located at the left rear corner of the transmission.)

Warning! - Do Not Load Test at Diagnostic Port

- B - Service Bat. +
- C - Service Bat. -
- A - Service Ignition +

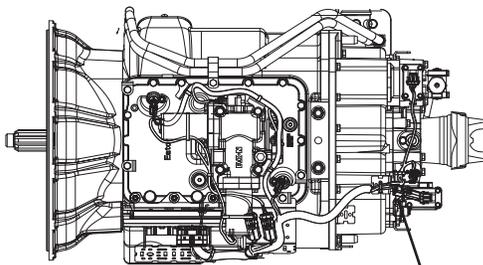
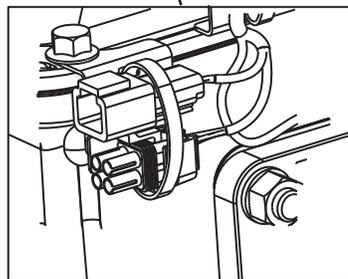
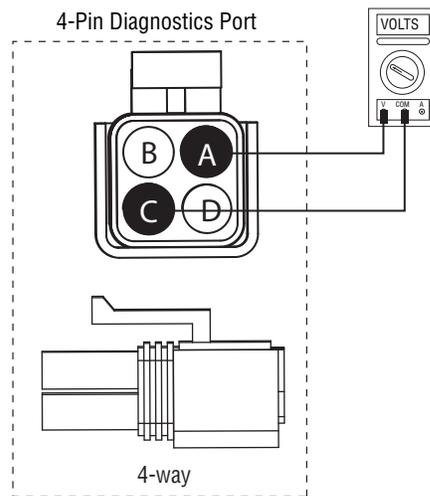
4-Pin Diagnostic Port
(Located at the left rear corner of the transmission.)

Procedure	→	Condition	→	Action
1. Key on.				
2. Measure voltage between pin A and pin C.		If voltage between pins A and C is within 0.6 volts of battery voltage		Go to STEP V
		If voltage is outside of range		Repair Ignition power supply to ECU. Fuse may be blown. Repeat test.

Warning! - Do Not Load Test at Diagnostic Port

B - Service Bat. +
C - Service Bat. -
A - Service Ignition +

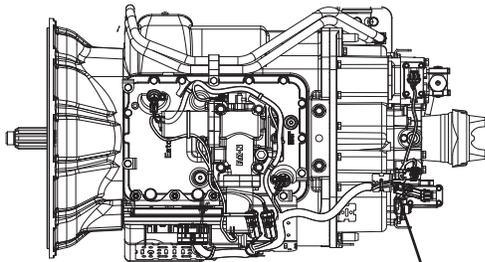
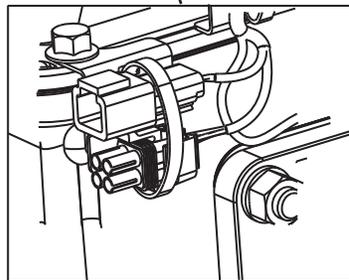
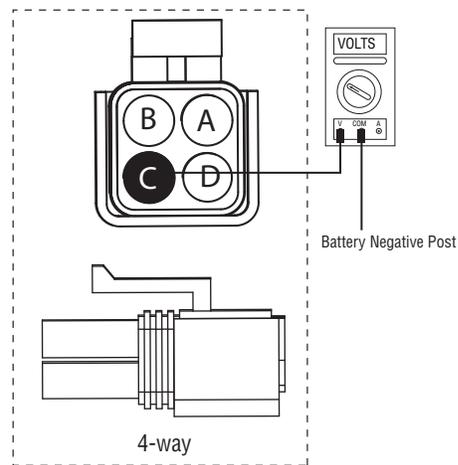
4-Pin Diagnostic Port
(Located at the left rear corner of the transmission.)

Procedure	→	Condition	→	Action
1. Locate diagnostic port on Transmission Harness.				
2. Key on.				
3. Measure voltage between pins C and the battery negative post.		If voltage between pin C and battery negative post is 0.70 volts or less		Go to STEP C
		If voltage is outside of range		Repair battery ground supply to Transmission ECU. Repeat test.

Warning! - Do Not Load Test at Diagnostic Port
4-Pin Diagnostics Port

B - Service Bat. +
C - Service Bat. -
A - Service Ignition +

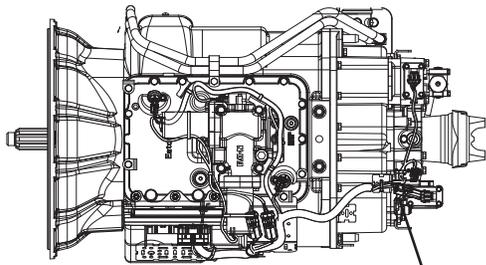
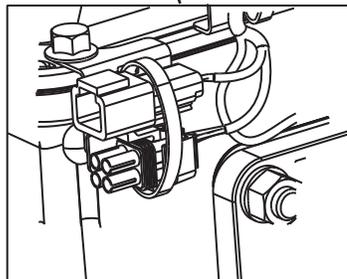
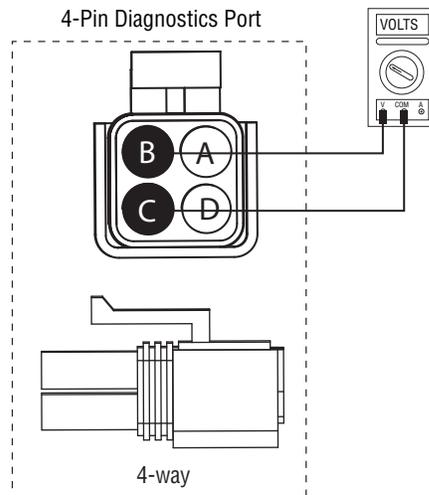
4-Pin Diagnostic Port
(Located at the left rear corner of the transmission.)

Procedure	→ Condition	→ Action
1. Locate diagnostic port on Transmission Harness.		
2. Key on.		
3. Measure voltage between pins B and pin C.	If voltage between pins B and C is within 0.6 volts of battery voltage	Go to STEP D
	If voltage is outside of range	Repair battery power supply to Transmission ECU. Fuse may be blown. Repeat test.

Warning! - Do Not Load Test at Diagnostic Port

- B - Service Bat. +
- C - Service Bat. -
- A - Service Ignition +

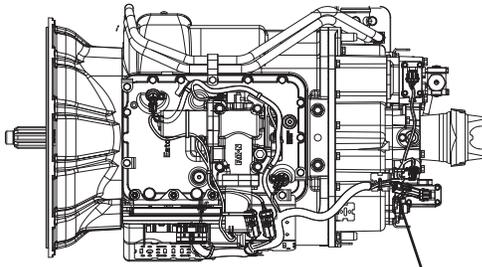
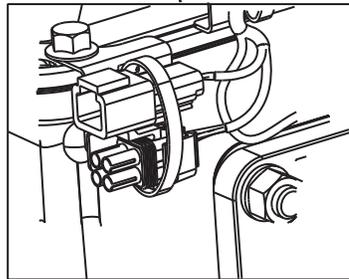
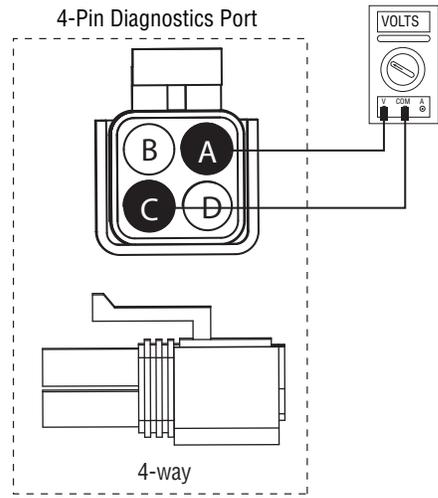
4-Pin Diagnostic Port
(Located at the left rear corner of the transmission.)

Procedure	→	Condition	→	Action
1. Key on.				
2. Measure voltage between pin A and pin C.		If voltage between pins A and C is within 0.6 volts of battery voltage		Go to STEP E
		If voltage is outside of range		Repair Ignition power supply to ECU. Fuse may be blown. Repeat test.

Warning! - Do Not Load Test at Diagnostic Port

B - Service Bat. +
C - Service Bat. -
A - Service Ignition +

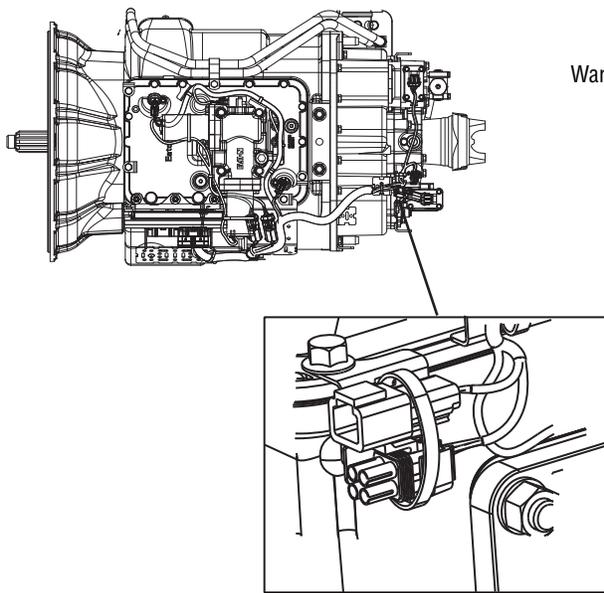
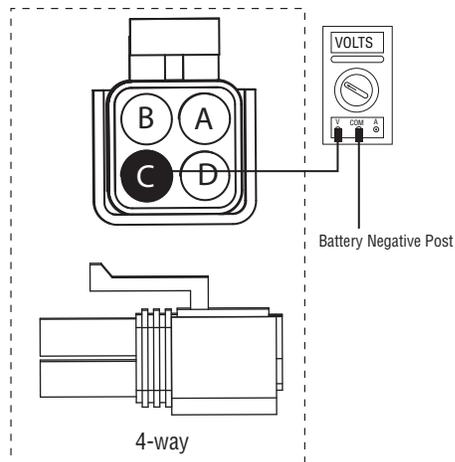
4-Pin Diagnostic Port
(Located at the left rear corner of the transmission.)

Procedure	Condition	Action
1. Locate diagnostic port on Transmission Harness.		
2. Key on.		
3. Measure voltage between pins C and the battery negative post.	If voltage between pin C and battery negative post is 0.70 volts or less If voltage is outside of range	Go to STEP C Repair battery ground supply to Transmission ECU. Repeat test.

Warning! - Do Not Load Test at Diagnostic Port
4-Pin Diagnostics Port

- B - Service Bat. +
- C - Service Bat. -
- A - Service Ignition +

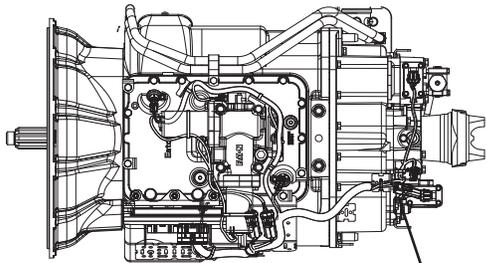
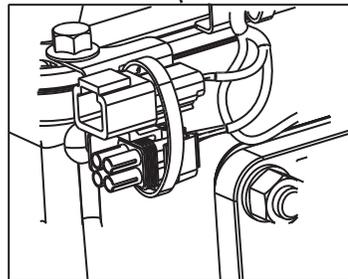
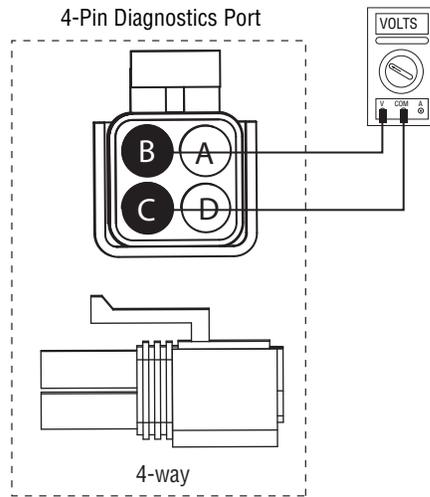
4-Pin Diagnostic Port
(Located at the left rear corner of the transmission.)

Procedure	→	Condition	→	Action
1. Locate diagnostic port on Transmission Harness.				
2. Key on.				
3. Measure voltage between pins B and pin C.		If voltage between pins B and C is within 0.6 volts of battery voltage		Go to STEP D
		If voltage is outside of range		Repair battery power supply to Transmission ECU. Fuse may be blown. Repeat test.

Warning! - Do Not Load Test at Diagnostic Port

B - Service Bat. +
C - Service Bat. -
A - Service Ignition +

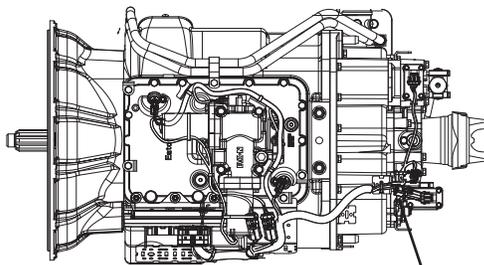
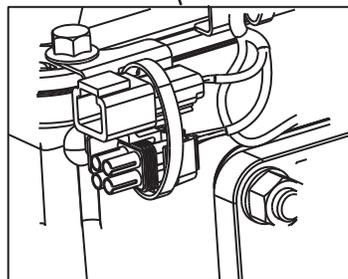
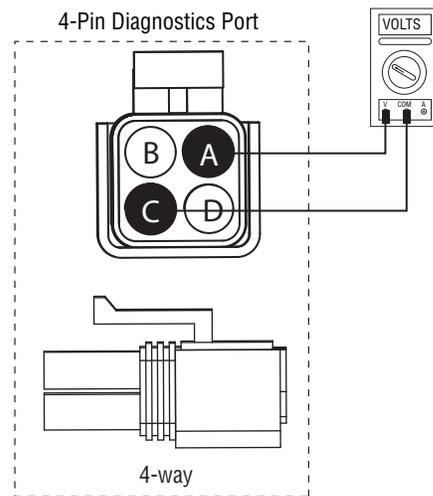
4-Pin Diagnostic Port
(Located at the left rear corner of the transmission.)

Procedure	→	Condition	→	Action
1. Key on.				
2. Measure voltage between pin A and pin C.		If voltage between pins A and C is within 0.6 volts of battery voltage		Go to STEP E
		If voltage is outside of range		Repair Ignition power supply to ECU. Fuse may be blown. Repeat test.

Warning! - Do Not Load Test at Diagnostic Port

B - Service Bat. +
C - Service Bat. -
A - Service Ignition +

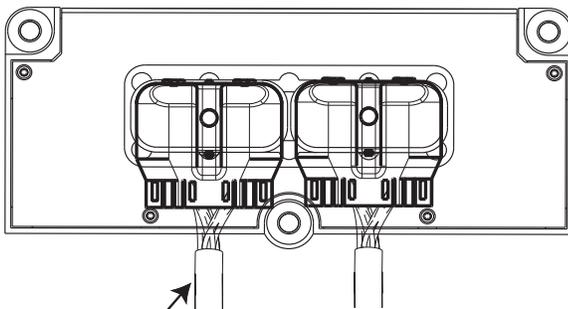
Vehicle Harness 38-way Connector

Procedure	→	Condition	→	Action
1. Key off.				
2. Measure resistance between <ul style="list-style-type: none"> • Vehicle Harness 38-way connector pin 2 and 3. 				
Note: Make sure the volt/ohm meter is on the proper scale (around 200 ohm scale)		If resistance between pin 2 and 3 is between 50 to 70 ohms		Go to STEP V
		If resistance is more than 70 ohms		One or more of the terminating resistors on the J1939 data link harness is either missing or out of range. Repair OEM J1939 Data Link Harness. Go to STEP V
		If resistance is less than 50 ohms		Repair the J1939 Data Link between the engine ECM and the Transmission ECU. Go to STEP V

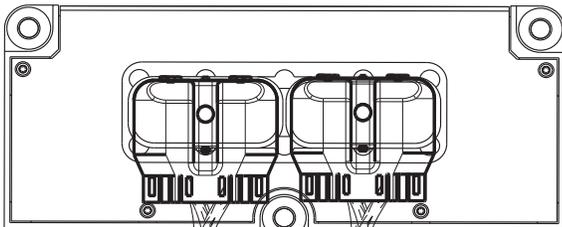
Vehicle Harness 38-way Connector

Procedure	→	Condition	→	Action
1. Key off.				
2. Measure resistance between Vehicle Harness 38-way connector pin 2 and 3.				
Note: Make sure the volt/ohm meter is on the proper scale (around 200 ohm scale).				
		If resistance between pin 2 and 3 is between 50 to 70 ohms		Go to STEP V
		If resistance is more than 70 ohms		One or more of the terminating resistors on the J1939 data link harness is either missing or out of range. Repair J1939 Data Link Harness. Go to STEP V
		If resistance is less than 50 ohms		Repair the J1939 Data Link between the Engine ECM and the Transmission ECU. Go to STEP V

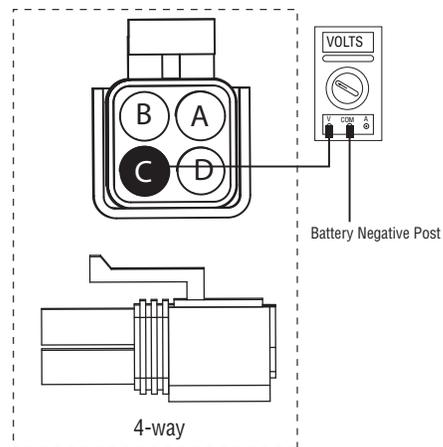
4-Pin Diagnostic Port
(Located at the left rear corner of the transmission.)

Warning! - Do Not Load Test at Diagnostic Port
4-Pin Diagnostics Port

B - Service Bat. +
C - Service Bat. -
A - Service Ignition +

Procedure	→ Condition	→ Action
1. Locate diagnostic port on Transmission Harness.		
2. Key on.		
3. Measure voltage between pins C and the battery negative post.	If voltage between pin C and battery negative post is 0.70 volts or less	Go to STEP C
	If voltage is outside of range	Repair battery ground supply to Transmission ECU. Repeat test.

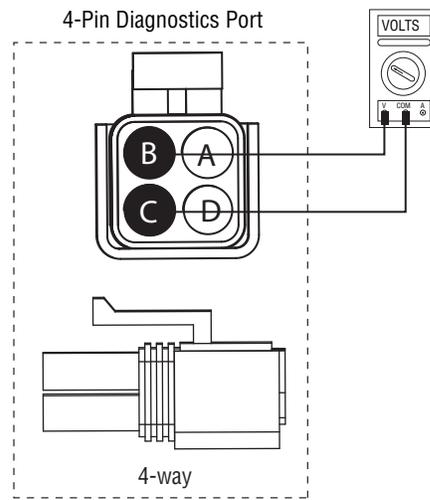
4-Pin Diagnostic Port
(Located at the left rear corner of the transmission.)

Warning! - Do Not Load Test at Diagnostic Port

B - Service Bat. +
C - Service Bat. -
A - Service Ignition +

Procedure	→	Condition	→	Action
1. Locate diagnostic port on Transmission Harness.				
2. Key on.				
3. Measure voltage between pins B and pin C.		If voltage between pins B and C is within 0.6 volts of battery voltage		Go to STEP D
		If voltage is outside of range		Repair battery power supply to Transmission ECU. Fuse may be blown. Repeat test.

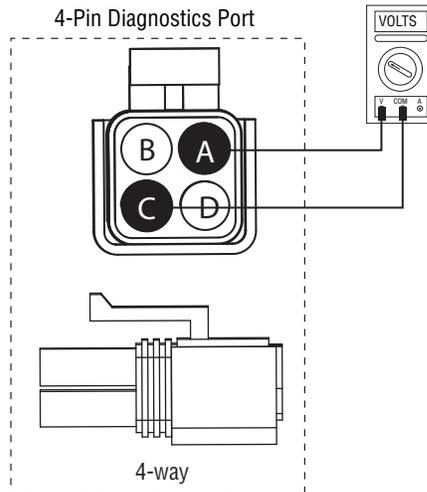
4-Pin Diagnostic Port
(Located at the left rear corner of the transmission.)

Warning! - Do Not Load Test at Diagnostic Port

B - Service Bat. +
C - Service Bat. -
A - Service Ignition +

Procedure	→	Condition	→	Action
1. Key on.				
2. Measure voltage between pin A and pin C.		If voltage between pins A and C is within 0.6 volts of battery voltage		Go to STEP E
		If voltage is outside of range		Repair Ignition power supply to ECU. Fuse may be blown. Repeat test.

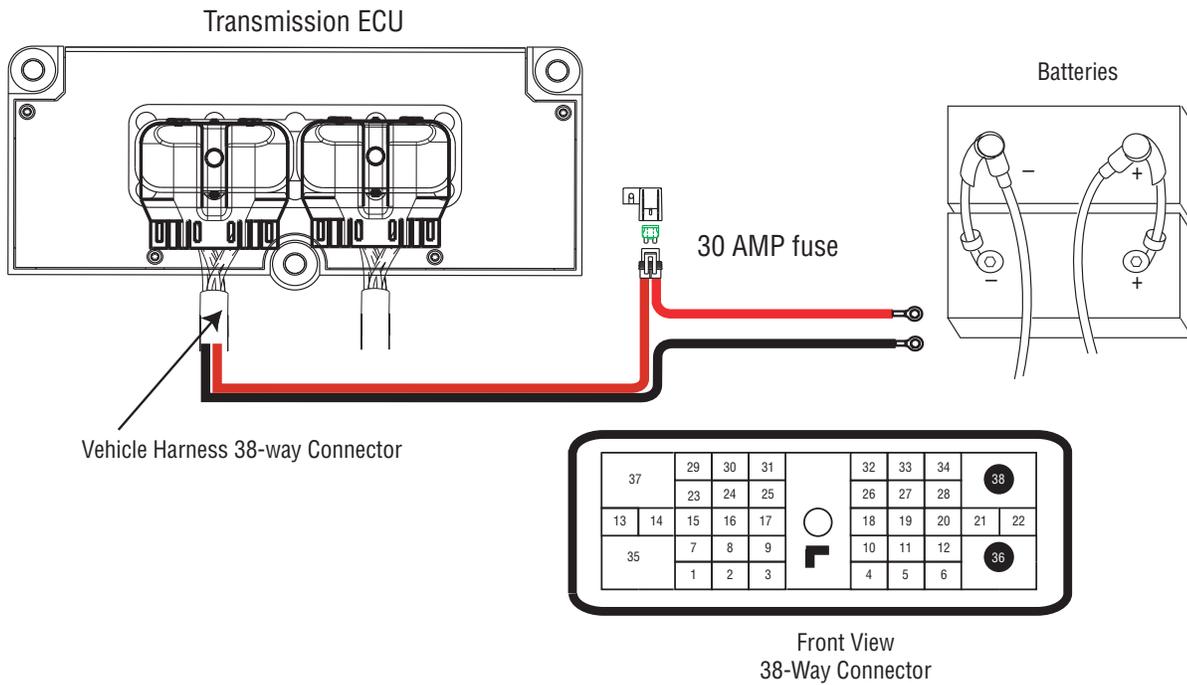
Procedure	→	Condition	→	Action
1. Key off.				
2. Disconnect negative battery cable.				
3. Disconnect the Vehicle Harness 38-way.				
4. Inspect main power 38-way connector terminals pin 36 and 38, in-line fuse holder, and power supply connections for integrity and corrosion.		If no problem found		Go to STEP V
		If problem is found		Repair power/ground path for the main power supply. Go to STEP V

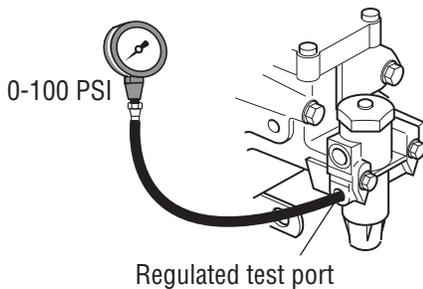
Procedure	→	Condition	→	Action
1. Key off.				
2. Install a 0-100 PSI air pressure gauge in the regulated test port of the air filter / regulator.				
3. Start engine and allow air pressure to build to governor cut-off.				
4. Monitor the vehicle air pressure gauge on the dash.		If air pressure cuts off at 90 to 120 PSI		Go to STEP B
		If air pressure is outside of range		Repair vehicle air system as required. Repeat this step.

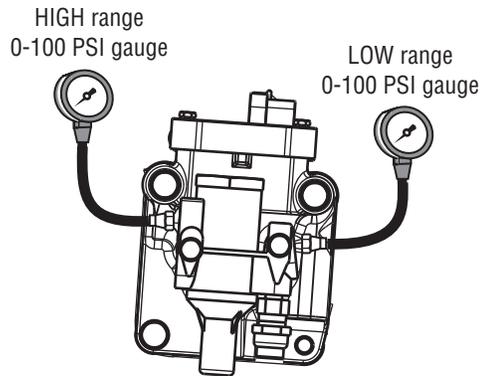
Procedure	→ Condition	→ Action
1. Key on.		
2. With Shift Control, select the highest reverse gear available by pressing the upshift button/arrow, then select neutral.	<p>If HIGH range gauge =</p> <ul style="list-style-type: none"> • 55 to 65 PSI for Non-LAS Models • 75 to 80 PSI for UltraShift PLUS LAS Models <p>And if LOW range gauge = 0 PSI</p> <p>If air pressure gauges do not read as shown above</p>	<p>Repair mechanical range system as required. Go to STEP V</p> <p>Replace Range Solenoid Valve and Range Cylinder Cover as required. Go to STEP V</p>

Important: Monitor gear display after selecting the highest reverse gear available and confirm gear position has changed in the display. A gear change is required to energize the range solenoid.

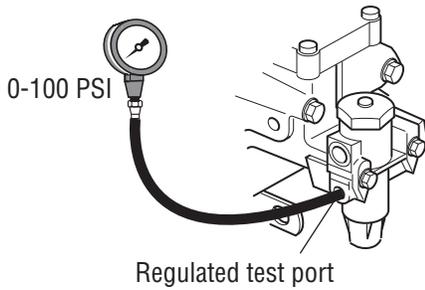
Procedure	→	Condition	→	Action
1. Key off.				
2. Install a 0-100 PSI air pressure gauge in the regulated test port of the air filter / regulator.				
3. Start engine and allow air pressure to build to governor cut-off.				
4. Monitor the vehicle air pressure gauge on the dash.		If air pressure cuts off at 90 to 120 PSI		Go to STEP B
		If air pressure is outside of range		Repair vehicle air system as required. Repeat this step.

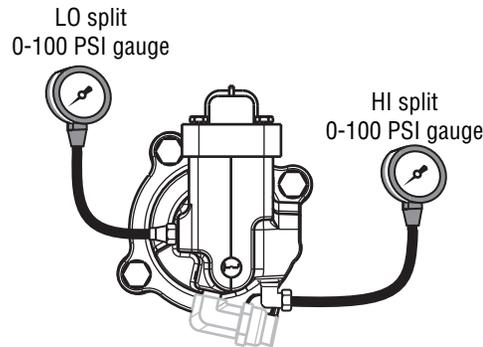
Procedure	→ Condition	→ Action
1. Key on.		
2. With Shift Control, select reverse (R2 in the gear display 13/18-speed). Note: If R2 isn't displayed the up arrow button needs to be pressed.	If HIGH Splitter gauge = 55 to 65 PSI and if LOW Splitter gauge = 0 PSI If air pressure gauges do not read as shown above	Repair Mechanical Splitter system as required. Go to STEP V Replace Splitter Solenoid Valve and Splitter Cylinder Cover as required. Go to STEP V

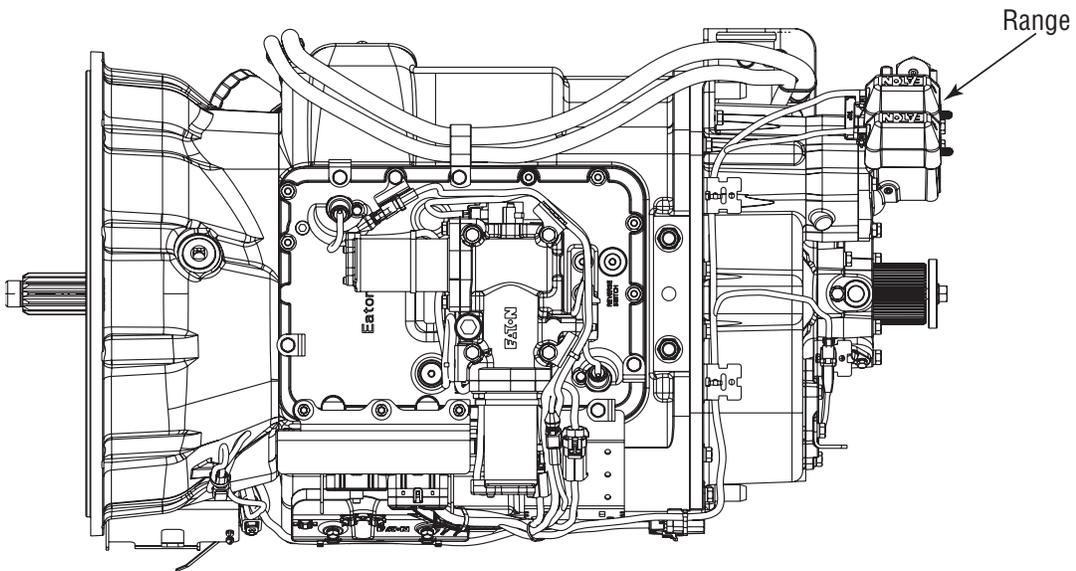
Alternate View - Combination
Cylinder Models

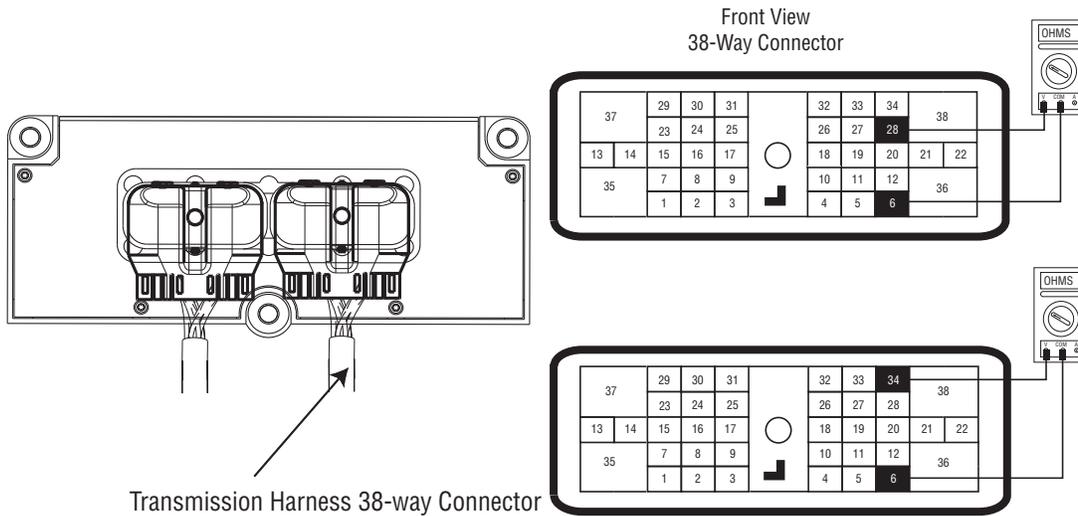
Procedure	→	Condition	→	Action
1. Key off.				
2. Disconnect negative battery cable.				
3. Disconnect the Transmission ECU 38-way connector.				
4. Measure resistance between the Transmission Harness 38-way connector pins:				
<ul style="list-style-type: none"> • 28 and 6 • 34 and 6 • Observe polarity on Volt\Ohm Meter. 		If resistance is 9 to 16 ohms		Go to STEP B
		If resistance is outside of range		Go to STEP C
