Eaton UltraShift PLUS[®], UltraShift[®] and AutoShift[®] Transmissions TRTS0930

March 2012

Transmission Models Included

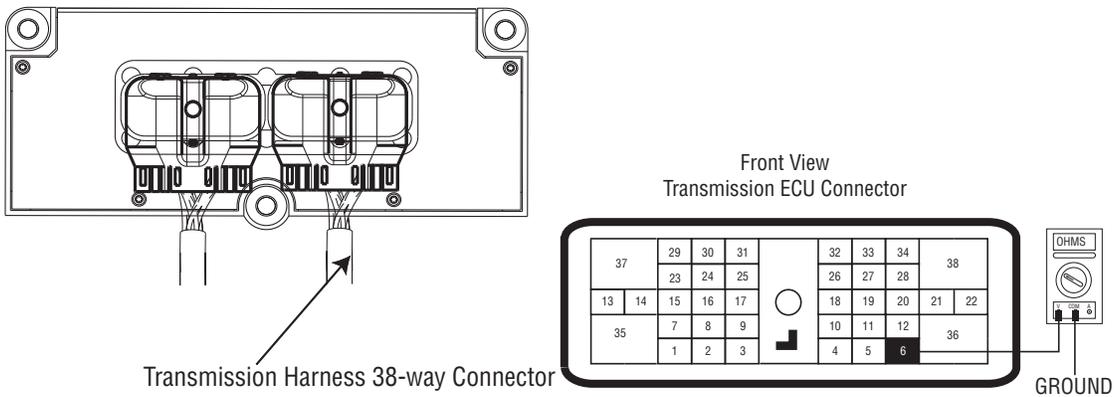
Procedure	→ Condition	→ Action
1. Measure resistance between the Transmission Harness 38-way connector pin 6 and ground.	If resistance is OL	Replace Transmission ECU (Only if Fault Code is Active). Go to STEP V
	If resistance is less than 10K ohm	Go to STEP C

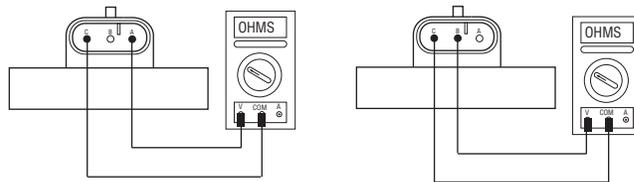
Procedure	Condition	Action
1. Disconnect the Transmission Harness from Range Solenoid Valve.		
2. Measure resistance between Range Solenoid Valve pins: <ul style="list-style-type: none"> • A and C • B and C 	If resistance is 9 to 16 ohms If resistance is outside of range	Go to STEP D Replace Range Solenoid Valve. Go to STEP V

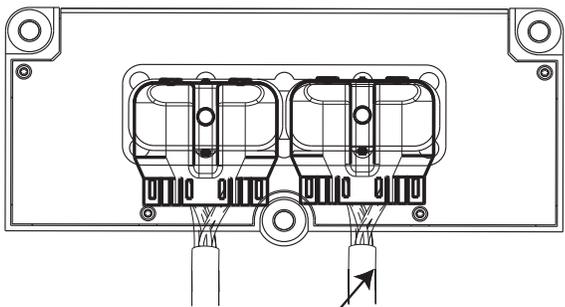
Transmission Harness 38-way Connector

Procedure	→	Condition	→	Action
1. Key off.				
2. Disconnect negative battery cable.				
3. Disconnect the Transmission Harness 38-way connector.				
4. Measure resistance between the Transmission Harness 38-way connector pins 33 and 5.		If resistance is 2 to 6 ohms		Go to STEP B
		If resistance is outside of range		Go to STEP C

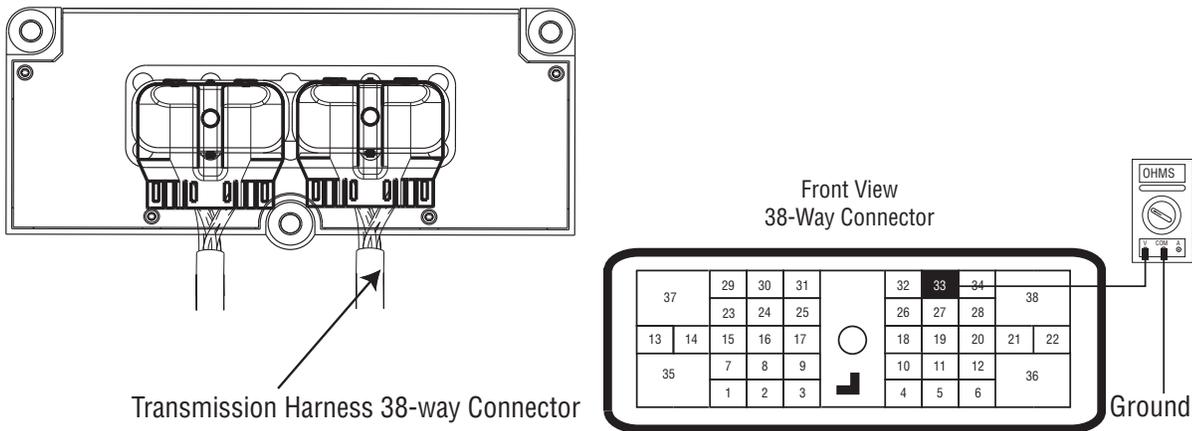
Procedure	Condition	Action
1. Measure resistance between the Transmission Harness 38-way connector pin 33 and ground.	If resistance is OL	Replace Transmission ECU (only if Fault Code is Active). Go to STEP V
	If resistance is less than 10K ohm	Go to STEP C

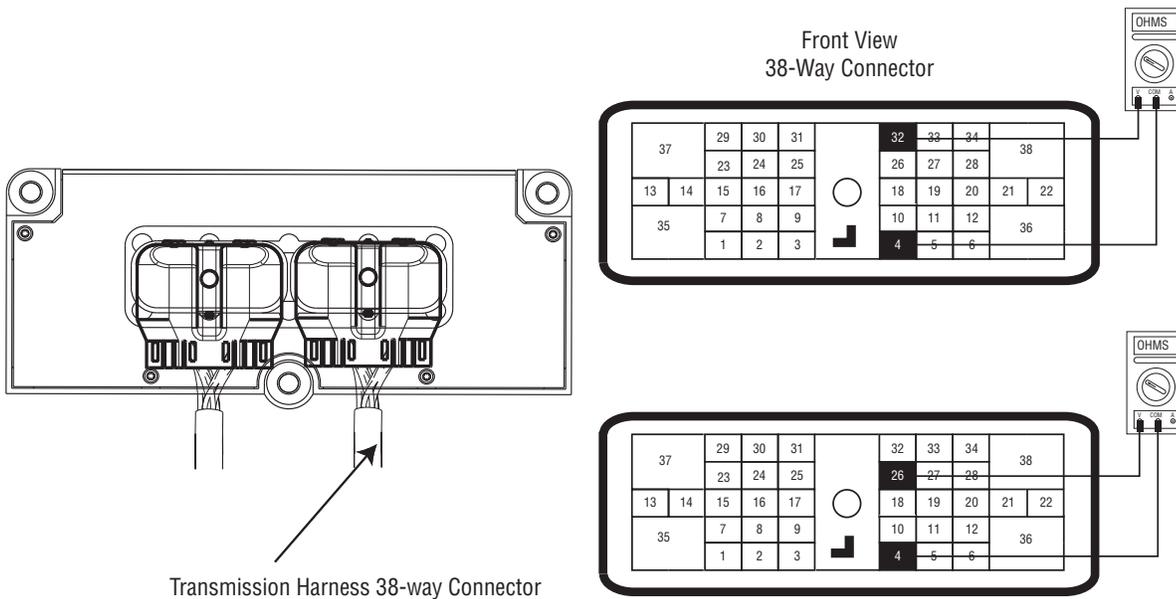
Procedure	→	Condition	→	Action
1. Key off.				
2. Disconnect negative battery cable.				
3. Disconnect the Transmission Harness 38-way connector.				
4. Measure resistance between the Transmission Harness 38-way connector pins:				
• 32 and 4		If resistance is 9 to 16 ohms		Go to STEP B
• 26 and 4		If resistance is outside of range		Go to STEP C

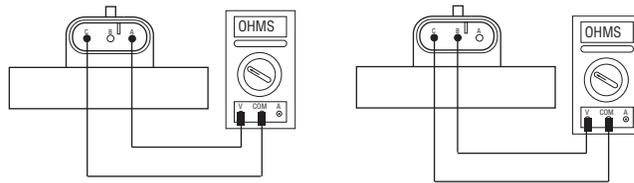
Procedure	Condition	Action
1. Disconnect the Transmission Harness from Splitter Solenoid Valve.		
2. Measure resistance between Splitter Solenoid Valve pins:		
<ul style="list-style-type: none"> • A and C • B and C 	If resistance is 9 to 16 ohms	Go to STEP D
	If resistance is outside of range	Replace Splitter Solenoid Valve. Go to STEP V

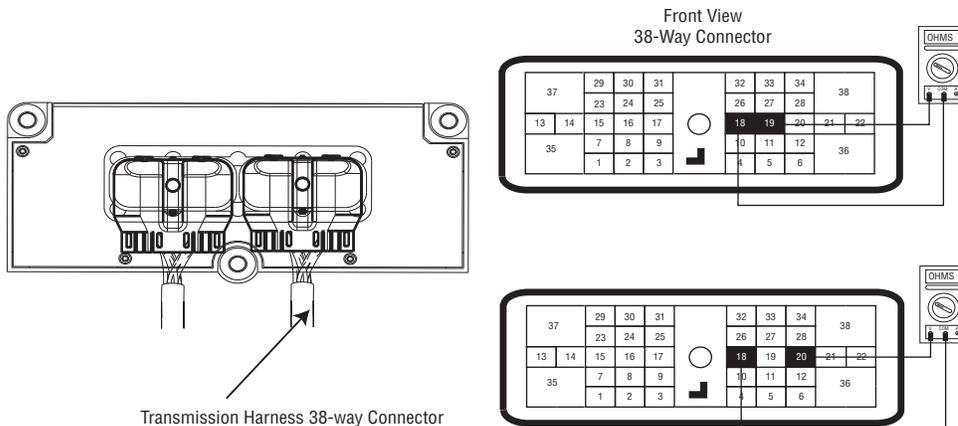
Procedure	→	Condition	→	Action
1. Measure resistance between Transmission Harness 38-way connector pin 18 to ground.		If resistance is OL		Reconnect 38-way connector, replace Transmission Controller (only if fault code is active.)
		If FMI 2, 3, 4, or 10 is present with an inactive code		Replace the XY shifter and Transmission Harness.
		If resistance is less than 10K ohm		Go to STEP C

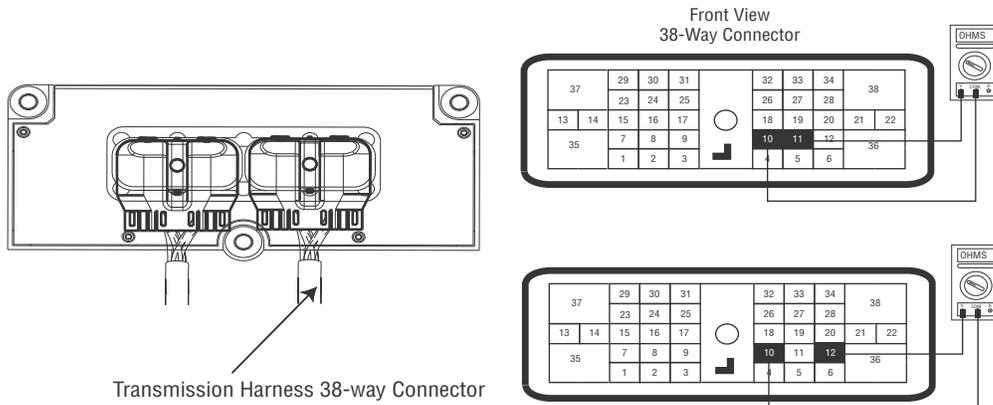
Procedure	→ Condition	→ Action
1. Measure resistance between Transmission Harness 38-way connector pin 10 to ground.	If resistance is OL	Reconnect 38-way connector, replace Transmission Controller (only if fault code is active.)
	If FMI 2, 3, or 4 is present with an inactive code	Replace the XY Shifter and Transmission Harness.
	If FMI 7 is present, remove XY Shifter to inspect for a broken shift finger. If the shift finger is broken	Replace the XY Shifter.
	If resistance is less than 10K ohm	Go to STEP C

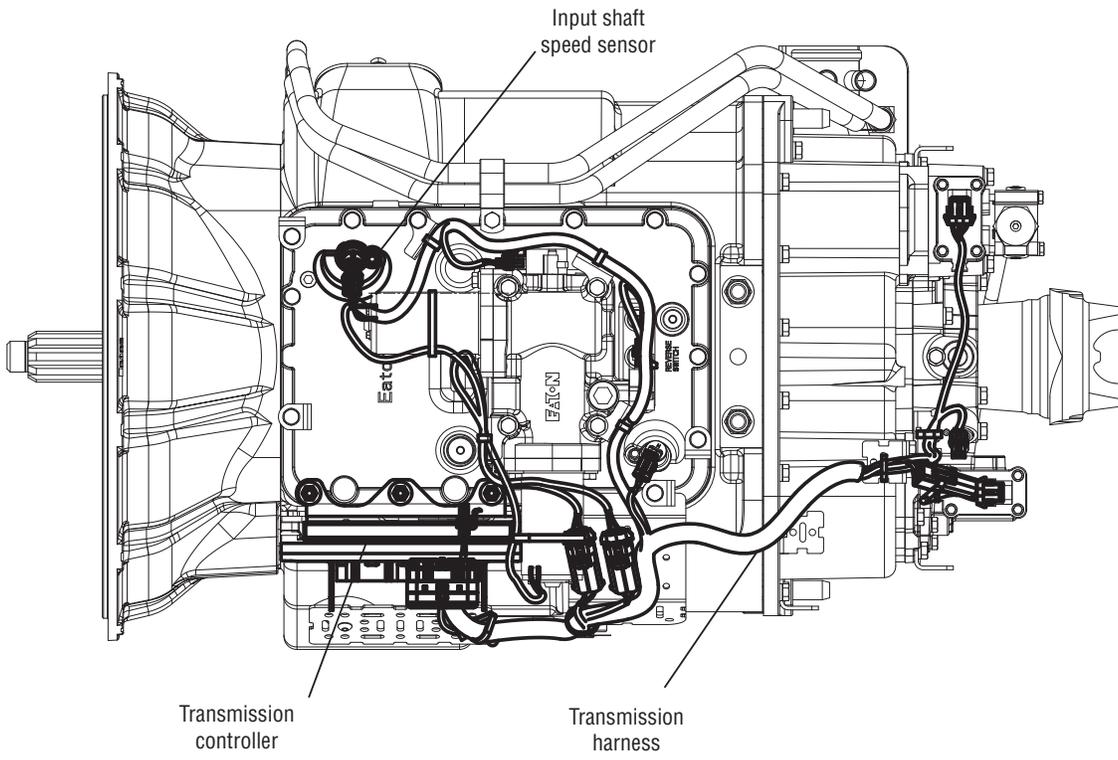
This fault code indicates an electrical problem in the Input Shaft Speed Sensor circuit. The signal from the sensor did not match the current operating conditions.

- Transmission Harness
- Input Shaft Speed Sensor
- Various Transmission Components
- Transmission ECU

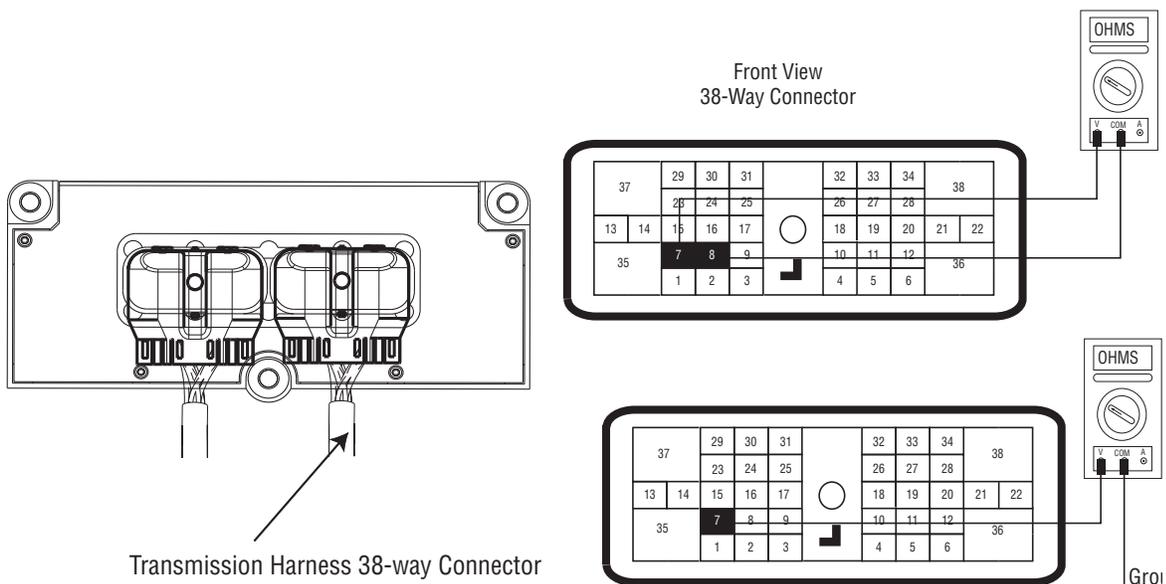
Procedure	Condition	Action
1. Key off.		
2. Disconnect negative battery cable.		
3. Disconnect the Transmission Harness 38-way connector.		
4. Measure resistance between the Transmission Harness 38-way connector pins 7 and 8 and pin 7 and ground.	If resistance is 2K to 4.5K ohm and pin 7 to ground is OL	Go to STEP C
	If resistance is outside of the range	Go to STEP D

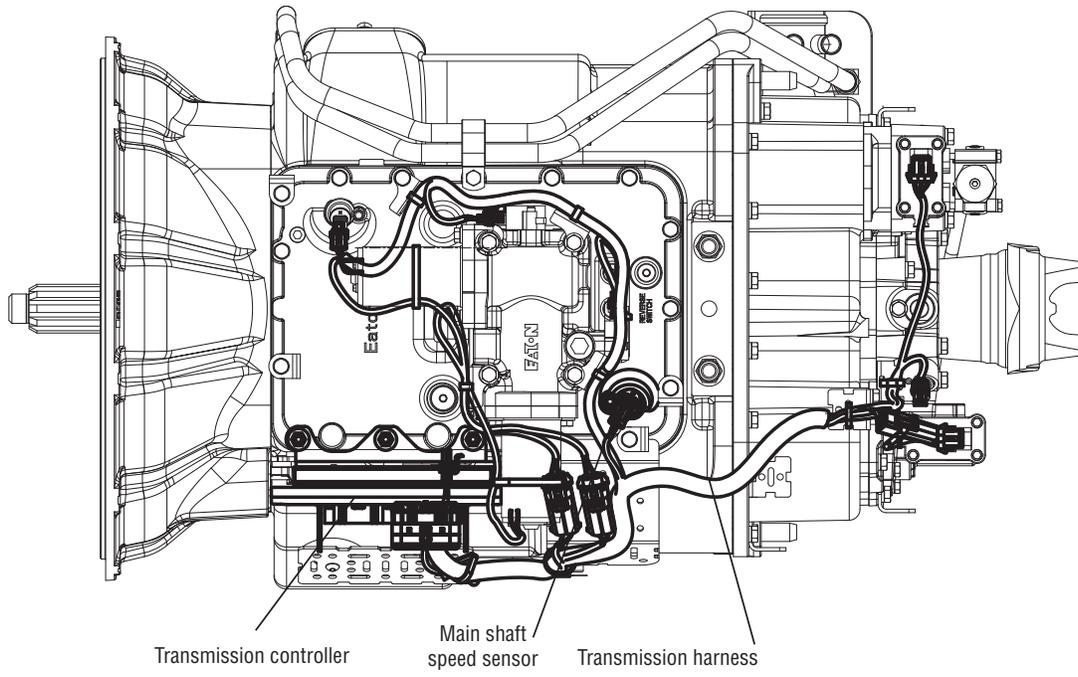
This fault code indicates an electrical problem in the Main Shaft Speed Sensor circuit. The signal from the sensor did not match the current operating conditions

- Transmission Harness
- Main Shaft Speed Sensor
- Various Transmission Components
- Transmission ECU

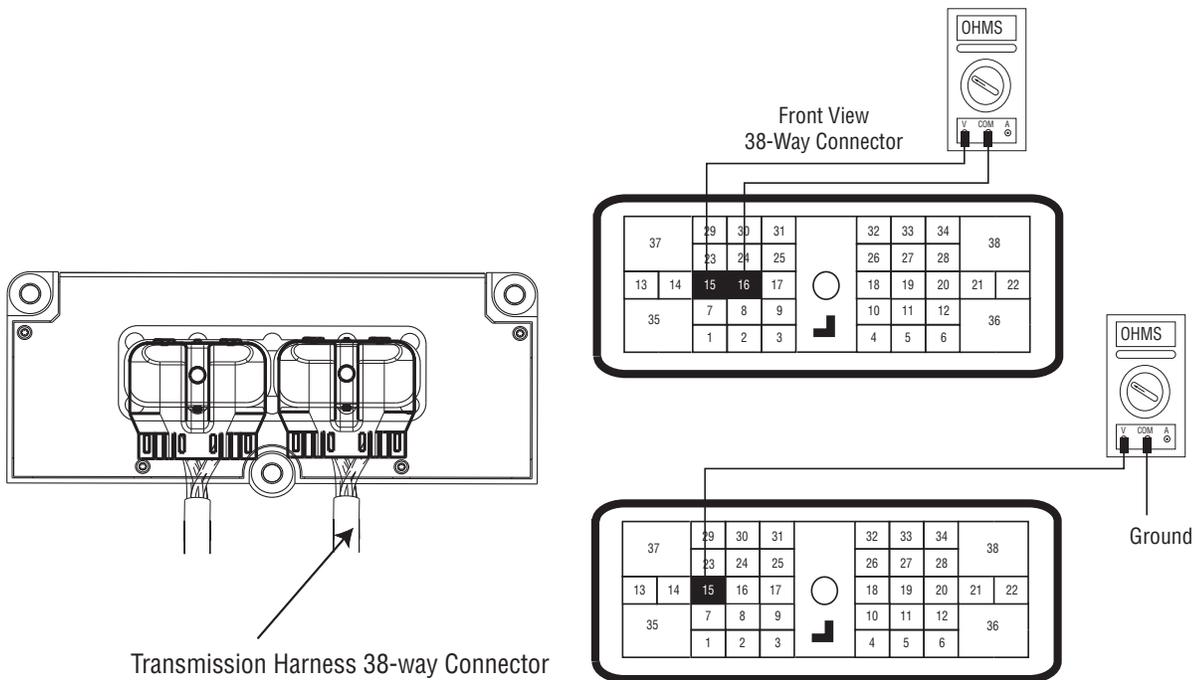
Procedure	→	Condition	→	Action
1. Key off.				
2. Disconnect negative battery cable.				
3. Disconnect the Transmission Harness 38-way connector.				
4. Measure resistance between the Transmission Harness 38-way connector pins 15 and 16 and 15 and ground.		If resistance is 2k to 4.5K ohm and pin 15 to ground is OL		Go to STEP B
		If resistance is outside of the range		Go to STEP C

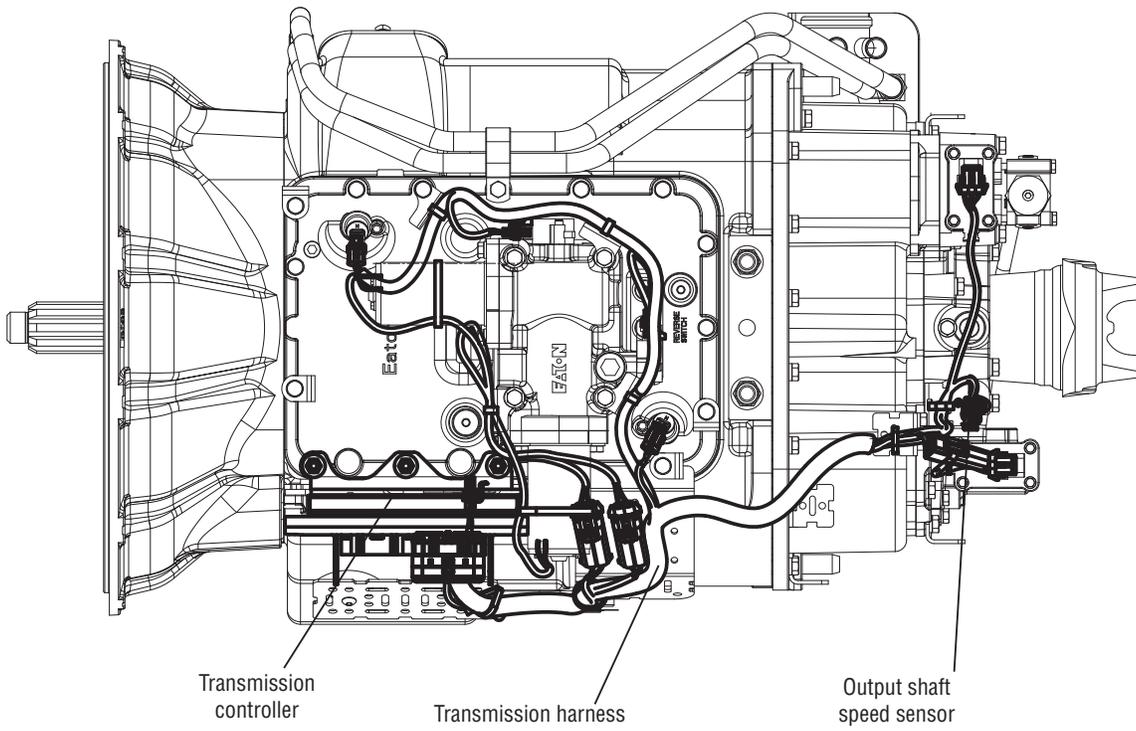
This fault code indicates an electrical problem in the Output Shaft Speed Sensor circuit. The signal from the sensor did not match the current operating conditions

- Transmission Harness
- Output Shaft Speed Sensor
- Various Transmission Components
- Transmission ECU
- Failed or Loose Tone Wheel

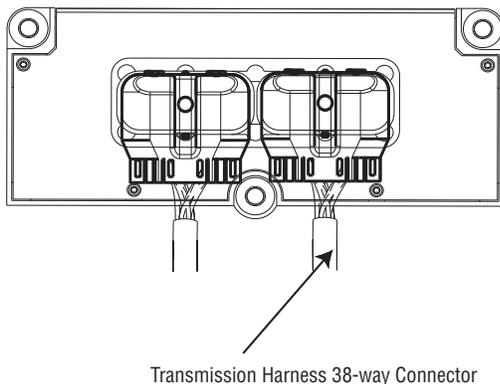
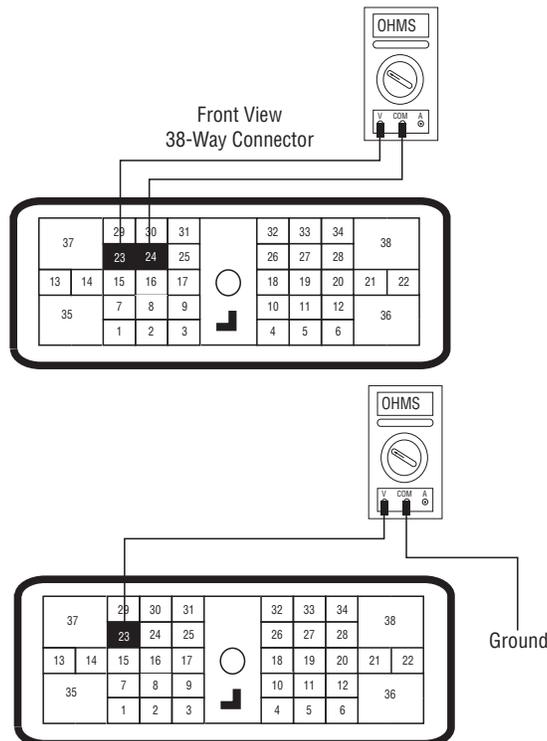
Procedure	→	Condition	→	Action
1. Key off.				
2. Disconnect negative battery cable.				
3. Disconnect the Transmission Harness 38-way connector.				
4. Measure resistance between the Transmission Harness 38-way connector pins 23 and 24 and 23 and ground.		If resistance is 2K to 4.5K ohm and pin 23 to ground is OL		Go to STEP B
		If resistance is outside of the range		Go to STEP C

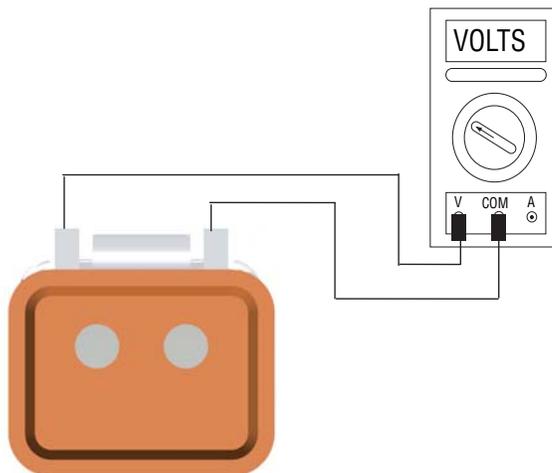
Procedure	Condition	Action
1. Key off.		
2. Disconnect the Transmission Harness from the Output Shaft Speed Sensor.		
3. With key on, measure voltage from Transmission Harness connector 1 and 2.	If voltage is within 4.9 - 5.1 volts	Replace the Output Shaft Sensor. Go to STEP V
	If voltage is out of range	Go to STEP F

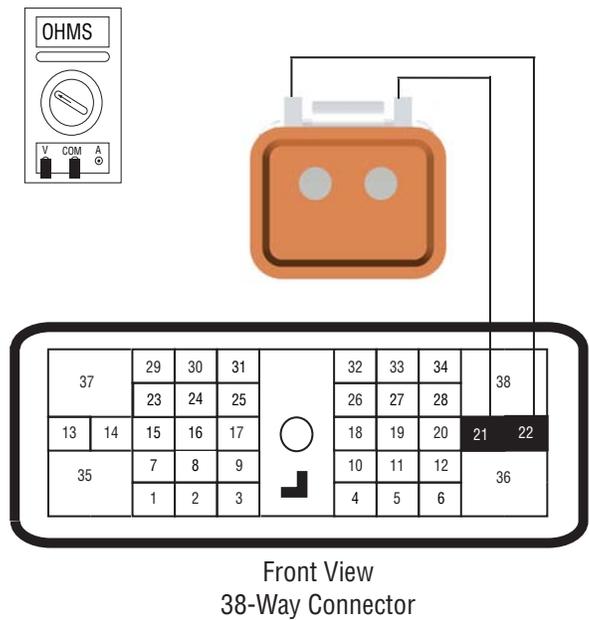
Procedure	→ Condition	→ Action
1. Key off.		
2. Disconnect negative battery cable.		
3. Disconnect the Transmission Harness 38-way connector.		
4. Check for connector damage and measure resistance between: - Transmission Harness 38-way connector pins 22 and Transmission Harness connector 1. - Transmission Harness 38-way connector pins 21 and Transmission Harness connector 2.	If harness connections are in good condition and resistance of both circuits measure between 0 to 0.3 ohms	Replace the ECU (Only if Fault Code is Active.) Go to STEP V
	If damaged or failed harness connectors are found, or if either or both circuits are out of range	Replace the Transmission Harness. Go to STEP V

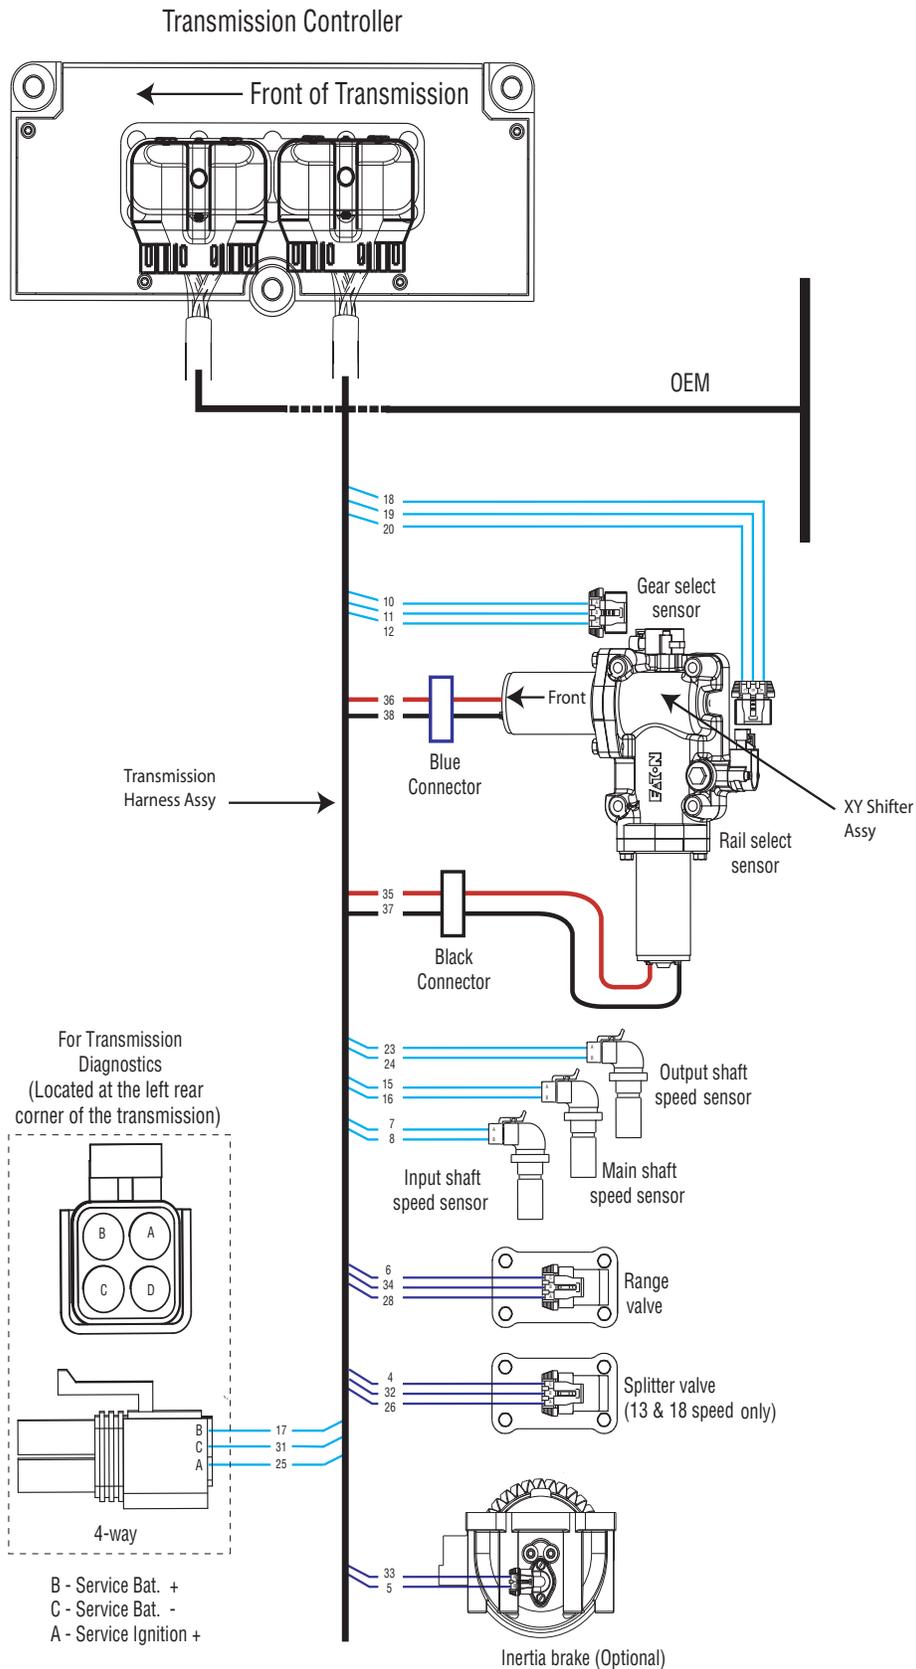
Component Code 61 Isolation Procedures

The TECU checks the rail motor for open or shorted connections. There are four fault conditions defined by the reported FMI via ServiceRanger software.

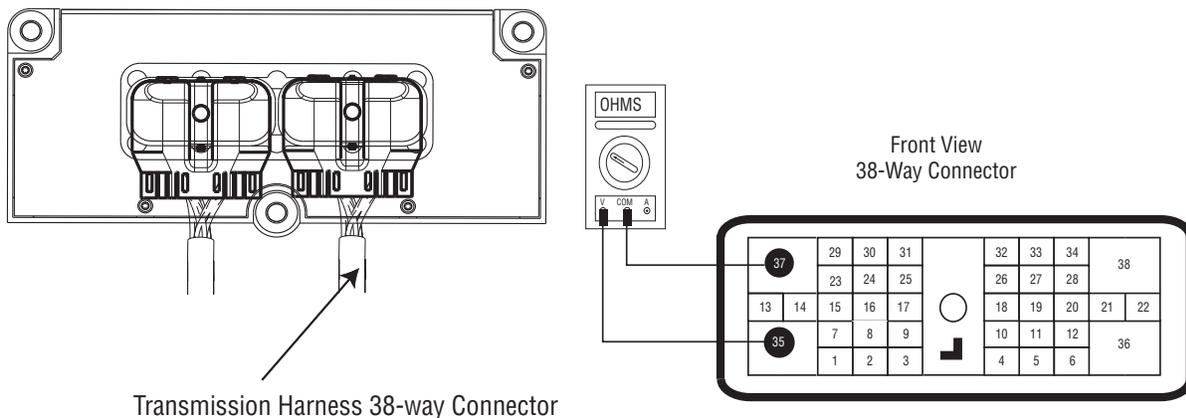
Procedure	Condition	Action
1. Key off.	Measured resistance is 2 ohms or less	Go to STEP C
2. Disconnect the negative battery cable.	Measured resistance is greater than 2 ohms	Go to STEP D
3. Disconnect the Transmission Harness 38-way connector from the TECU.		
4. Measure resistance between pins 35 and 37.

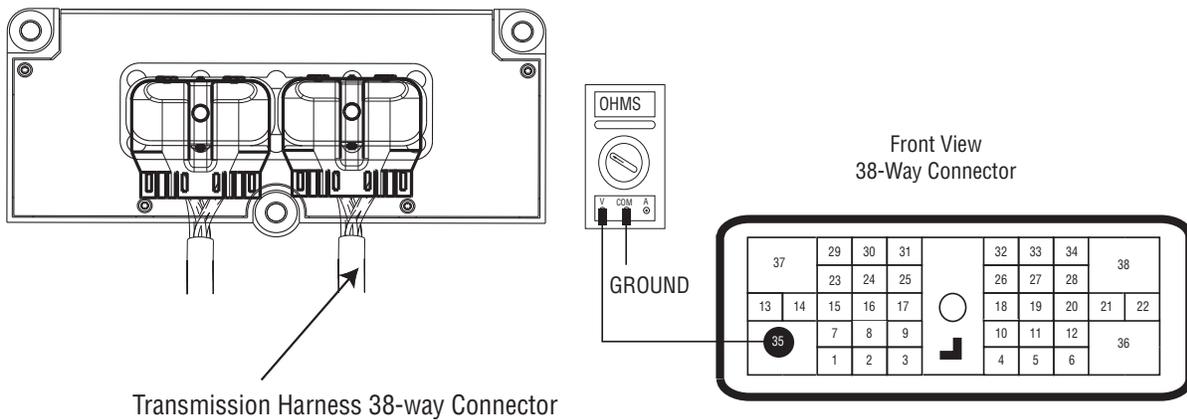
Procedure	Condition	Action
1. Measure the resistance between pin 35 and ground.	Measured resistance is 1M ohm or greater	Go to STEP E
	Measured resistance is less than 1M ohm	Go to STEP D

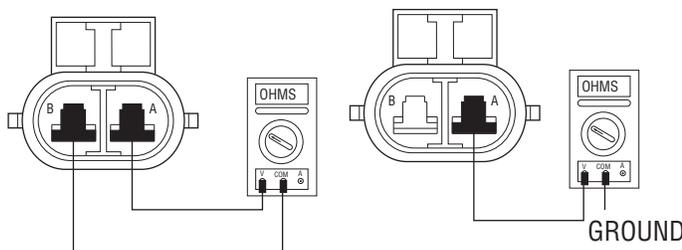
Procedure	Condition	Action
1. Disconnect the black 2-way rail motor connector from the transmission harness.	Measured resistance is: <ul style="list-style-type: none"> • Pin A to B – 2 ohms or less • Pin A to Ground – 1M ohm or greater 	Replace the Transmission Harness. Go to STEP V
2. Measure the resistance of the Rail Motor at the 2-way connector.	Measured resistance is out of range	Replace the XY shifter. Go to STEP V

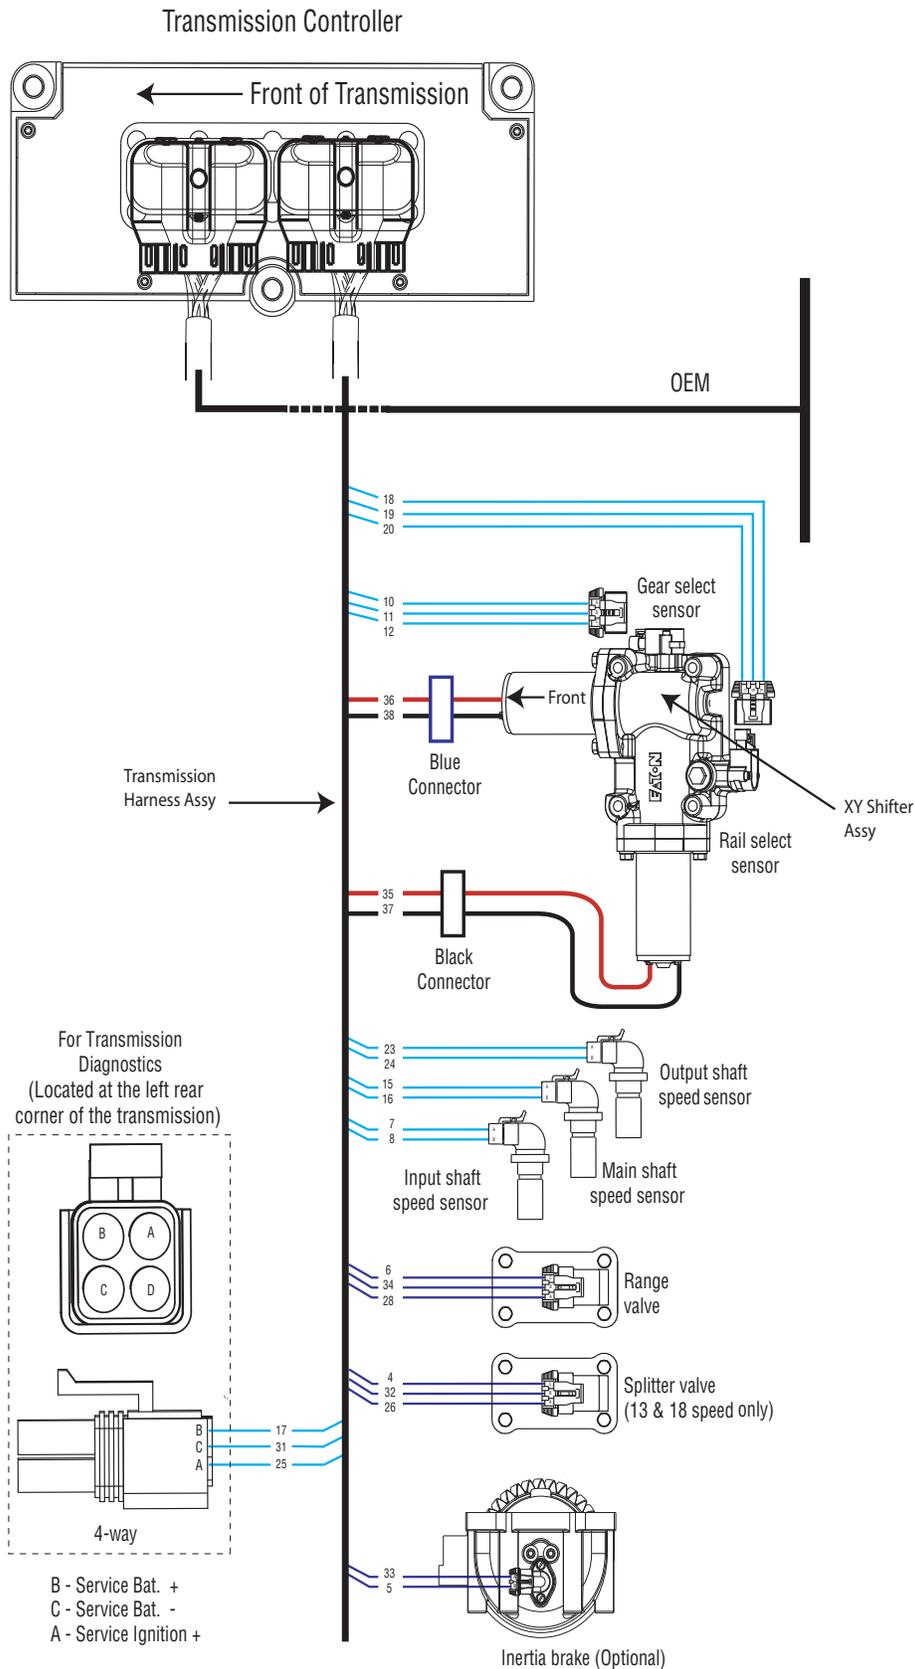
Component Code 63 Isolation Procedures

The TECU checks the gear motor and controller for open or shorted connections. There are four fault conditions defined by the reported FMI via ServiceRanger software.

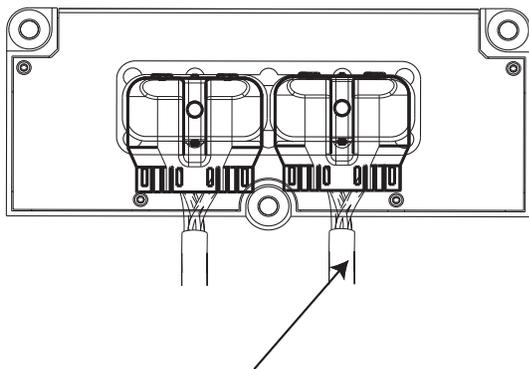
Transmission Harness 38-way Connector

Procedure	Condition	Action
1. Key off.	Measured resistance is 2 ohms or less	Go to STEP C
2. Disconnect the negative battery cable.	Measured resistance is greater than 2 ohms	Go to STEP D
3. Disconnect the Transmission Harness 38-way connector from the TECU.		
4. Measure resistance between pins 36 and 38.

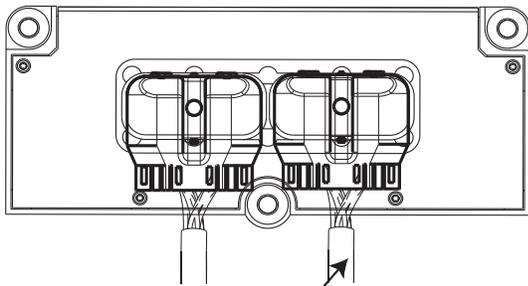
Transmission Harness 38-way Connector

Procedure	Condition	Action
1. Measure the resistance between pin 36 and ground.	Measured resistance is 1M ohm or greater	Go to STEP E
	Measured resistance is less than 1M ohm	Go to STEP D

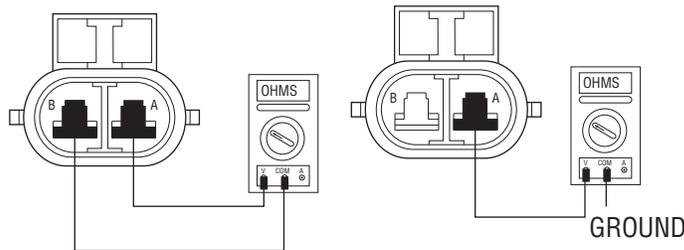
Procedure	Condition	Action
1. Disconnect the blue 2-way gear motor connector from the transmission harness.	Measured resistance is: <ul style="list-style-type: none"> Pin A to B – 2 ohms or less Pin A to Ground – 1M ohm or greater 	Replace the Transmission Harness. Go to STEP V
2. Measure the resistance of the gear motor at the 2-way connector.	Measured resistance is out of range	Replace the XY shifter. Go to STEP V

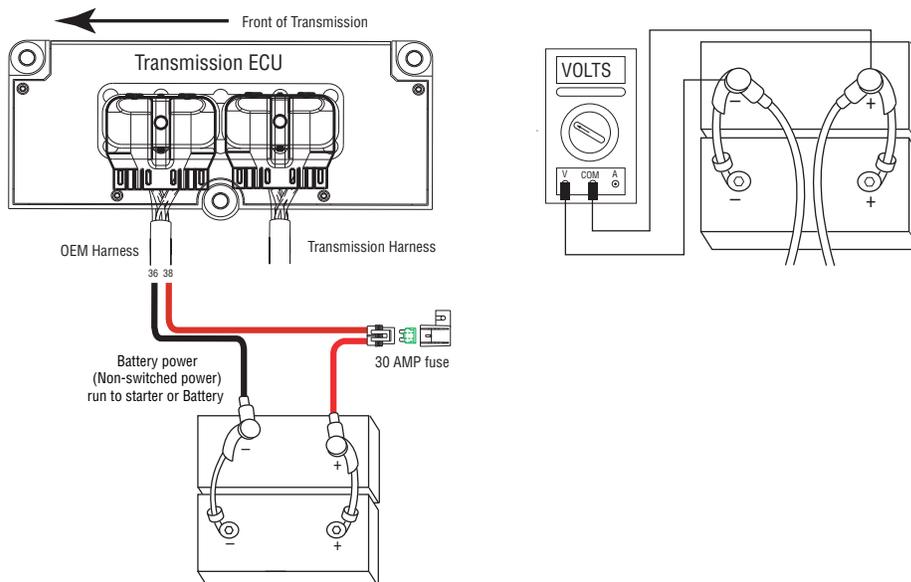
Procedure	→	Condition	→	Action
3. Key off.				
4. Inspect starter / battery and in-line fuse holder connections for integrity.				
5. Measure voltage across batteries.		If voltage is 11 to 13 volts on a 12-volt system or 22 to 26 on a 24-volt system		Proceed with battery load test. Repair or replace batteries as required. Go to STEP C
		If voltage is outside of range		Repair or replace batteries and charge system as required. Repeat test.

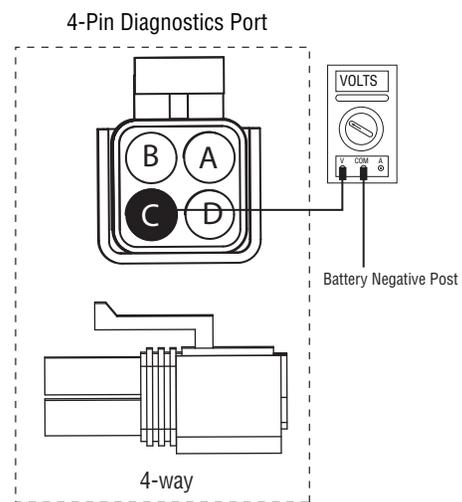
4-Pin Diagnostic Port
(Located at the left rear corner of the transmission.)

Procedure	→	Condition	→	Action
1. Locate the diagnostic port on the Transmission Harness - located at the left rear corner of the transmission.				
2. Key on.				
3. Measure voltage between pins C and the battery negative post.		If voltage between pin C and battery negative post is 0.70 volts or less		Go to STEP D
		If voltage is outside of range		Repair battery ground supply to Transmission ECU. Repeat test.

B - Service Bat. +
C - Service Bat. -
A - Service Ignition +

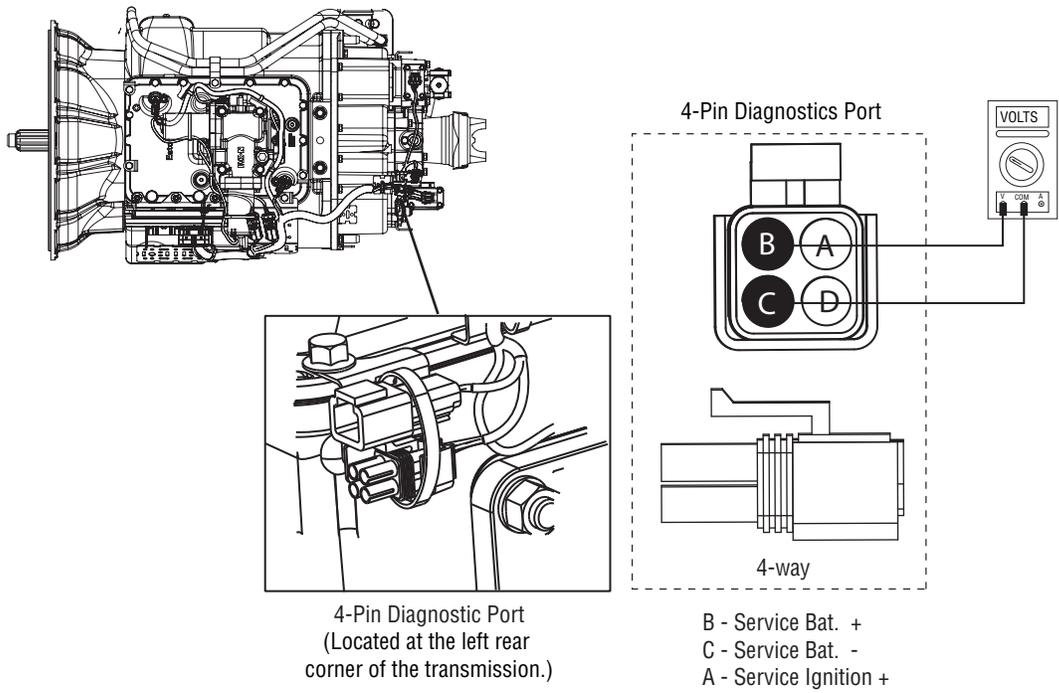
Procedure	→	Condition	→	Action
1. Key on.				
2. Measure voltage between pin B and pin C.		If voltage between pins B and C is within 0.6 volts of battery voltage		Go to STEP E
		If voltage is outside of range		Repair battery power supply to Transmission ECU. Fuse may be blown. Repeat test.

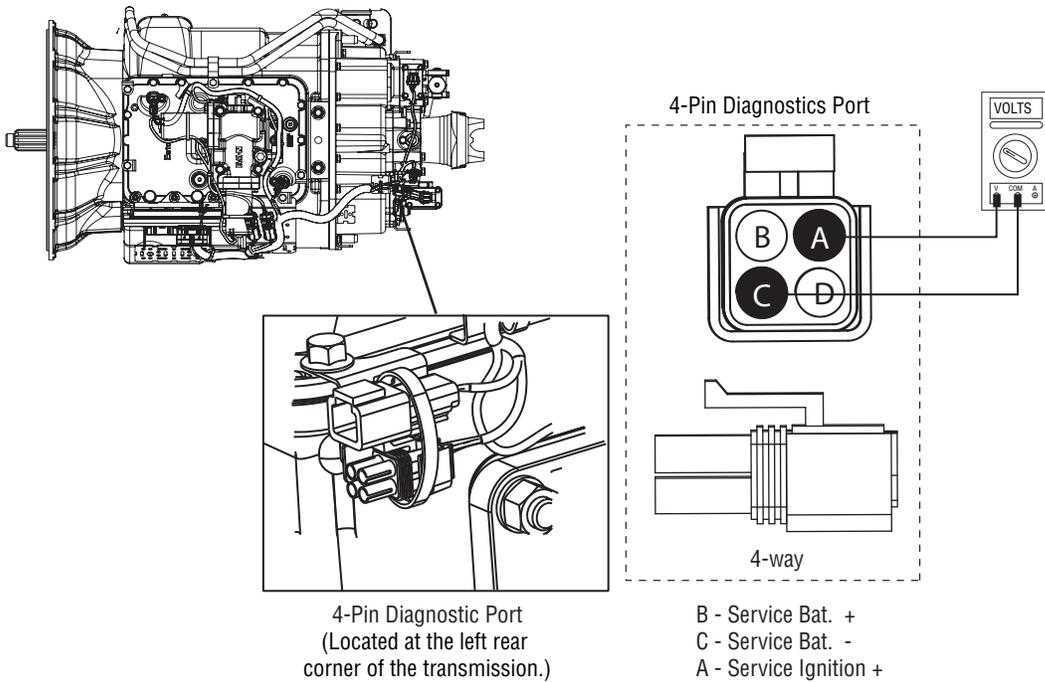
Procedure	→	Condition	→	Action
1. Key on.				
2. Measure voltage between pin A and pin C.		If voltage between pin A and C is within 0.6 volts of battery voltage		Go to STEP F
		If voltage is outside of range		Repair Ignition power supply to ECU. Fuse may be blown. Repeat test.

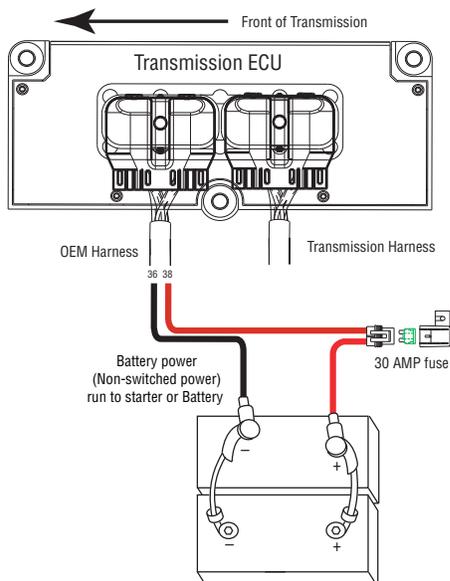
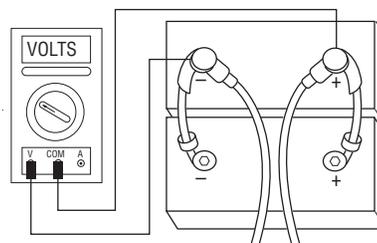
Procedure	→	Condition	→	Action
3. Key off.				
4. Inspect starter / battery and inline fuse holder connections for integrity.				
5. Measure voltage across batteries.		If voltage is 11 to 13 volts on a 12-volt system or 22 to 26 on a 24-volt system		Proceed with battery load test. Repair or replace batteries as required. Go to STEP C
		If voltage is outside of range		Repair or replace batteries and charge system as required. Repeat test.

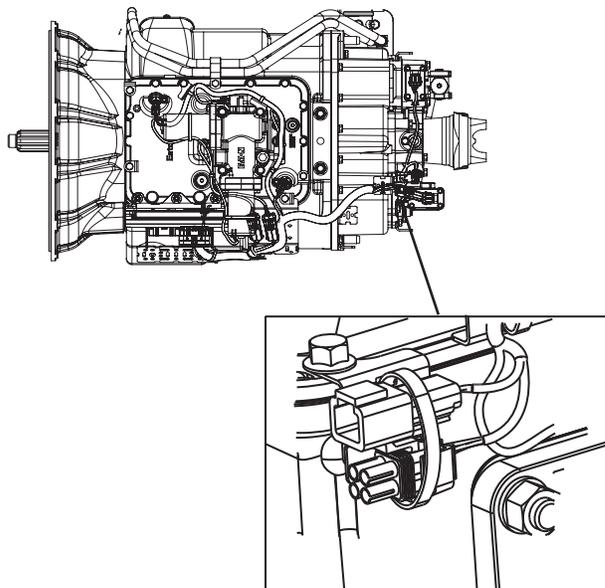
4-Pin Diagnostic Port
(Located at the left rear corner of the transmission.)

Procedure	→	Condition	→	Action
1. Locate the diagnostic port on the Transmission Harness - located at the left rear corner of the transmission.				
2. Key on.				
3. Measure voltage between pins C and the battery negative post.		If voltage between pin C and battery negative post is 0.70 volts or less.		Go to STEP D
		If voltage is outside of range		Repair battery ground supply to Transmission ECU. Repeat test.

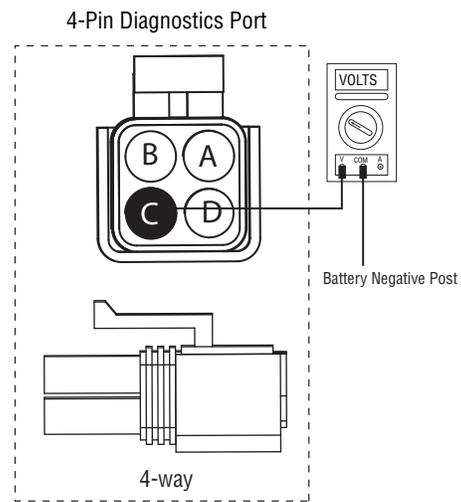
B - Service Bat. +
C - Service Bat. -
A - Service Ignition +

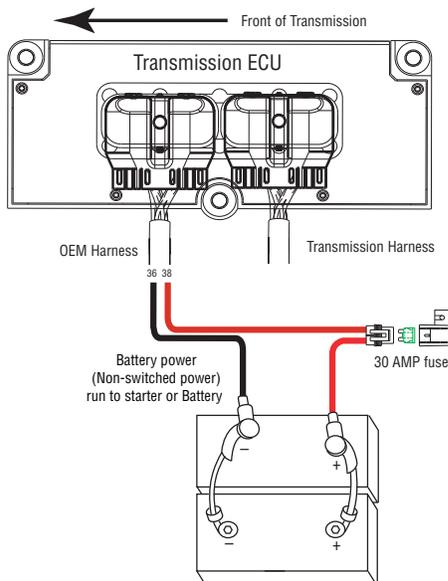
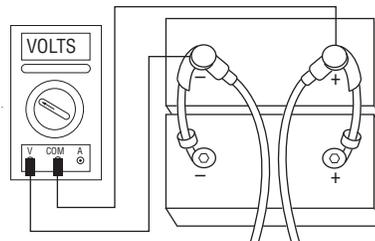
Procedure	→	Condition	→	Action
3. Key off.				
4. Inspect starter / battery and inline fuse holder connections for integrity.				
5. Measure voltage across batteries.		If voltage is 11 to 13 volts on a 12-volt system or 22 to 26 on a 24-volt system		Proceed with battery load test. Repair or replace batteries as required. Go to STEP C
		If voltage is outside of range		Repair or replace batteries and charge system as required. Repeat test.

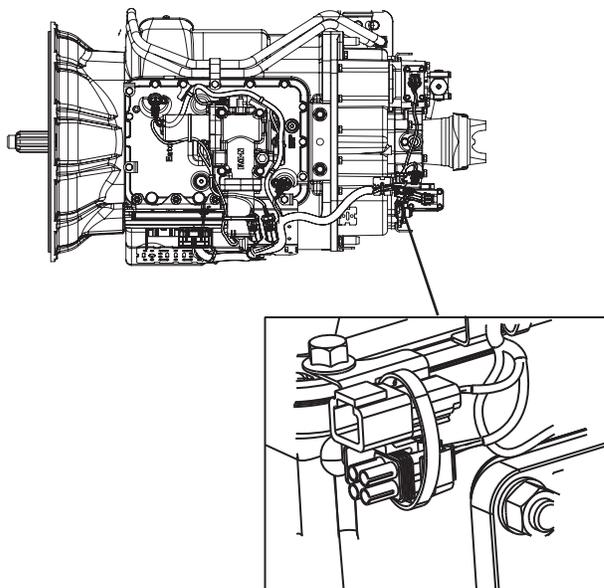
4-Pin Diagnostic Port
(Located at the left rear corner of the transmission.)

Procedure	→	Condition	→	Action
1. Locate the diagnostic port on the Transmission Harness - located at the left rear corner of the transmission.				
2. Key on.				
3. Measure voltage between pins C and the battery negative post.		If voltage between pin C and battery negative post is 0.70 volts or less		Go to STEP D
		If voltage is outside of range		Repair battery ground supply to Transmission ECU. Repeat test.

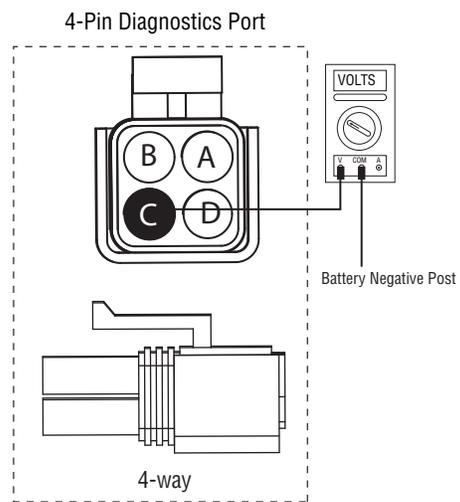
B - Service Bat. +
C - Service Bat. -
A - Service Ignition +

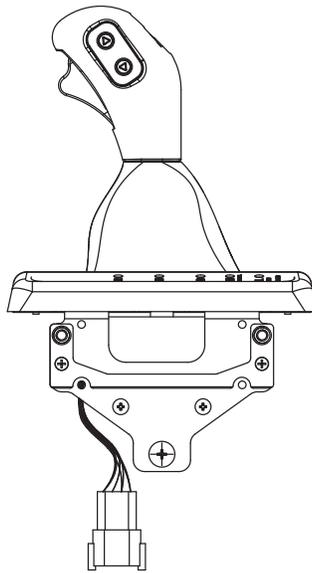
Procedure	→	Condition	→	Action
1. Key on.				
2. Retrieve Codes. Go to Fault Code Retrieval/Clearing .		If code 83 is active		Replace Eaton Shift Lever or OEM Shift Lever.
		If 83 is inactive		Test complete.

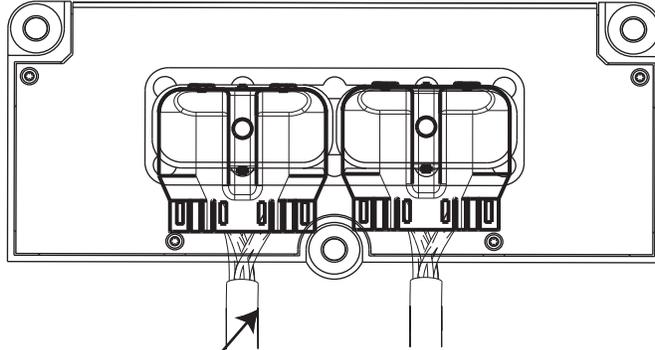
Vehicle Harness 38-way Connector

Procedure	→	Condition	→	Action
1. Verify shift control device is connected to the OEM wiring.				
2. Key on.				
3. Retrieve codes. Go to Fault Code Retrieval/Clearing .		If code 84 is active		Repair OEM wiring between Transmission ECU and shift control device.

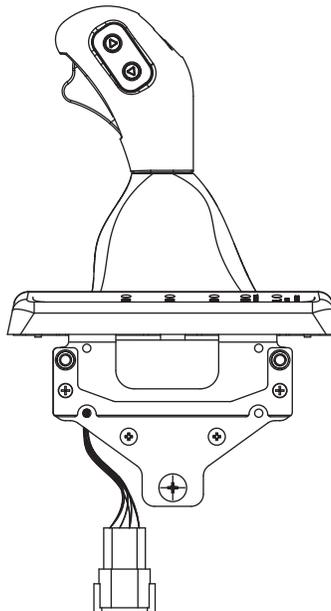
Eaton Shift Lever

Procedure	→	Condition	→	Action
1. Verify shift control device is connected to the OEM wiring.				
2. Key on.				
3. Retrieve codes. Go to Fault Code Retrieval/Clearing .		If code 85 is active		Verify correct shift control device is installed on vehicle.

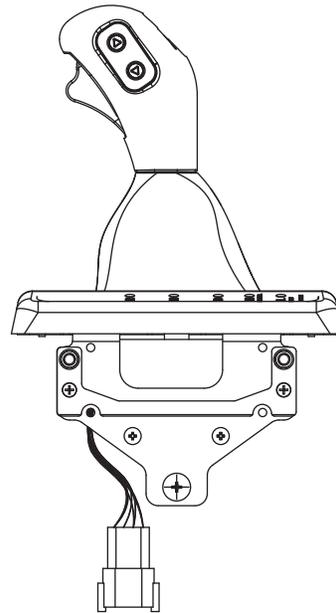
Eaton Shift Lever

Procedure	→	Condition	→	Action
1. Start engine.				
2. Place Shift Device in "Manual".				
3. Drive the vehicle and use the buttons to initiate upshifts and downshifts, when shift conditions permit.		If the up and down buttons are working properly, the transmission will make upshifts and downshifts		Test complete.
		If the transmission does not make upshifts and/or downshifts		Replace Shift Control. Repeat test.

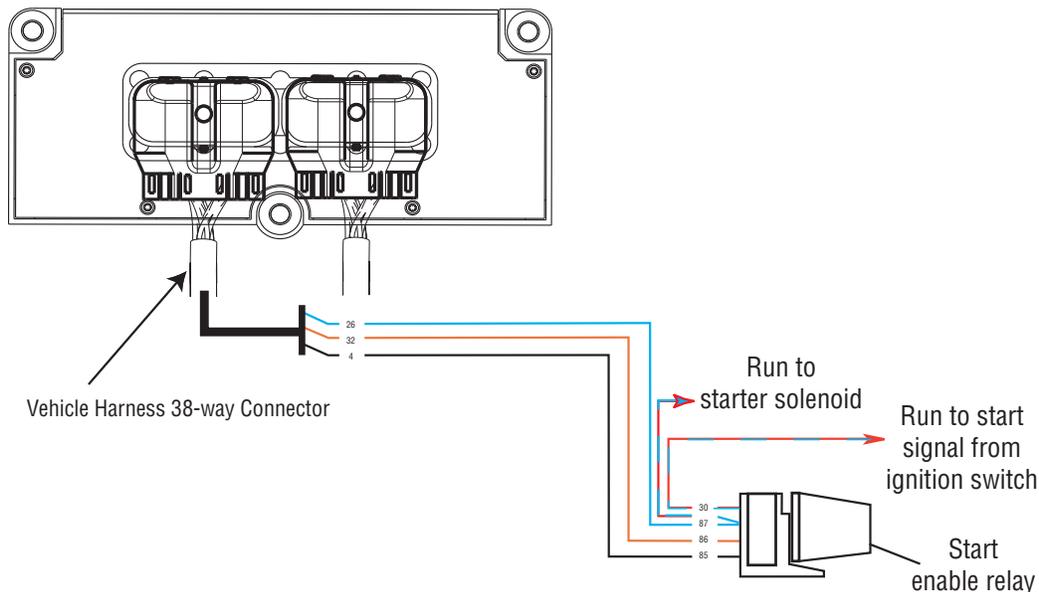
Trans ECU Legend

All OEM responsible wiring shown is "typical". Consult specific application.

Procedure	→	Condition	→	Action
1. Key off.				
Note: The Start Enable Relay must be wired according to Eaton GEN III requirements (shown on previous page) for this test to work properly. If wired differently, consult OEM for correct wiring schematic.				
2. Disconnect negative battery cable.				
3. Disconnect Vehicle Harness 38-way connector.				
4. Reconnect negative battery cable.				
5. Key on.				
6. Engage Starter.		If engine cranks		Go to STEP F
		If engine does not crank		Go to STEP G

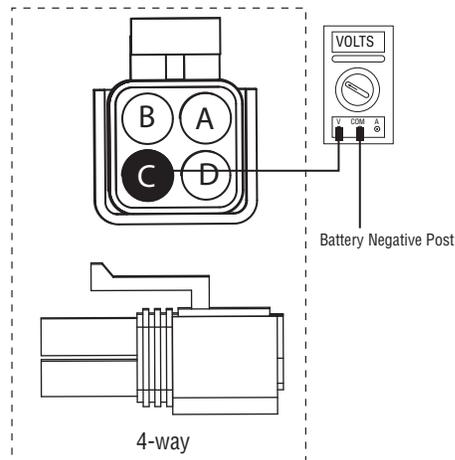
Procedure	→	Condition	→	Action
1. Locate diagnostic port on Transmission Harness.				
2. Key on.				
3. Measure voltage between pins C and the battery negative post.		If voltage between pin C and battery negative post is 0.70 volts or less		Go to STEP C
		If voltage is outside of range		Repair battery ground supply to Transmission ECU. Repeat test.

B - Service Bat. +
C - Service Bat. -

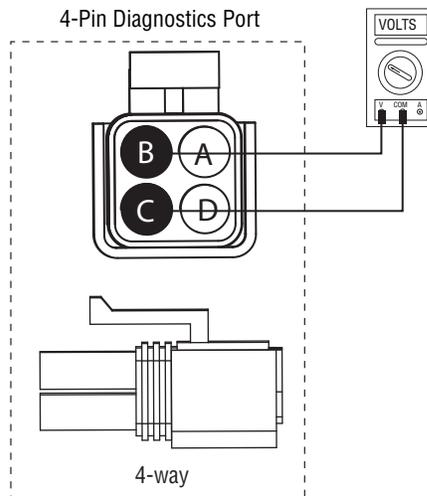
4-Pin Diagnostic Port
(Located at the left rear corner of the transmission.)

Procedure	→	Condition	→	Action
1. Locate diagnostic port on Transmission Harness.				
2. Key on.				
3. Measure voltage between pins B and pin C.		If voltage between pins B and C is within 0.6 volts of battery voltage		Go to STEP D
		If voltage is outside of range		Repair battery power supply to Transmission ECU. Fuse may be blown. Repeat test.

B - Service Bat. +
C - Service Bat. -
A - Service Ignition +
