Eaton UltraShift PLUS[®], UltraShift[®] and AutoShift[®] Transmissions TRTS0930

March 2012

Transmission Models Included

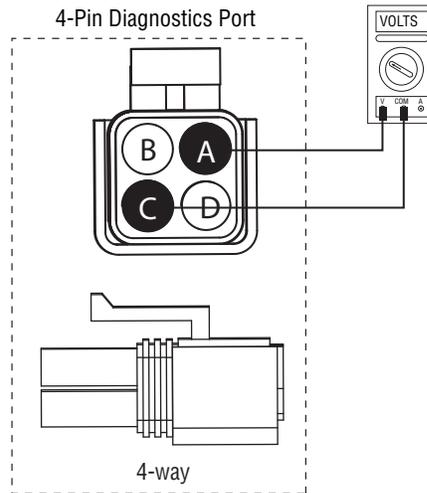
4-Pin Diagnostic Port
(Located at the left rear corner of the transmission.)

Procedure	→	Condition	→	Action
1. Key on.				
2. Measure voltage between pin A and pin C.		If voltage between pins A and C is within 0.6 volts of battery voltage		Go to STEP E
		If voltage is outside of range		Repair Ignition power supply to ECU. Fuse may be blown. Repeat test.

- B - Service Bat. +
- C - Service Bat. -
- A - Service Ignition +

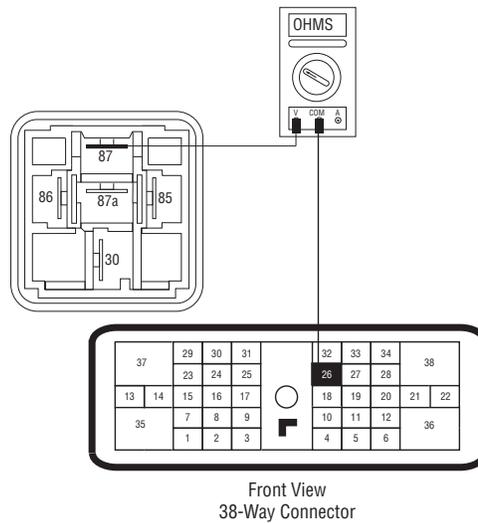
Procedure	→	Condition	→	Action
1. Key off.				
2. Disconnect negative battery cable.				
3. Disconnect Vehicle Harness 38-way connector.				
4. Disconnect the Start Enable Relay.				
5. Measure resistance between pin 87 of the start enable relay connector and pin 26 of the Vehicle Harness 38-Way connector.		If resistance is 0 to 0.3 ohms		Go to STEP V
		If resistance is greater than 10K ohm		Repair wiring. Go to STEP V

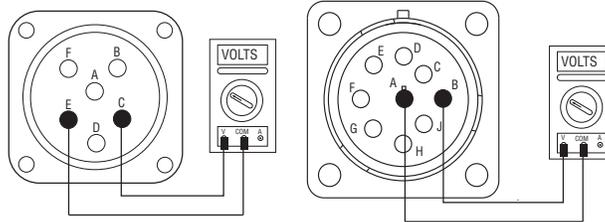
Procedure	→ Condition	→ Action
1. Key off.		
2. Measure voltage either between 6-way diagnostic connector pins C and E or 9-way diagnostic connector pins B and A.	<p>If voltage is within 0.6 volts of battery voltage</p> <p>If voltage is outside of range</p>	<p>Go to STEP B</p> <p>Repair battery or ground wire to vehicle diagnostic connector. Go to STEP V</p>

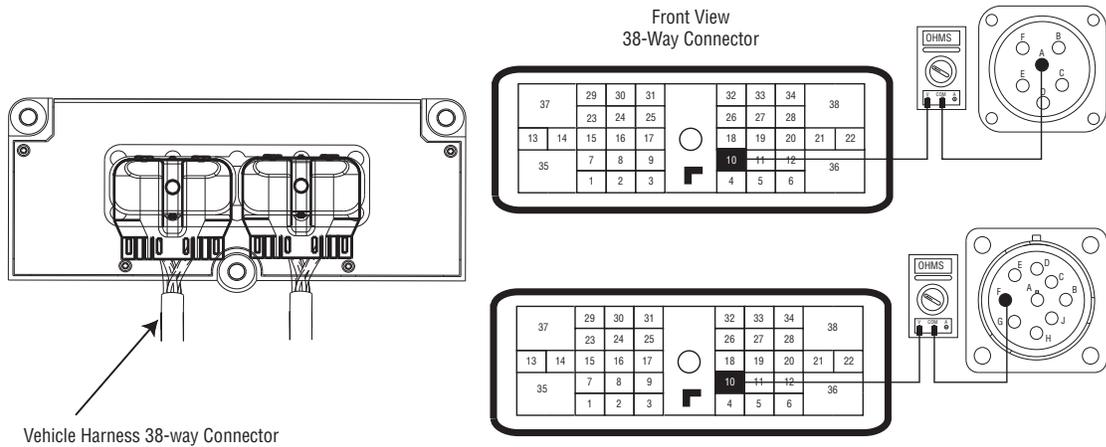
Procedure	→	Condition	→	Action
1. Key off.				
2. Disconnect negative battery cable.				
3. Disconnect Vehicle Harness 38-way connector.				
4. Measure resistance from Vehicle Harness 38-way connector pin 10 and either 6-way diagnostic connector pin A or 9-way diagnostic connector pin F.		If resistance is 0 to 0.3 ohms		Go to STEP C
		If resistance is outside of range		Repair vehicle interface harness. Repeat this step.

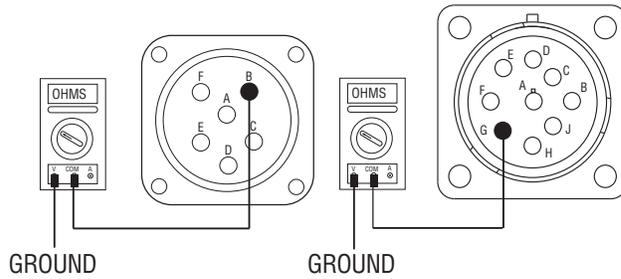
Procedure	→ Condition	→ Action
1. Measure resistance between either 6-way diagnostic connector pin B or 9-way diagnostic connector pin G and ground.	If resistance is OL	Go to STEP V
	If resistance is less than 10K ohm	Repair vehicle interface harness. Go to STEP V

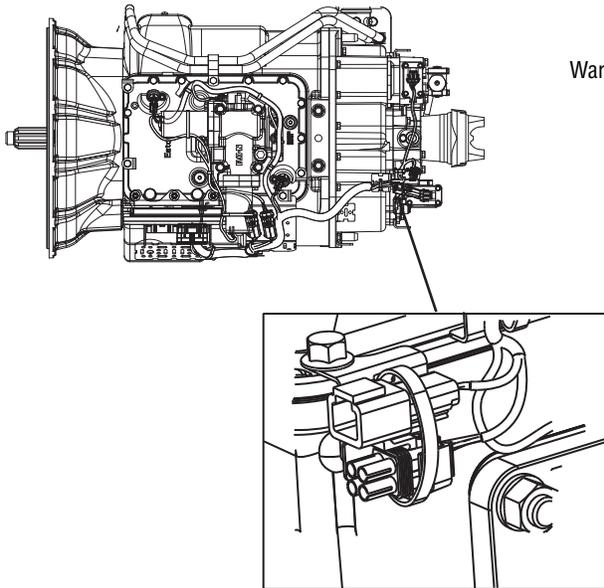
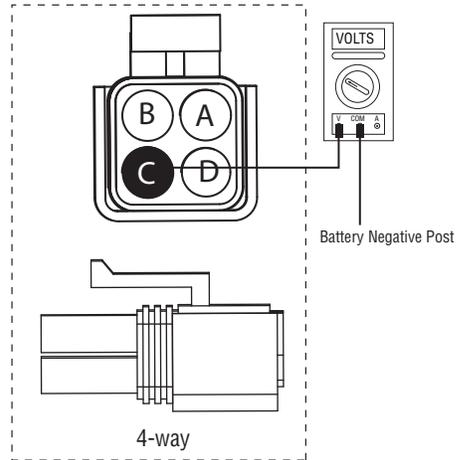
Procedure	→	Condition	→	Action
1. Locate diagnostic port on Transmission Harness.				
2. Key on.				
3. Measure voltage between pins C and the battery negative post.		If voltage between pin C and battery negative post is 0.70 volts or less		Go to STEP E
		If voltage is outside of range		Repair battery ground supply to Transmission ECU. Repeat test.

4-Pin Diagnostic Port
(Located at the left rear corner of the transmission.)

B - Service Bat. +
C - Service Bat. -
A - Service Ignition +

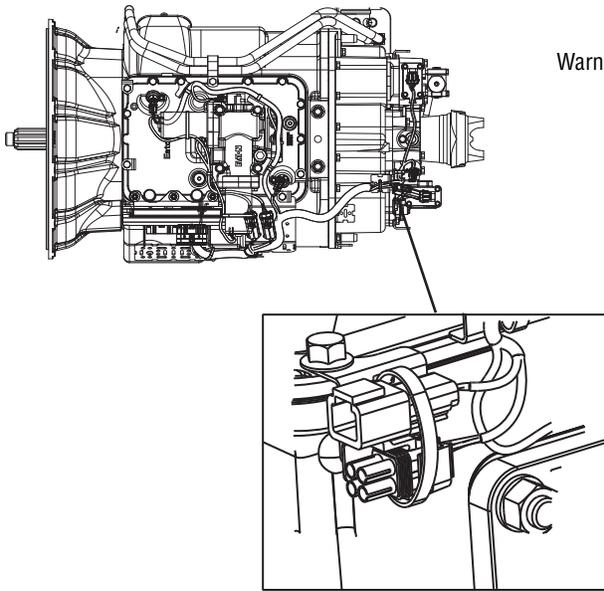
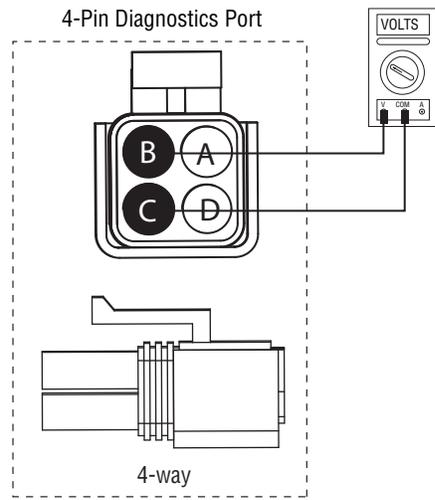
Procedure	→	Condition	→	Action
1. Locate diagnostic port on Transmission Harness.				
2. Key on.				
3. Measure voltage between pins B and pin C.		If voltage between pins B and C is within 0.6 volts of battery voltage		Go to STEP F
		If voltage is outside of range		Repair battery power supply to Transmission ECU. Fuse may be blown. Repeat test.

4-Pin Diagnostic Port
(Located at the left rear corner of the transmission.)

- B - Service Bat. +
- C - Service Bat. -
- A - Service Ignition +

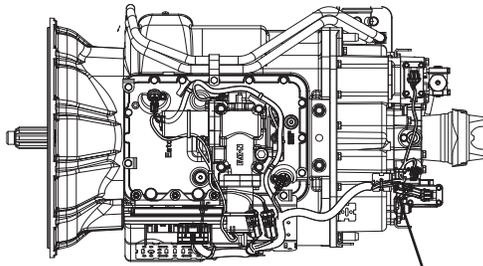
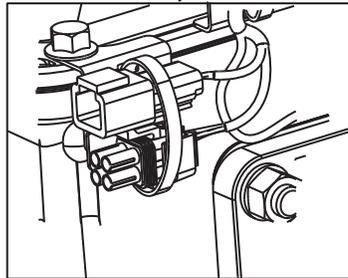
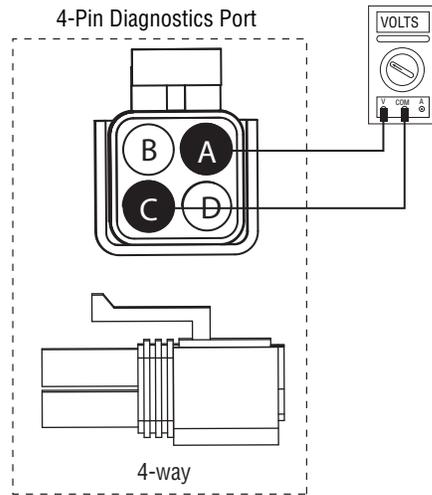
Procedure	→	Condition	→	Action
1. Key on.				
2. Measure voltage between pin A and pin C.		<p>If voltage between pins A and C is within 0.6 volts of battery voltage</p> <p>If voltage is outside of range</p>		<p>Go to STEP G</p> <p>Repair Ignition power supply to ECU. Fuse may be blown. Repeat test.</p>

4-Pin Diagnostic Port
(Located at the left rear corner of the transmission.)

B - Service Bat. +
C - Service Bat. -
A - Service Ignition +

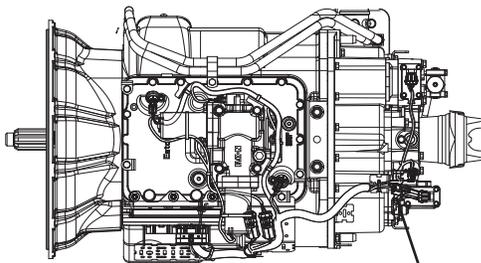
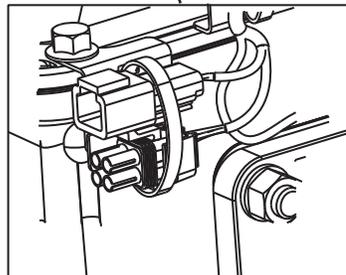
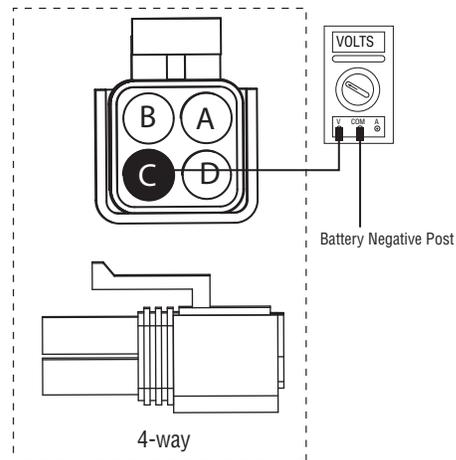
Procedure	→	Condition	→	Action
1. Locate diagnostic port on Transmission Harness.				
2. Key on.				
3. Measure voltage between pins C and the battery negative post.		If voltage between pin C and battery negative post is 0.70 volts or less		Go to STEP C
		If voltage is outside of range		Repair battery ground supply to Transmission ECU. Repeat test.

4-Pin Diagnostic Port
(Located at the left rear corner of the transmission.)

- B - Service Bat. +
- C - Service Bat. -
- A - Service Ignition +

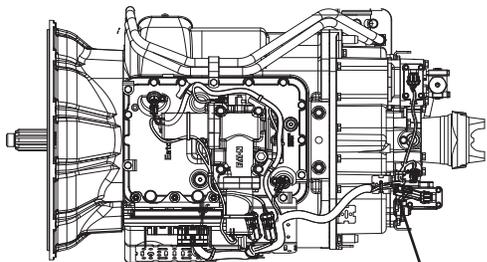
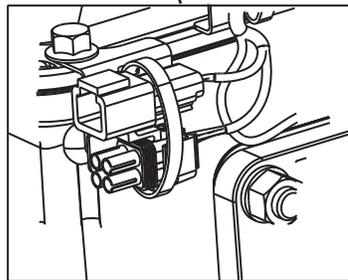
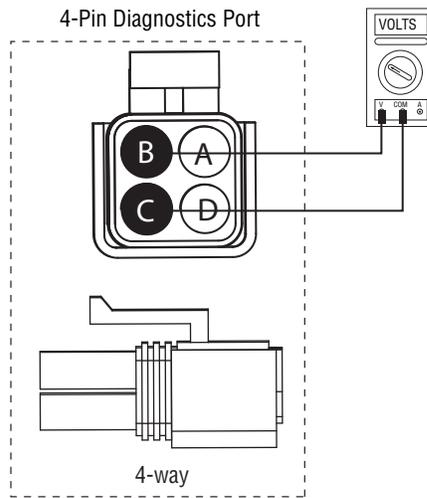
Procedure	→	Condition	→	Action
1. Locate diagnostic port on Transmission Harness.				
2. Key on.				
3. Measure voltage between pins B and pin C.		If voltage between pins B and C is within 0.6 volts of battery voltage		Go to STEP D
		If voltage is outside of range		Repair battery power supply to Transmission ECU. Fuse may be blown. Repeat test.

4-Pin Diagnostic Port
(Located at the left rear corner of the transmission.)

- B - Service Bat. +
- C - Service Bat. -
- A - Service Ignition +

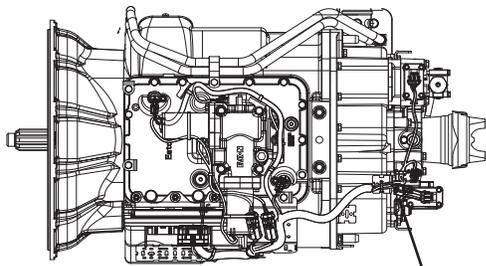
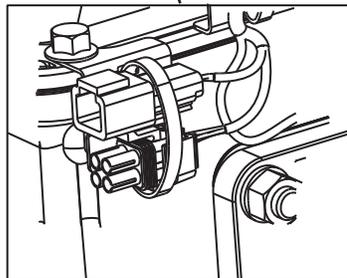
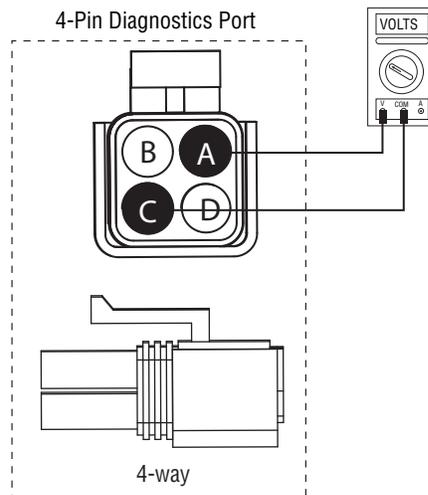
Procedure	→	Condition	→	Action
1. Key on.				
2. Measure voltage between pin A and pin C.		If voltage between pins A and C is within 0.6 volts of battery voltage If voltage is outside of range		Go to STEP E Repair Ignition power supply to ECU. Fuse may be blown. Repeat test.

4-Pin Diagnostic Port
(Located at the left rear corner of the transmission.)

B - Service Bat. +
 C - Service Bat. -
 A - Service Ignition +

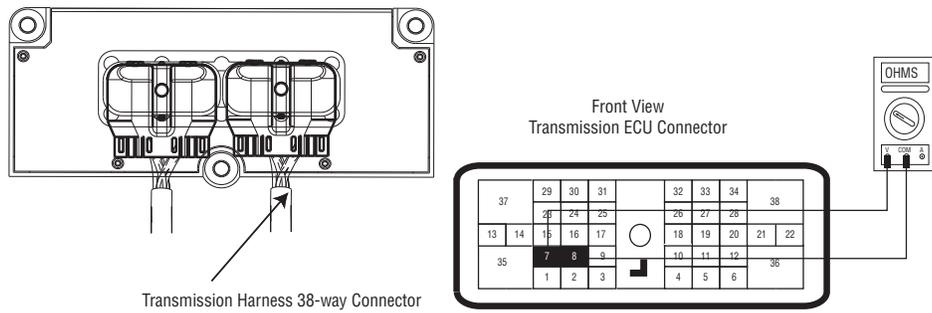
Procedure	→	Condition	→	Action
1. Key off.				
2. Disconnect negative battery cable.				
3. Disconnect the Transmission Harness 38-way connector.				
4. Measure the resistance between the Transmission Harness 38-way connector pins 7 and 8.		If resistance is 2K to 4.5K ohm		Go to STEP H
		If resistance is outside of range		Go to STEP J

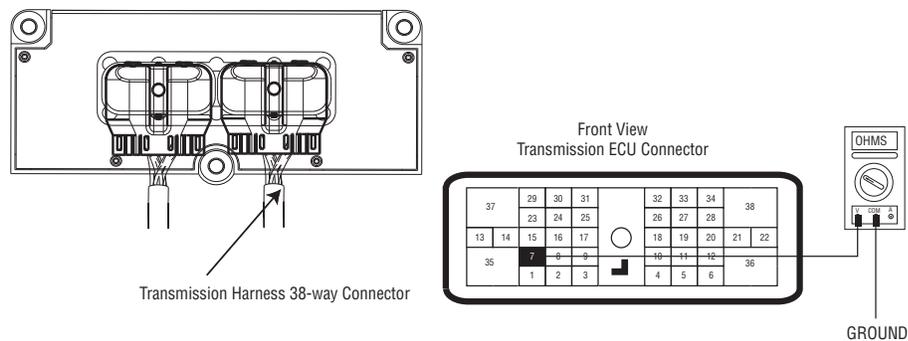
Procedure	→	Condition	→	Action
1. Measure resistance between the Transmission Harness 38-way connector pin 7 and ground.		If resistance is OL		Go to STEP I
		If resistance is less than 10K ohm		Go to STEP J

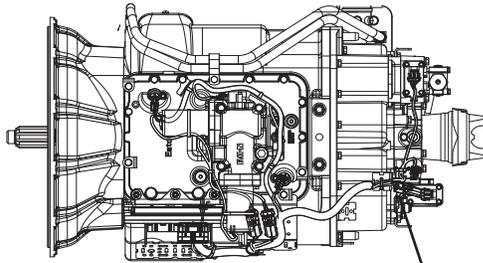
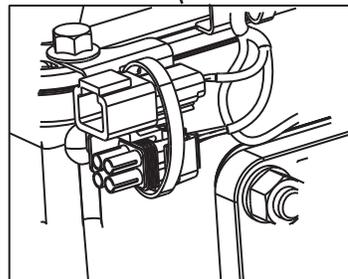
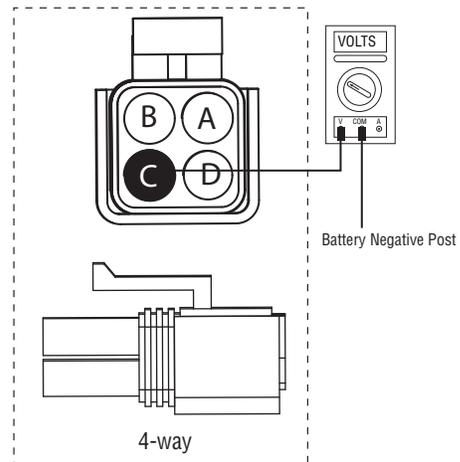
Procedure	→	Condition	→	Action
1. Locate diagnostic port on Transmission Harness.				
2. Key on.				
3. Measure voltage between pins C and the battery negative post.		If voltage between pin C and battery negative post is 0.70 volts or less		Go to STEP C
		If voltage is outside of range		Repair battery ground supply to Transmission ECU. Repeat test.

4-Pin Diagnostic Port
(Located at the left rear corner of the transmission.)

B - Service Bat. +
C - Service Bat. -
A - Service Ignition +

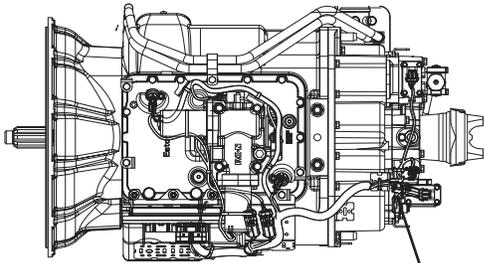
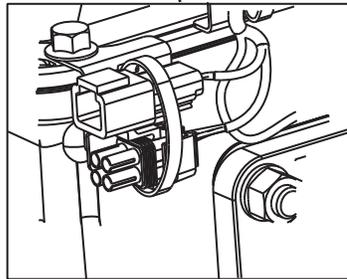
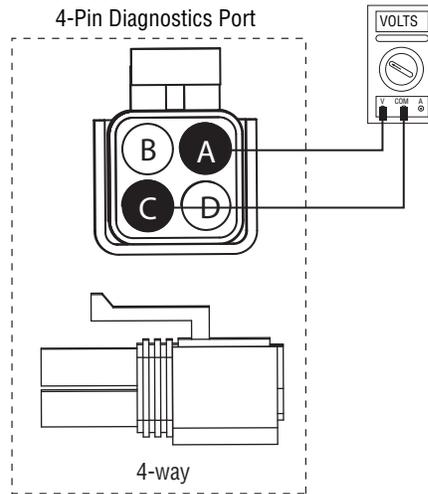
Procedure	→	Condition	→	Action
1. Key on.				
2. Measure voltage between pin A and pin C.		If voltage between pins A and C is within 0.6 volts of battery voltage		Go to STEP E
		If voltage is outside of range		Repair Ignition power supply to ECU. Fuse may be blown. Repeat test.

4-Pin Diagnostic Port
(Located at the left rear corner of the transmission.)

B - Service Bat. +
C - Service Bat. -
A - Service Ignition +

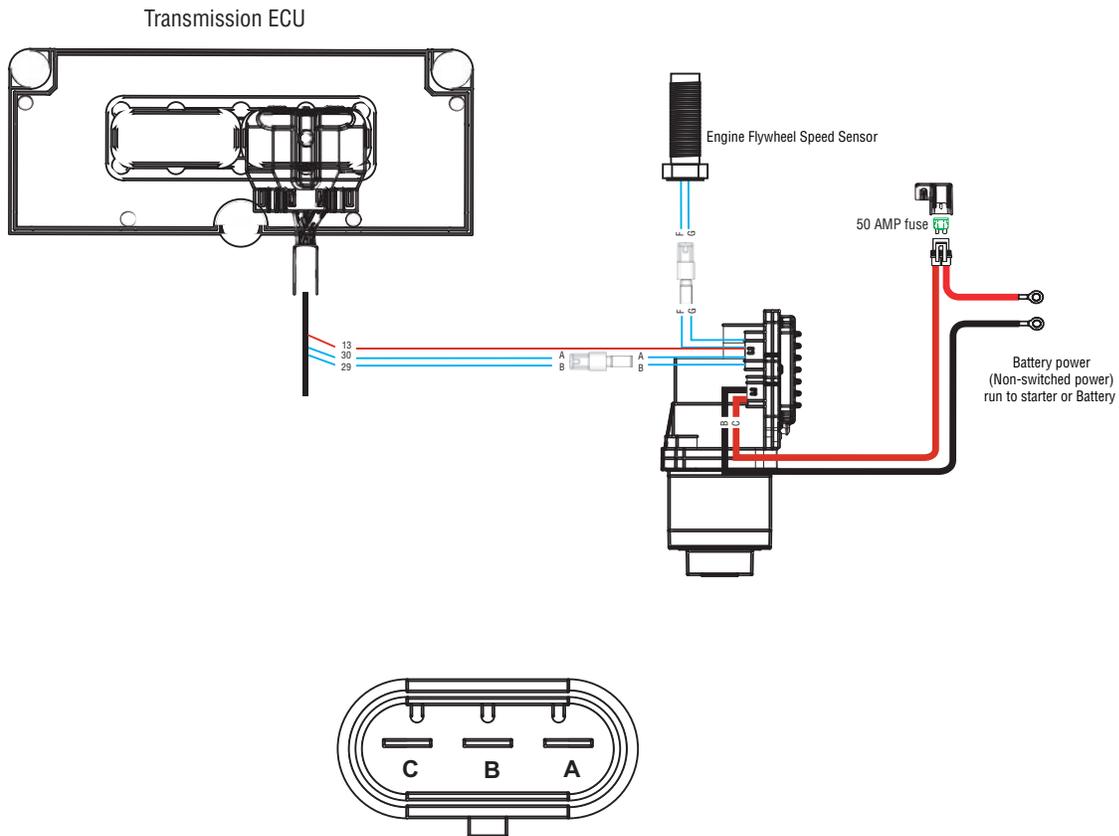
Procedure	→	Condition	→	Action
1. Key off.				
2. Disconnect battery negative.				
3. Disconnect ECA 3-way connector.				
4. Reconnect battery negative.				
5. Measure voltage between pin B and pin C of 3-way connector.		If voltage between pin B and pin C of 3-way connector is within 0.6 volts of battery voltage		Go to STEP F
		If voltage is outside of range		Repair battery power supply to ECA. Fuse may be blown. Repeat test.

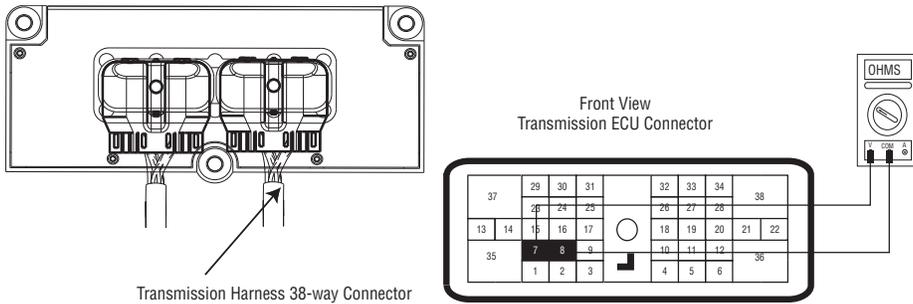
Procedure	Condition	Action
1. Key off.		
2. Disconnect negative battery cable.		
3. Disconnect the Transmission Harness 38-way connector.		
4. Measure the resistance between the Transmission Harness 38-way connector pins 7 and 8.	If resistance is 2K to 4.5K ohm	Go to STEP I
	If resistance is outside of range	Go to STEP K

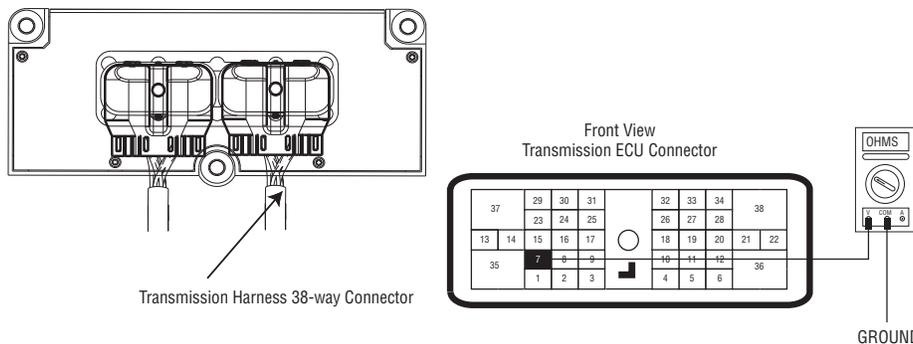
Procedure	Condition	Action
1. Measure resistance between the Transmission Harness 38-way connector pin 7 and ground.	If resistance is OL	Go to STEP J
	If resistance is less than 10K ohm	Go to STEP K

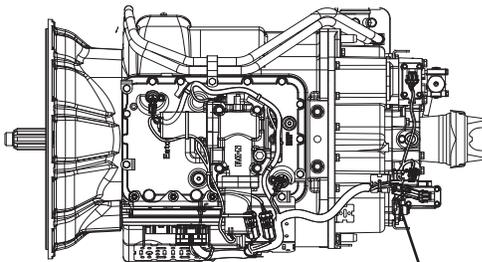
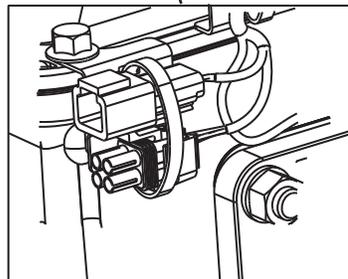
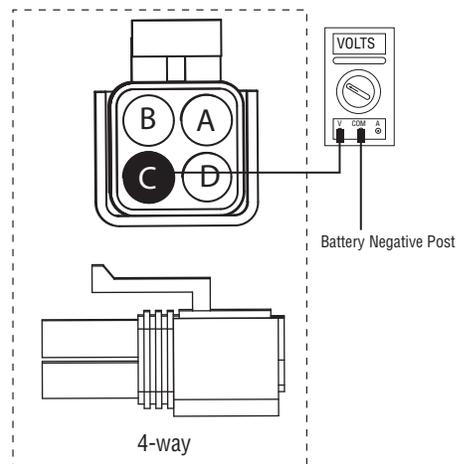
Procedure	→	Condition	→	Action
1. Locate diagnostic port on Transmission Harness.				
2. Key on.				
3. Measure voltage between pins C and the battery negative post.		If voltage between pin C and battery negative post is 0.70 volts or less		Go to STEP C
		If voltage is outside of range		Repair battery ground supply to Transmission ECU. Repeat test.

4-Pin Diagnostic Port
(Located at the left rear corner of the transmission.)

B - Service Bat. +
C - Service Bat. -
A - Service Ignition +

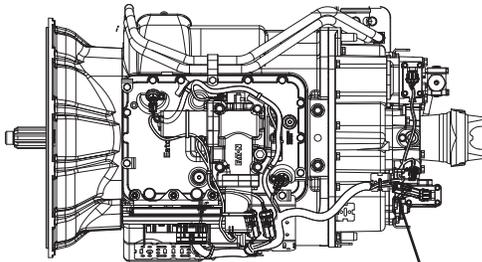
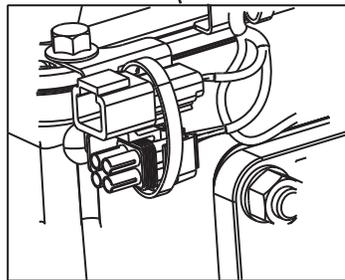
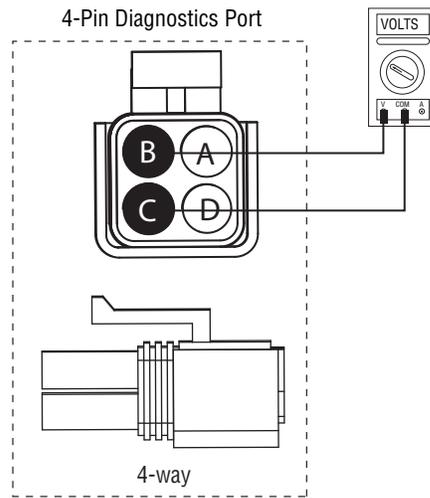
Procedure	→	Condition	→	Action
1. Locate diagnostic port on Transmission Harness.				
2. Key on.				
3. Measure voltage between pins B and pin C.		If voltage between pins B and C is within 0.6 volts of battery voltage		Go to STEP D
		If voltage is outside of range		Repair battery power supply to Transmission ECU. Fuse may be blown. Repeat test.

4-Pin Diagnostic Port
(Located at the left rear corner of the transmission.)

- B - Service Bat. +
- C - Service Bat. -
- A - Service Ignition +

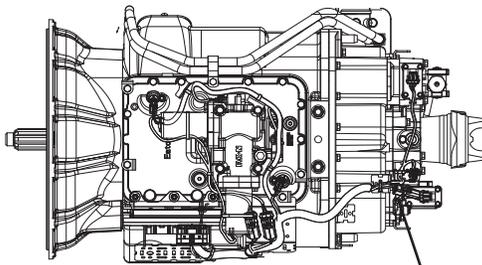
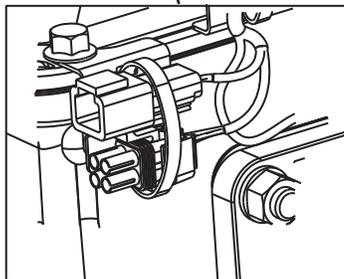
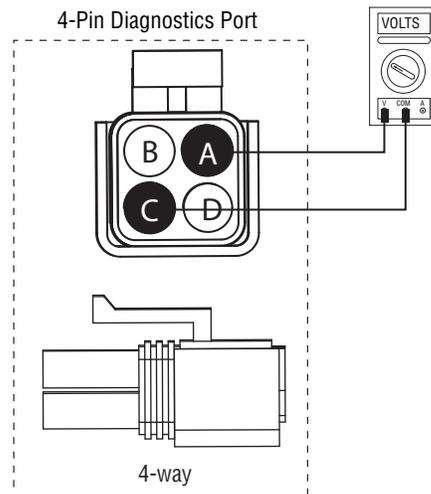
4-Pin Diagnostic Port
(Located at the left rear corner of the transmission.)

Procedure	→	Condition	→	Action
1. Key on.				
2. Measure voltage between pin A and pin C.		If voltage between pins A and C is within 0.6 volts of battery voltage		Go to STEP E
		If voltage is outside of range		Repair Ignition power supply to ECU. Fuse may be blown. Repeat test.

Warning! - Do Not Load Test at Diagnostic Port

B - Service Bat. +
C - Service Bat. -
A - Service Ignition +

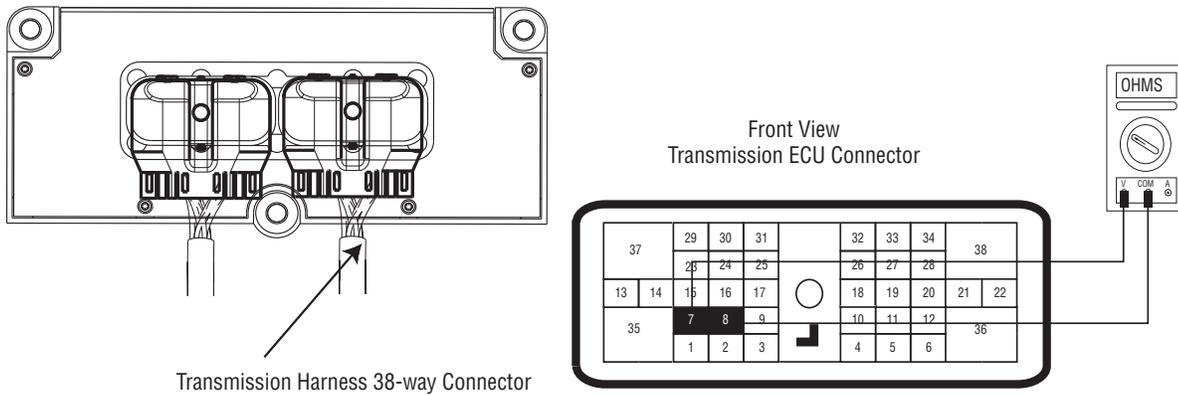
Procedure	→	Condition	→	Action
1. Key off.				
2. Disconnect negative battery cable.				
3. Disconnect the Transmission Harness 38-way connector.				
4. Measure the resistance between the Transmission Harness 38-way connector pins 7 and 8.		If resistance is 2K to 4.5K ohm		Go to STEP H
		If resistance is outside of range		Go to STEP J

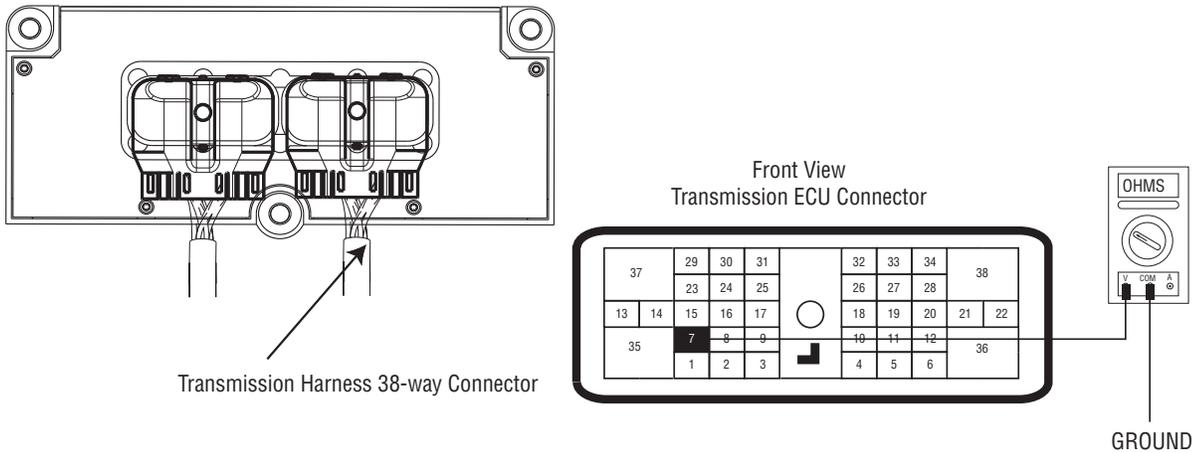
Procedure	Condition	Action
1. Measure resistance between the Transmission Harness 38-way connector pin 7 and ground.	If resistance is OL	Go to STEP I
	If resistance is less than 10K ohm	Go to STEP J

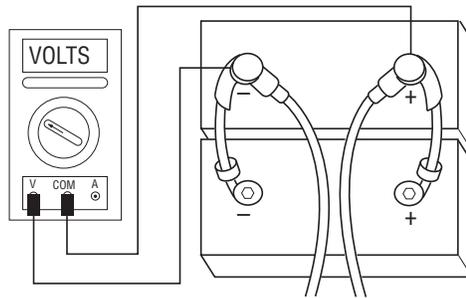
Procedure	Condition	Action
1. Key off.		
2. Inspect starter/battery and inline fuse holder connections for integrity.		
3. Measure voltage across batteries.	If voltage is 11 to 13 volts on a 12 volt system or 22 to 26 on a 24 volt system	Proceed with battery load test. Repair or replace batteries as required. Go to STEP B
	If voltage is outside of range	Repair or replace batteries and charging system as required. Repeat this step.

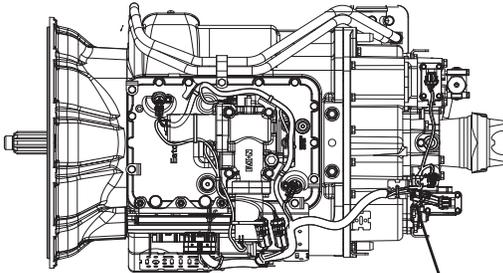
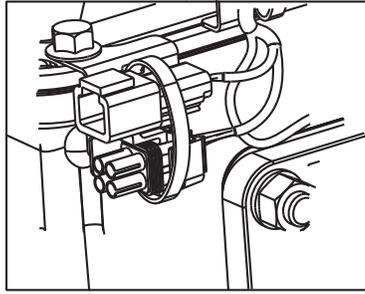
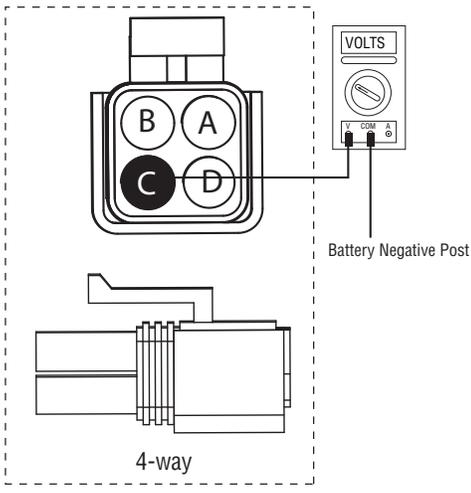
4-Pin Diagnostic Port
(Located at the left rear corner of the transmission.)

Procedure	Condition	Action
1. Locate diagnostic port on Transmission Harness.		
2. Key on.		
3. Measure voltage between pins C and the battery negative post.	If voltage between pin C and battery negative post is 0.70 volts or less	Go to STEP C
	If voltage is outside of range	Repair battery ground supply to Transmission ECU. Repeat test.

Warning! - Do Not Load Test at Diagnostic Port
4-Pin Diagnostics Port

- B - Service Bat. +
- C - Service Bat. -
- A - Service Ignition +

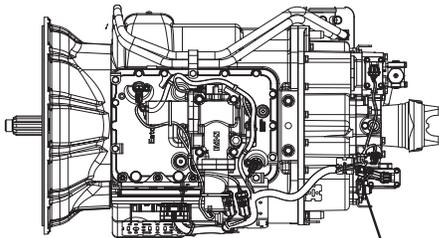
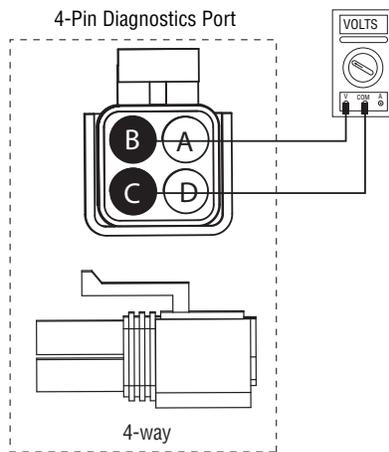
4-Pin Diagnostic Port
(Located at the left rear corner of the transmission.)

Procedure	→	Condition	→	Action
1. Locate diagnostic port on Transmission Harness.				
2. Key on.				
3. Measure voltage between pins B and pin C.		If voltage between pins B and C is within 0.6 volts of battery voltage If voltage is outside of range		Go to STEP D Repair battery power supply to Transmission ECU. Fuse may be blown. Repeat test.

Warning! - Do Not Load Test at Diagnostic Port

- B - Service Bat. +
- C - Service Bat. -
- A - Service Ignition +

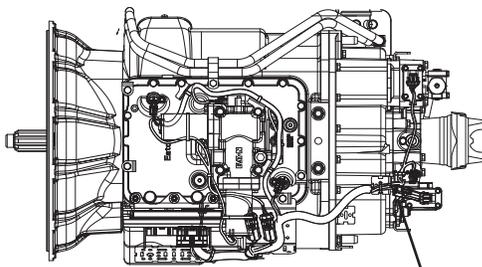
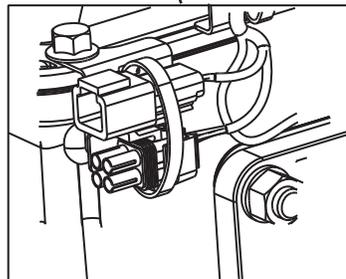
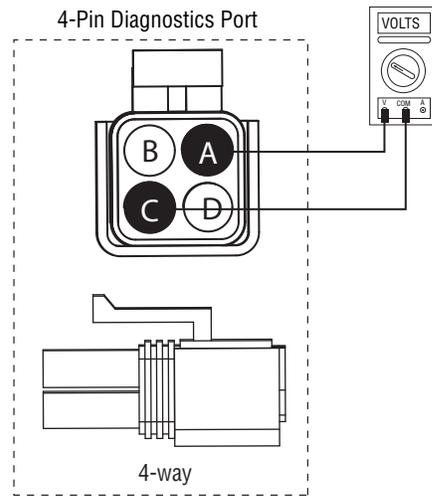
4-Pin Diagnostic Port
(Located at the left rear corner of the transmission.)

Procedure	→	Condition	→	Action
1. Key on.				
2. Measure voltage between pin A and pin C.		If voltage between pins A and C is within 0.6 volts of battery voltage		Go to STEP E
		If voltage is outside of range		Repair Ignition power supply to ECU. Fuse may be blown. Repeat test.

Warning! - Do Not Load Test at Diagnostic Port

B - Service Bat. +
C - Service Bat. -
A - Service Ignition +

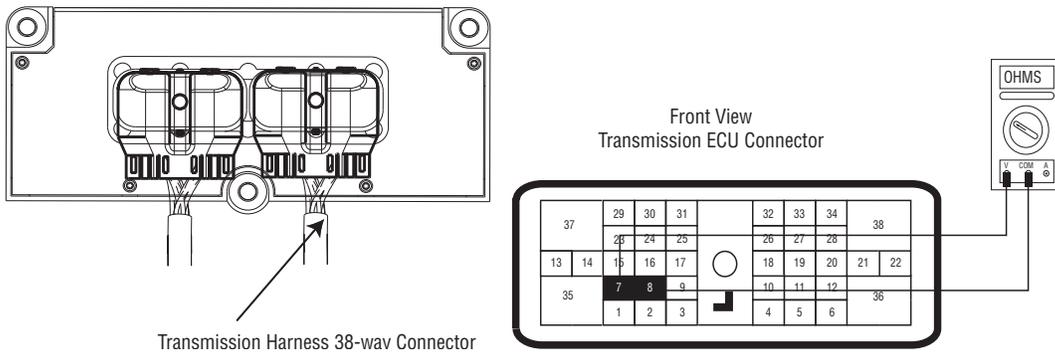
Procedure	→	Condition	→	Action
1. Key off.				
2. Disconnect negative battery cable.				
3. Disconnect the Transmission Harness 38-way connector.				
4. Measure the resistance between the Transmission Harness 38-way connector pins 7 and 8.		If resistance is 2K to 4.5K ohm		Go to STEP G
		If resistance is outside of range		Go to STEP I

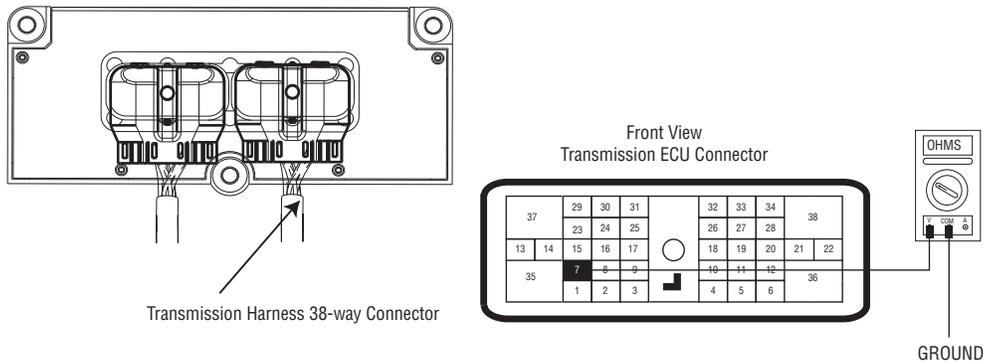
Procedure	Condition	Action
1. Measure resistance between the Transmission Harness 38-way connector pin 7 and ground.	If resistance is OL	Go to STEP H
	If resistance is less than 10K ohm	Go to STEP I

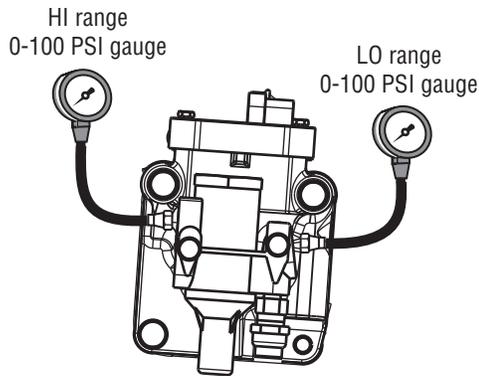
Procedure	→	Condition	→	Action
1. Key off.				
2. Install both 0-100 PSI air pressure gauges into the range cover diagnostic ports.				
3. Start vehicle and allow air pressure to build to governor cut-off.				
4. Turn off engine, but leave key in "ON" position.				
5. With Shift Control, select reverse, then select neutral.		If LOW range gauge = 55 to 65 PSI and If HIGH range gauge = 0 PSI Note: Five minutes is allowed for checking the air pressure after shifting the transmission to neutral.		Go to STEP P
		If both air pressure gauges do not read as listed above		Replace Range Solenoid Valve and Range Cylinder Cover as required. Go to STEP V

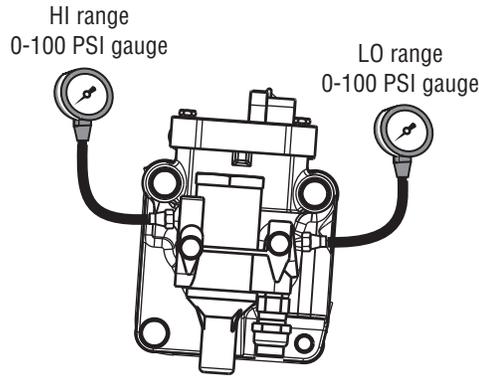
Procedure	→	Condition	→	Action
1. Key on.				
2. With the Shift Control, select the highest reverse gear available by pressing the upshift button/arrow, then select neutral.		If HIGH range gauge = 55 to 65 PSI and If LOW range gauge = 0 PSI		Go to STEP Q
		If both air pressure gauges do not read as listed above		Replace Range SOlenoid Valve and Range CYlinder Cover as required. Go to STEP V

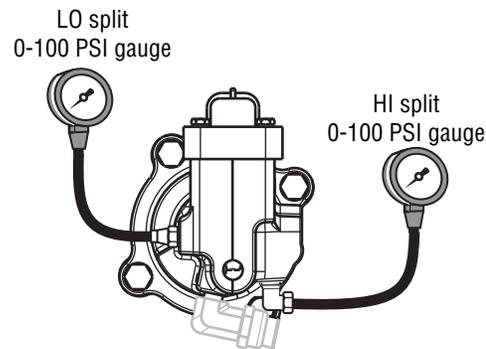
Procedure	→	Condition	→	Action
1. Key off.				
2. Start vehicle and allow air pressure to build to governor cut-off.				
3. Turn off engine, but leave key in "ON" position.				
4. With Shift Control, select reverse (R1 in gear display for 13/18-speed), then select neutral		If HIGH Splitter gauge = 55 to 65 PSI and if LOW Splitter gauge = 0 PSI Note: Five minutes is allowed for checking the pressure after moving the Shift Lever to neutral.		Go to STEP S
		If air pressure gauges do not read as shown above		Replace SPlitter Solenoid Valve and Splitter Cylinder Cover as required. Go to STEP V

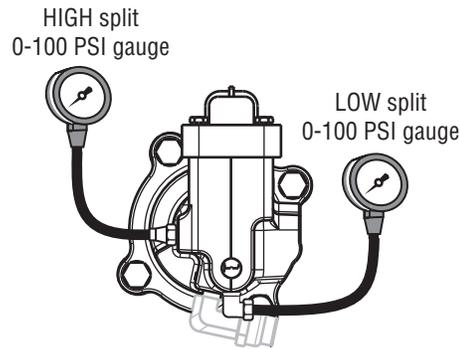
Procedure	→	Condition	→	Action
1. Key on.				
2. With Shift Control, select reverse (R2 in the gear display 13/18-speed). Note: If R2 isn't displayed the up arrow button needs to be pressed.		If LOW Splitter gauge =55 to 65 PSI and if HIGH Splitter gauge = 0 PSI If air pressure gauges do not read as shown above		Go to STEP V Replace Splitter Solenoid Valve and Splitter Cylinder Cover as required. Go to STEP V

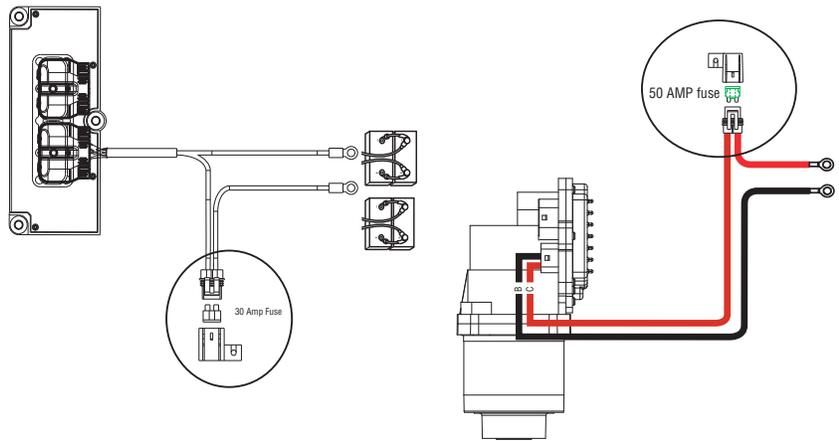
1. Key off.
2. Remove and clean all battery and battery to frame connections.
3. Remove and clean ground supply to engine ECU.
4. Inspect starter/battery and in-line 30 amp fuse holder connections for corrosion or damaged contacts. Also inspect the 50 amp fuse holder on vehicles equipped with an Electronic Clutch Actuator (ECA.)

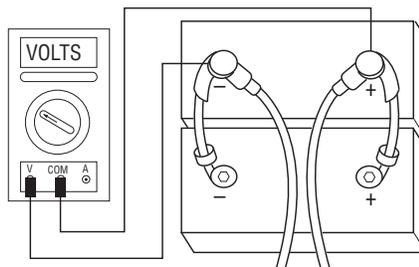
5. Measure voltage across batteries.

If voltage is 11 to 13 volts on a 12 volt system or 22 to 26 on a 24 volt system

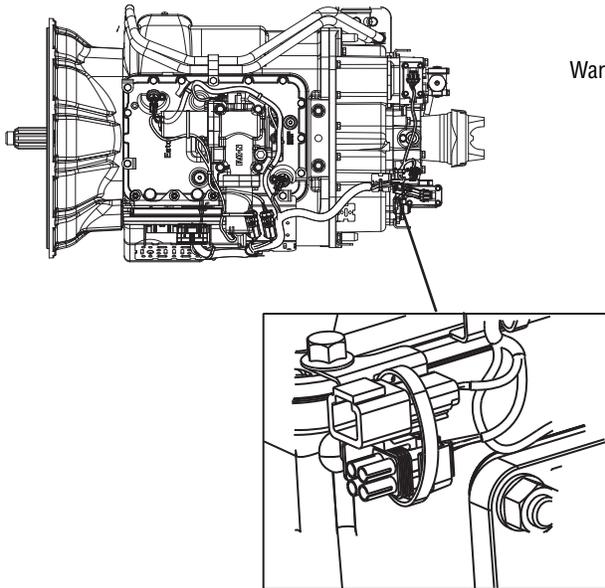
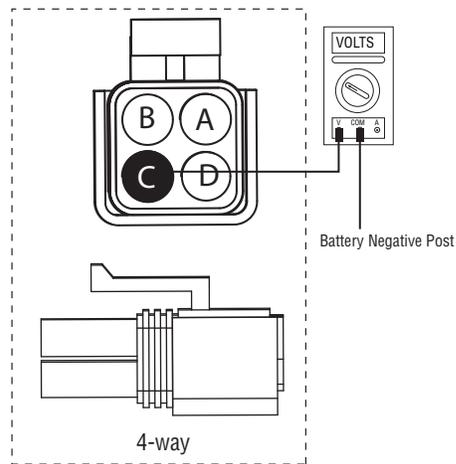
4-Pin Diagnostic Port
(Located at the left rear corner of the transmission.)

Procedure	Condition	Action
1. Locate diagnostic port on Transmission Harness.		
2. Key on.		
3. Measure voltage between pins C and the battery negative post.	If voltage between pin C and battery negative post is 0.70 volts or less	Go to STEP C
	If voltage is outside of range	Repair battery ground supply to Transmission ECU. Repeat test.

Warning! - Do Not Load Test at Diagnostic Port
4-Pin Diagnostics Port

- B - Service Bat. +
- C - Service Bat. -
- A - Service Ignition +

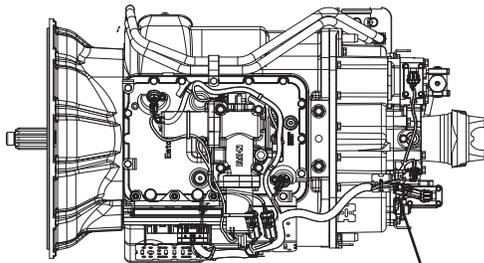
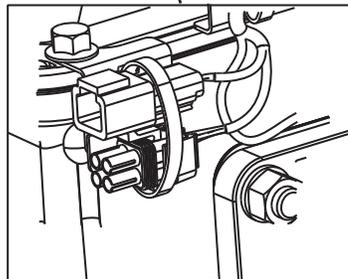
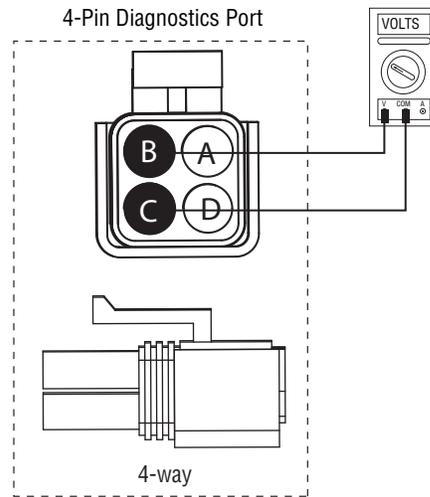
4-Pin Diagnostic Port
(Located at the left rear corner of the transmission.)

Procedure	→	Condition	→	Action
1. Locate diagnostic port on Transmission Harness.				
2. Key on.				
3. Measure voltage between pins B and pin C.		If voltage between pins B and C is within 0.6 volts of battery voltage If voltage is outside of range		Go to STEP D Repair battery power supply to Transmission ECU. Fuse may be blown. Repeat test.

Warning! - Do Not Load Test at Diagnostic Port

B - Service Bat. +
C - Service Bat. -
A - Service Ignition +

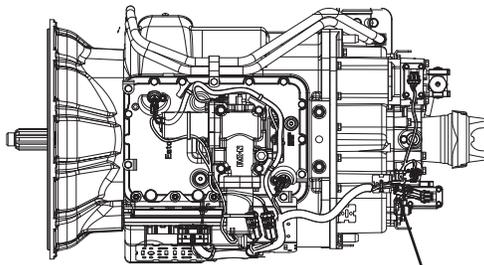
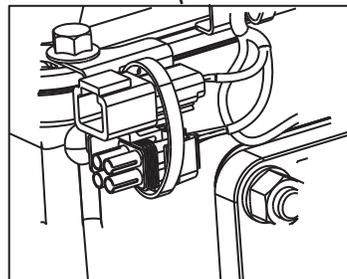
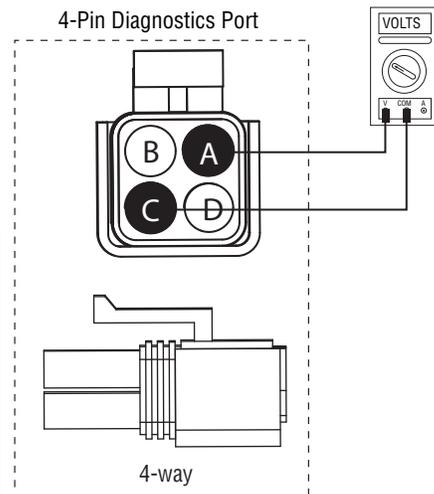
4-Pin Diagnostic Port
(Located at the left rear corner of the transmission.)

Procedure	Condition	Action
1. Key on.		
2. Measure voltage between pin A and pin C.	If voltage between pins A and C is within 0.6 volts of battery voltage	Go to STEP E
	If voltage is outside of range	Repair Ignition power supply to ECU. Fuse may be blown. Repeat test.

Warning! - Do Not Load Test at Diagnostic Port

B - Service Bat. +
C - Service Bat. -
A - Service Ignition +

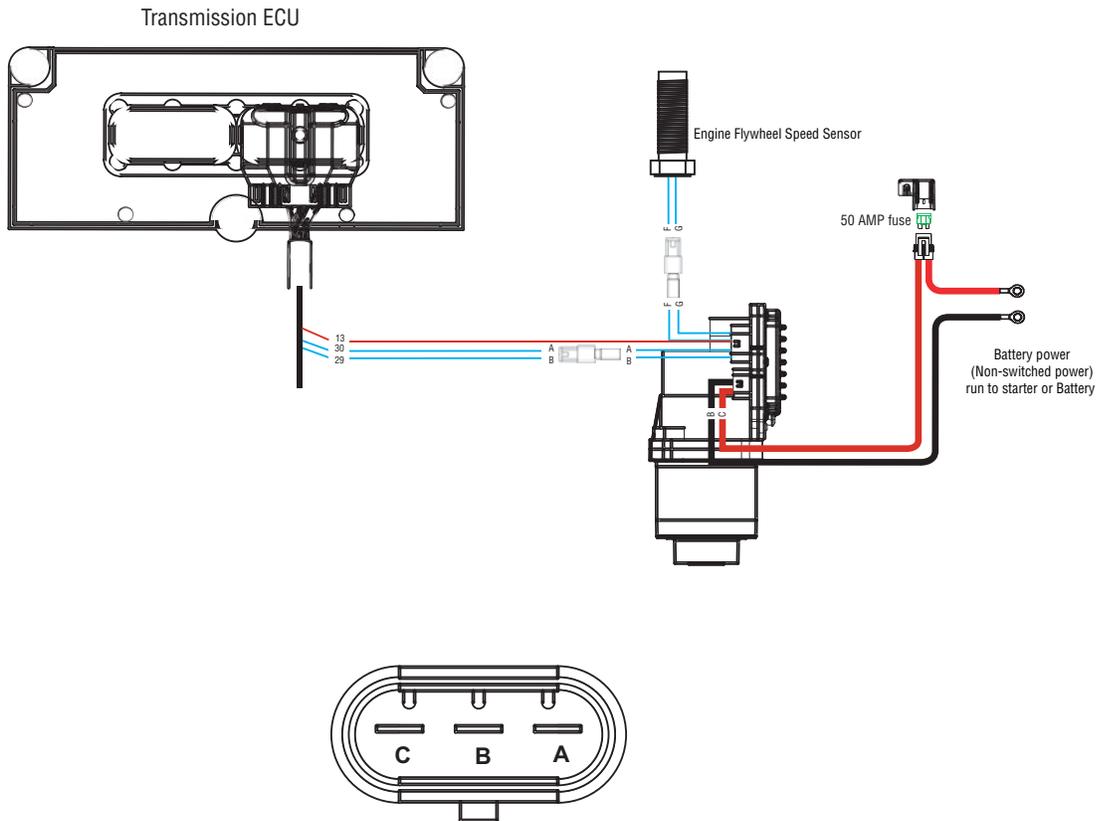
Procedure	→	Condition	→	Action
1. Key off.				
2. Disconnect battery negative.				
3. Disconnect ECA 3-way connector.				
4. Reconnect battery negative.				
5. Measure voltage between pin B and pin C of 3-way connector.		If voltage between pin B and pin C of 3-way connector is within 0.6 volts of battery voltage		Go to STEP F
		If voltage is outside of range		Repair battery power supply to ECA. Fuse may be blown. Repeat test.

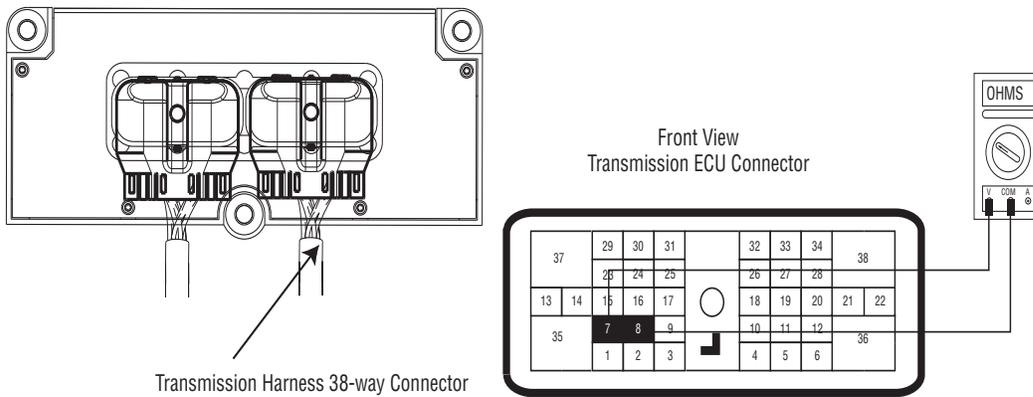
Procedure	Condition	Action
1. Key off.		
2. Disconnect negative battery cable.		
3. Disconnect the Transmission Harness 38-way connector.		
4. Measure the resistance between the Transmission Harness 38-way connector pins 7 and 8.	If resistance is 2K to 4.5K ohm	Go to STEP I
	If resistance is outside of range	Go to STEP K

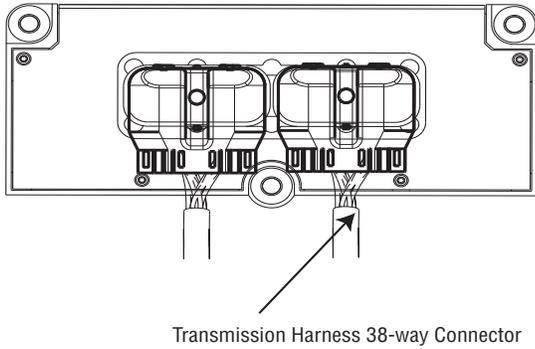
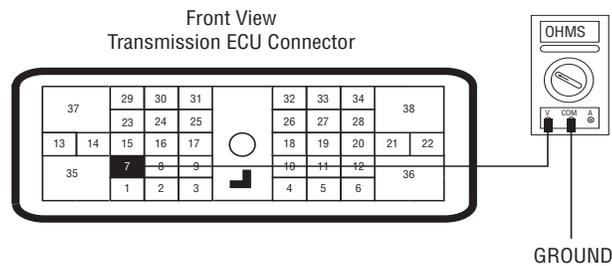
Procedure	Condition	Action
Measure resistance between the Transmission Harness 38-way connector pin 7 and ground.	If resistance is OL	Go to STEP J
	If resistance is less than 10K ohm	Go to STEP K

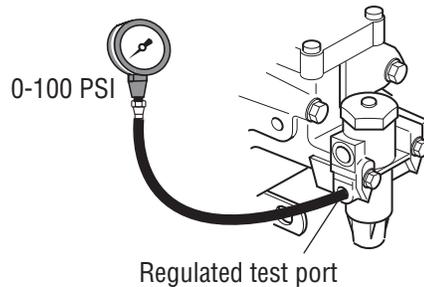
Procedure	→	Condition	→	Action
1. Key off.				
2. Install a 0-100 PSI air pressure gauge in the regulated test port of the air filter / regulator.				
3. Start engine and allow air pressure to build to governor cut-off.				
4. Monitor the vehicle air pressure gauge on the dash.		If air pressure cuts off at 90 to 120 PSI		Go to STEP N
		If air pressure is outside of range		Repair vehicle air system as required. Repeat test.

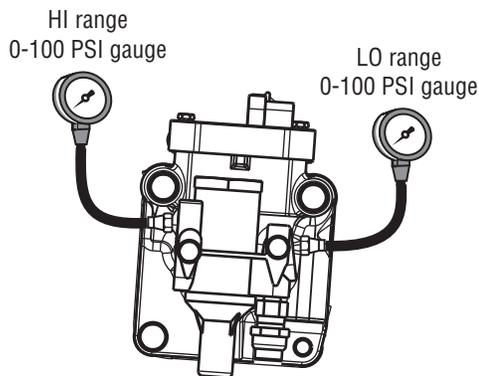
Procedure	→	Condition	→	Action
1. Key off.				
2. Install both 0-100 PSI air pressure gauges into the range cover diagnostic ports.				
3. Start vehicle and allow air pressure to build to governor cut-off.				
4. Turn off engine, but leave key in "ON" position.				
5. With Shift Control, select reverse, then select neutral.		If LOW range gauge = 55 to 65 PSI and If HIGH range gauge = 0 PSI Note: Five minutes is allowed for checking the air pressure after shifting the transmission to neutral.		Go to STEP R
		If both air pressure gauges do not read as listed above		Replace Range Solenoid Valve and Range Cylinder Cover as required. Go to STEP V

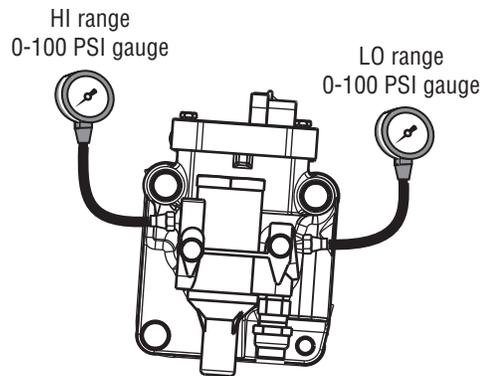
Procedure	→ Condition	→ Action
1. Key on.		
2. With the Shift Control, select the highest reverse gear available by pressing the upshift button/arrow, then select neutral.	If HIGH range gauge = 55 to 65 PSI and If LOW range gauge = 0 PSI If both air pressure gauges do not read as listed above	Go to STEP S Replace Range Solenoid Valve and Range Cylinder Cover as required. Go to STEP V

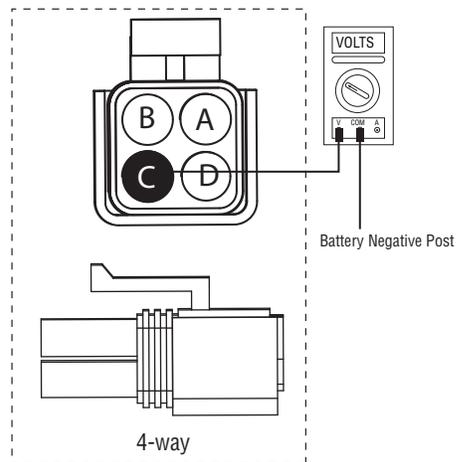
4-Pin Diagnostic Port
(Located at the left rear corner of the transmission.)

Warning! - Do Not Load Test at Diagnostic Port
4-Pin Diagnostics Port

B - Service Bat. +
C - Service Bat. -
A - Service Ignition +

Procedure	→	Condition	→	Action
1. Locate diagnostic port on Transmission Harness.				
2. Key on.				
3. Measure voltage between pins C and the battery negative post.		If voltage between pin C and battery negative post is 0.70 volts or less		Go to STEP C
		If voltage is outside of range		Repair battery ground supply to Transmission ECU. Repeat test.

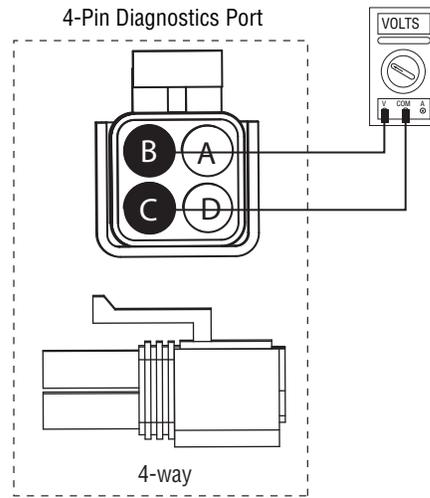
4-Pin Diagnostic Port
(Located at the left rear corner of the transmission.)

Warning! - Do Not Load Test at Diagnostic Port

- B - Service Bat. +
- C - Service Bat. -
- A - Service Ignition +

Procedure	→	Condition	→	Action
1. Locate diagnostic port on Transmission Harness.				
2. Key on.				
3. Measure voltage between pins B and pin C.		If voltage between pins B and C is within 0.6 volts of battery voltage		Go to STEP D
		If voltage is outside of range		Repair battery power supply to Transmission ECU. Fuse may be blown. Repeat test.

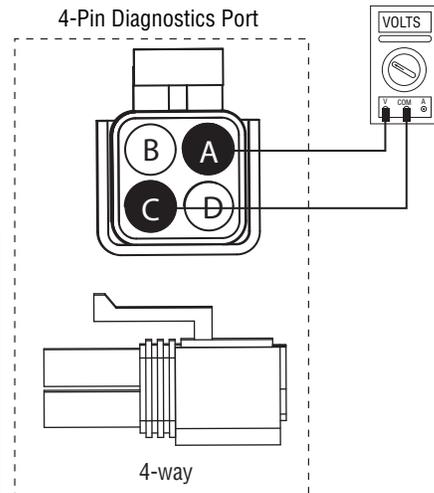
4-Pin Diagnostic Port
(Located at the left rear corner of the transmission.)

Warning! - Do Not Load Test at Diagnostic Port

- B - Service Bat. +
- C - Service Bat. -
- A - Service Ignition +

Procedure	→	Condition	→	Action
1. Key on.				
2. Measure voltage between pin A and pin C.		If voltage between pins A and C is within 0.6 volts of battery voltage If voltage is outside of range		Go to STEP E Repair Ignition power supply to ECU. Fuse may be blown. Repeat test.
