Eaton UltraShift PLUS[®], UltraShift[®] and AutoShift[®] Transmissions TRTS0930

March 2012

Transmission Models Included

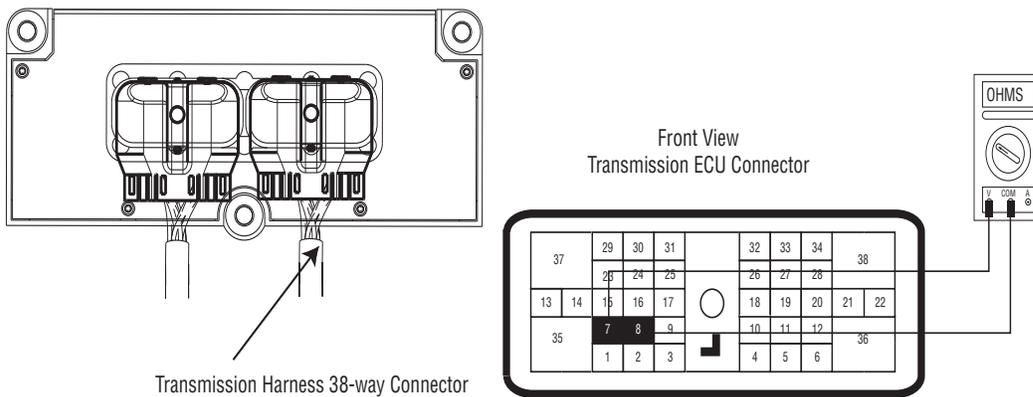
Procedure	→	Condition	→	Action
1. Key off.				
2. Disconnect negative battery cable.				
3. Disconnect the Transmission Harness 38-way connector.				
4. Measure the resistance between the Transmission Harness 38-way connector pins 7 and 8.		If resistance is 2K to 4.5K ohm		Go to STEP G
		If resistance is outside of range		Go to STEP I

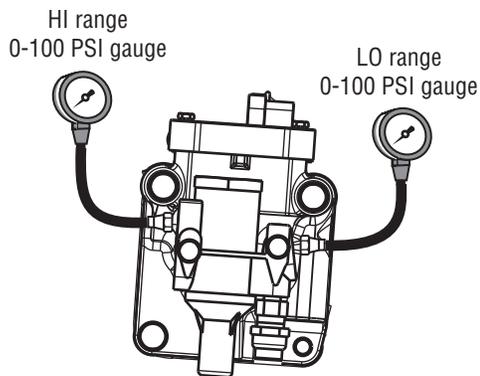
Procedure	→	Condition	→	Action
1. Key off.				
2. Install both 0-100 PSI air pressure gauges into the range cover diagnostic ports.				
3. Start vehicle and allow air pressure to build to governor cut-off.				
4. Turn off engine, but leave key in "ON" position.				
5. With Shift Control, select reverse, then select neutral.		If LOW range gauge = 55 to 65 PSI and If HIGH range gauge = 0 PSI Note: Five minutes is allowed for checking the air pressure after shifting the transmission to neutral.		Go to STEP C
		If both air pressure gauges do not read as listed above		Replace Solenoid Valve and Range Cylinder Cover as required. Go to STEP V

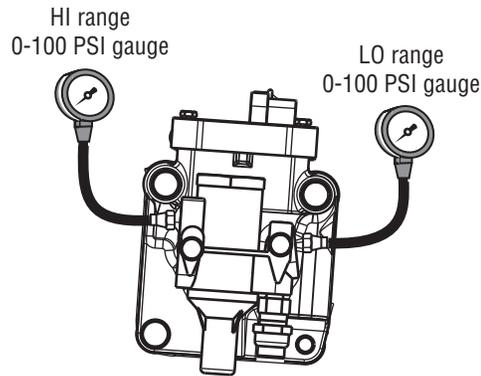
Procedure	→	Condition	→	Action
1. Key on.				
2. With the Shift Control, select the highest reverse gear available by pressing the upshift button/arrow, then select neutral.		If HIGH range gauge = 55 to 65 PSI and If LOW range gauge = 0 PSI		Go to STEP Q
		If both air pressure gauges do not read as listed above		Replace Range Solenoid Valve and Range Cylinder cover as required. Go to STEP V

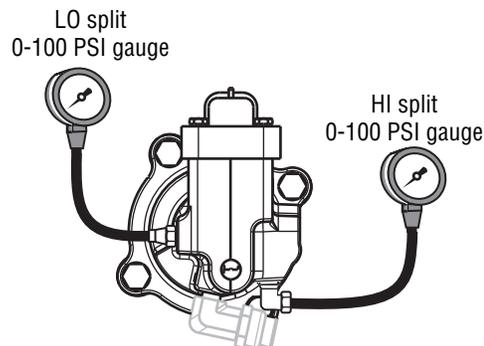
Procedure	→	Condition	→	Action
<ol style="list-style-type: none"> 1. Key off. 2. Start vehicle and allow air pressure to build to governor cut-off. 3. Turn off engine, but leave key in "ON" position. 4. With Shift Control, select reverse (R1 in gear display for 13/18-speed), then select neutral. 		<p>If HIGH Splitter gauge = 55 to 65 PSI and if LOW Splitter gauge = 0 PSI</p> <p>Note: Five minutes is allowed for checking the pressure after moving the Shift Lever to neutral.</p> <p>If air pressure gauges do not read as shown above</p>		<p>Go to STEP S</p> <p>Replace Splitter Solenoid Valve and Splitter Cylinder Cover as required. Go to STEP V</p>

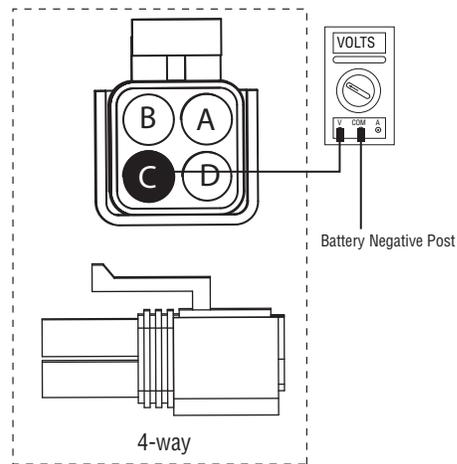
4-Pin Diagnostic Port
(Located at the left rear corner of the transmission.)

Warning! - Do Not Load Test at Diagnostic Port
4-Pin Diagnostics Port

- B - Service Bat. +
- C - Service Bat. -
- A - Service Ignition +

Procedure	→	Condition	→	Action
1. Locate diagnostic port on Transmission Harness.				
2. Key on.				
3. Measure voltage between pins C and the battery negative post.		If voltage between pin C and battery negative post is 0.70 volts or less		Go to STEP D
		If voltage is outside of range		Repair battery ground supply to Transmission ECU. Repeat test.

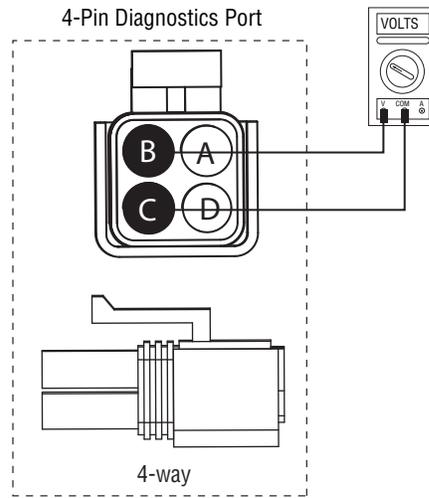
4-Pin Diagnostic Port
(Located at the left rear corner of the transmission.)

Warning! - Do Not Load Test at Diagnostic Port

- B - Service Bat. +
- C - Service Bat. -
- A - Service Ignition +

Procedure	→	Condition	→	Action
1. Locate diagnostic port on Transmission Harness.				
2. Key on.				
3. Measure voltage between pins B and pin C.		If voltage between pins B and C is within 0.6 volts of battery voltage		Go to STEP E
		If voltage is outside of range		Repair battery power supply to Transmission ECU. Fuse may be blown. Repeat test.

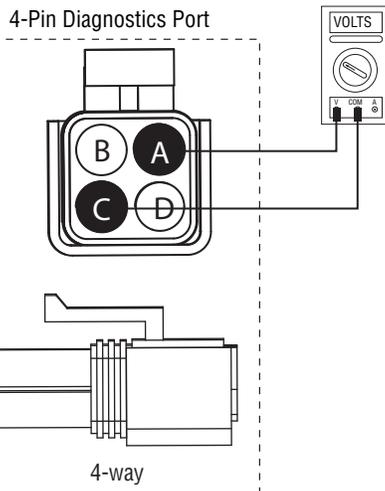
4-Pin Diagnostic Port
(Located at the left rear corner of the transmission.)

Warning! - Do Not Load Test at Diagnostic Port

B - Service Bat. +
C - Service Bat. -
A - Service Ignition +

Procedure	→	Condition	→	Action
1. Key on.				
2. Measure voltage between pin A and pin C.		If voltage between pins A and C is within 0.6 volts of battery voltage		Go to STEP F
		If voltage is outside of range		Repair Ignition power supply to ECU. Fuse may be blown. Repeat test.

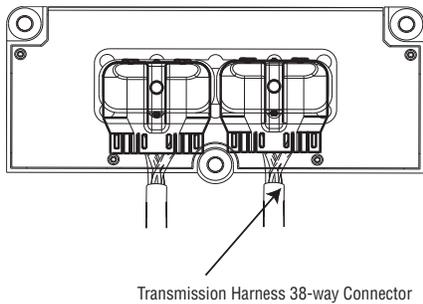
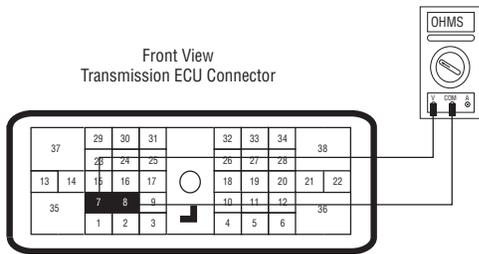
Procedure	Condition	Action
1. Key off.		
2. Disconnect negative battery cable.		
3. Disconnect the Transmission Harness 38-way connector.		
4. Measure the resistance between the Transmission Harness 38-way connector pins 7 and 8.	If resistance is 2K to 4.5K ohm	Go to STEP I
	If resistance is outside of range	Go to STEP J

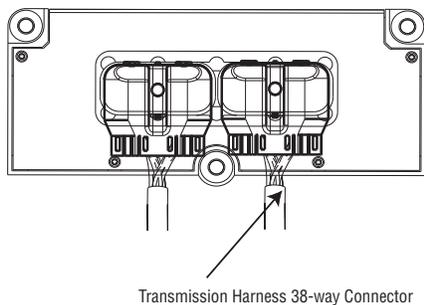
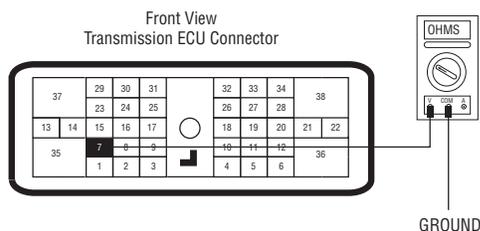
Procedure	Condition	Action
1. Measure resistance between the Transmission Harness 38-way connector pin 7 and ground.	If resistance is OL	Go to STEP J
	If resistance is less than 10K ohm	Go to STEP K

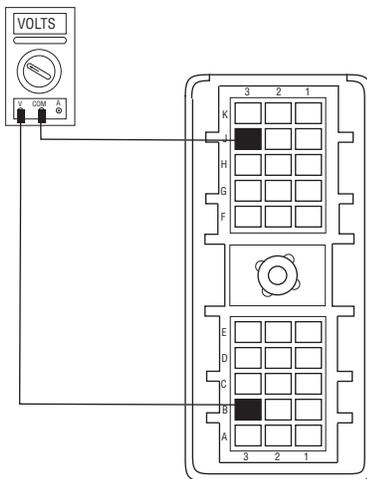
Procedure	→	Condition	→	Action
1. Key off.				
2. Disconnect Shift Control 30-way connector.				
3. Key on.				
4. Turn dimmer switch to max.				
5. Measure voltage between pin B3 and J3.		If voltage is within 0.6 volts of battery voltage		Replace Shift Control. Go to STEP V
		If voltage is outside of range		Repair OEM wire between pin B3 and the dash lights. Go to STEP V

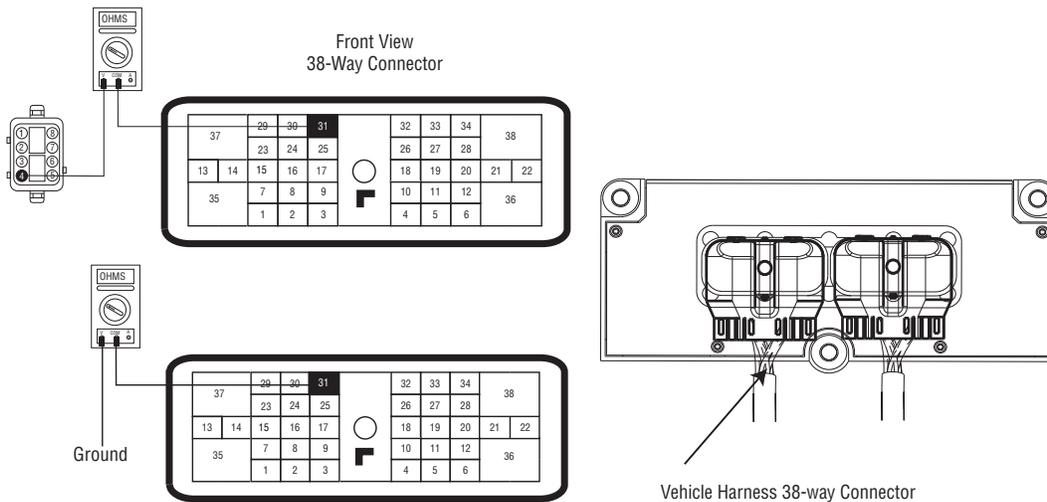
Procedure	→	Condition	→	Action
1. Key off.				
2. Disconnect Negative battery cable.				
3. Disconnect Vehicle Harness 38-way connector.				
4. Measure resistance between: <ul style="list-style-type: none"> • Vehicle Harness 38-way connector pin 31 and Vehicle Harness 8-way connector pin 4. • Vehicle Harness 38-way connector pin 31 and ground. 		If resistance between pins 31 and 4 is 0 to 0.3 ohms and if resistance between pin 31 and ground is OL		Go to STEP G
		If any of the above conditions are not met		Repair harness between Vehicle Harness 38-way connector pin 31 and Vehicle Harness 8-way connector pin 4. Go to STEP V

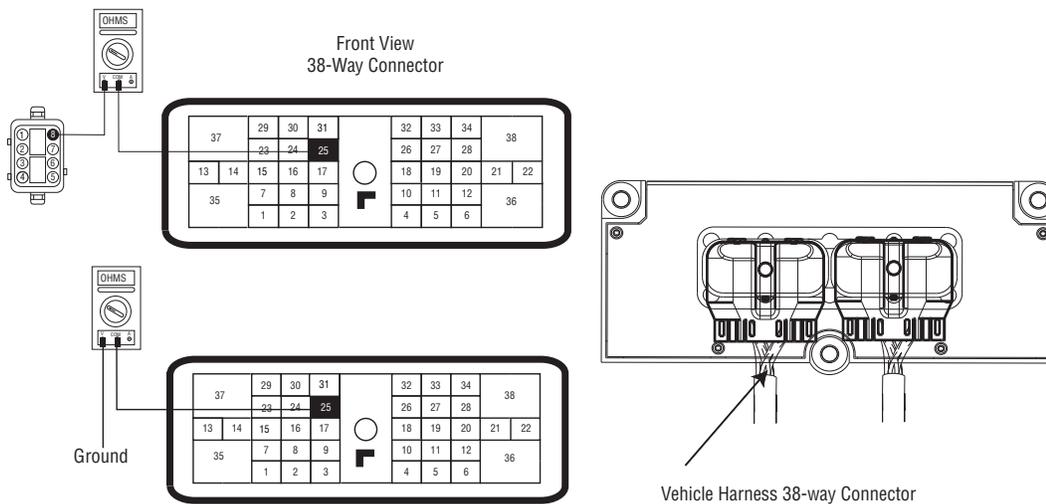
Procedure	→	Condition	→	Action
1. Key off.				
2. Measure resistance between:		If resistance between pins 25 and 3 is 0 to 0.3 ohms and if resistance between 25 and ground is OL		Perform Electrical Pre-test. If test passes replace transmission ECU. Go to STEP V
<ul style="list-style-type: none"> • Vehicle Harness 38-way connector pin 25 and Vehicle Harness 8-way connector pin 3 • Vehicle Harness 38-way connector pin 25 and ground

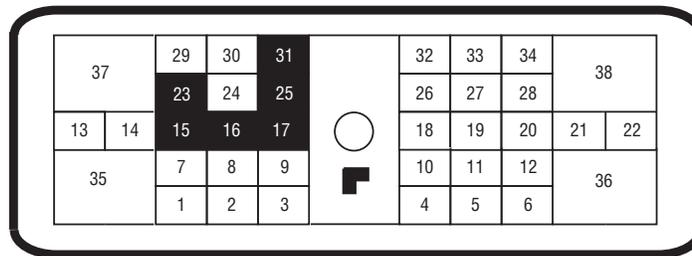
Front View
Transmission ECU Connector

FROM	TO	DESCRIPTION
J1-15	C2-1	Shift Control Input (Mode Auto)
J1-17	C2-2	Shift Control Input (Mode Common)
J1-25	C2-3	Shift Control Power Minus
J1-31	C2-4	Shift Control Power Plus
	C2-5	Dash Lights
J1-23	C2-6	Service Light Output
J1-16	C2-8	Shift Control Input (Mode Manual)
	C2-7	No Connection

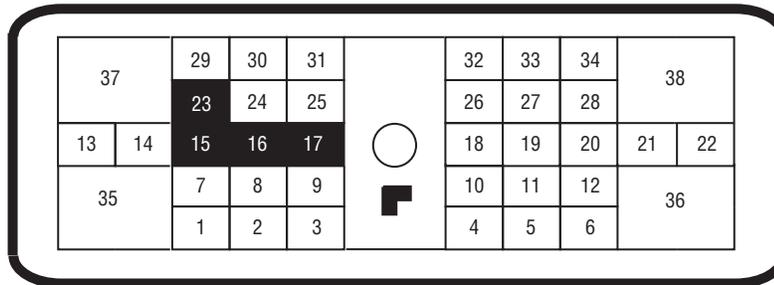
Front View
Transmission ECU Connector

FROM	TO	DESCRIPTION
J1-15	F2-B	Shift Control Input (Mode Auto)
J1-16	F2-A	Shift Control Input (Mode Manual)
J1-17	F2-C	Shift Control Input (Mode Common)
J1-23	F3-A	Service Lamp Output
F3-B		Ground

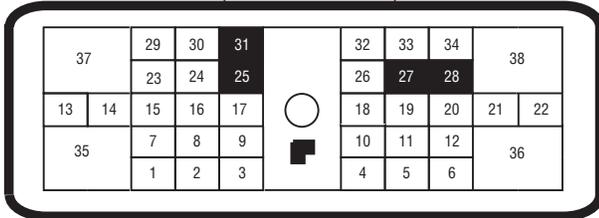
Front View
Transmission ECU Connector
(Vehicle Interface)

FROM	TO	DESCRIPTION
J1-27	C2-F2	EPL- LO
J1-28	C2-F1	EPL+ HI
J1-25	C2-J3	Ground 1
J1-31	C2-C1	Ignition
C2-B3		Dimmer Control Input

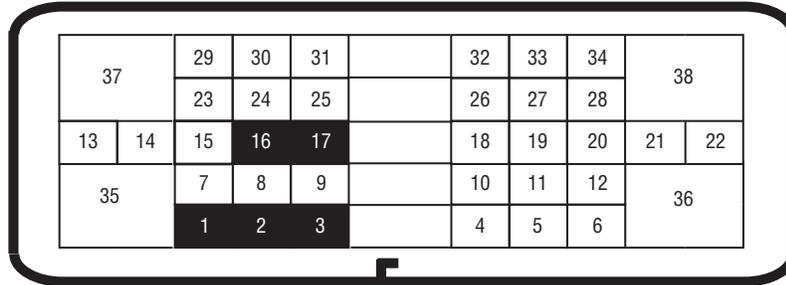
Front View
Transmission ECU Connector
(Vehicle Interface)

FROM	TO	DESCRIPTION
J1-16	Connector C2	Shift Control Input (Neutral Request Signal)
J1-17	Connector C2	Shift Control Input (Neutral Request Return)
OEM	Connector C2	Shift Control Power Minus (Ground)
OEM	Connector C2	Shift Control Power Plus (Ignition)
OEM	Connector C2	Shift Control Power Plus (Battery)
Connector C2	OEM	J1939 High
OEM	Connector C2	J1939 Low
OEM	Connector C2	J1939 Shield

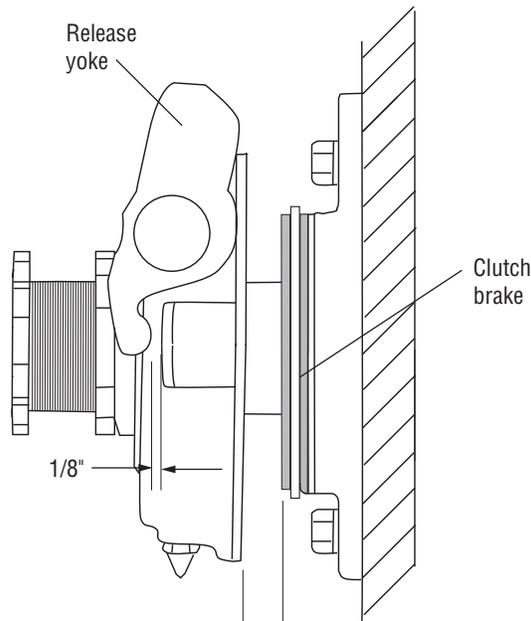
Insert a 0.010" feeler gauge between the release bearing and the clutch brake. have an assistant fully depress the clutch pedal. The 0.010" feeler gauge should be squeezed between the rear of the release bearing and the clutch brake. Have the assistant slowly let up the clutch pedal. The 0.010" feeler gauge should slide out when the clutch pedal is 1/2" to 1" above the cab floor or lower pedal stop.

If the 0.010" feeler gauge is not adequately squeezed to prevent removal, or can be removed with the pedal less than 1/2" or greater than 1", Check and adjust the clutch pedal height and travel per the chassis manufacturer's instructions. In addition, check the external clutch linkage for excessive wear or obstruction preventing complete travel.

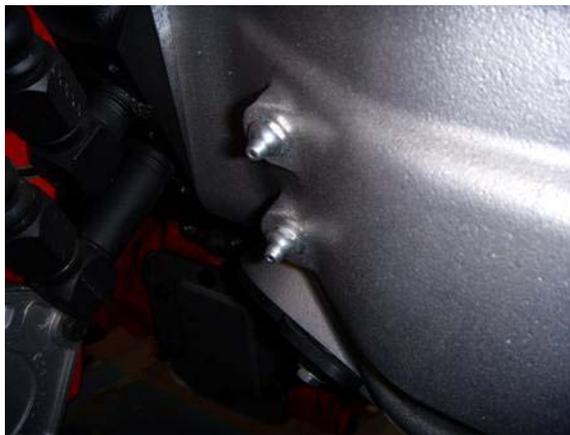
The heavy-duty ECA clutch housing has two grease fittings on the lower right side. The upper port is marked “CS” for the upper cross-shaft assembly, while the lower port is marked “RB” for the release bearing.

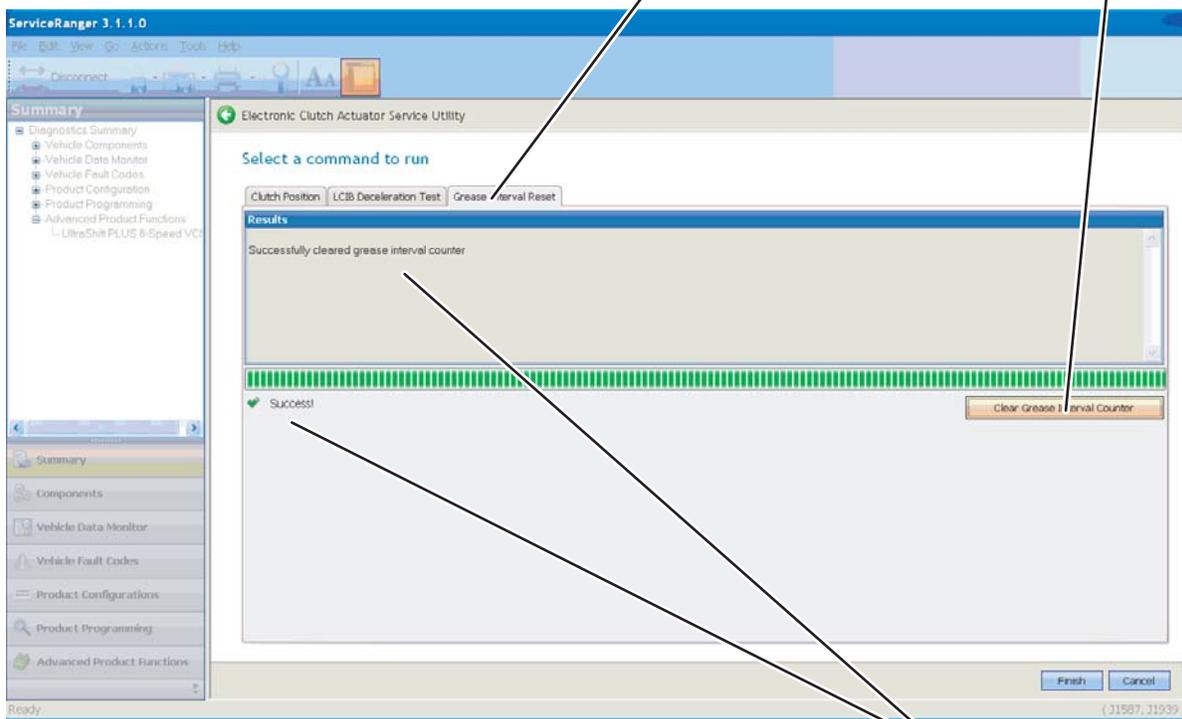
7 Choose Grease Interval Reset tab.

8 Click on Clear Grease Interval Counter.

9 Confirm Positive results.

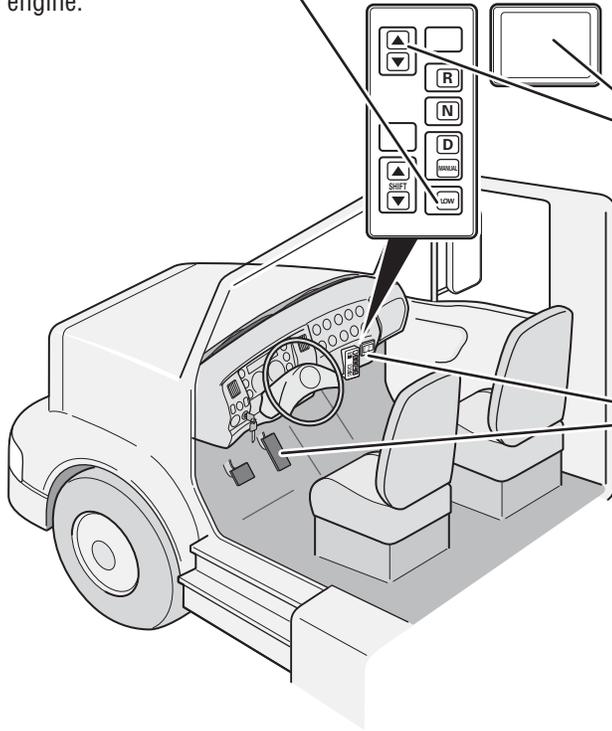
- 2** Select low mode on the shift device.

- 3** Press the manual up-shift button until the gear display shows "3".

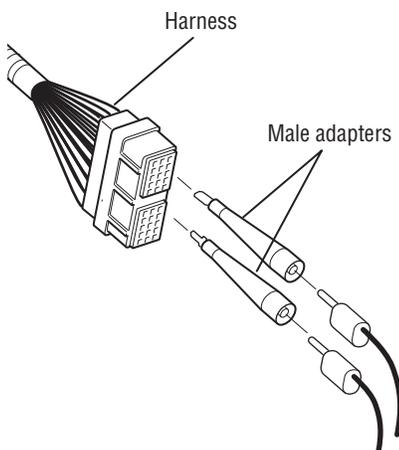
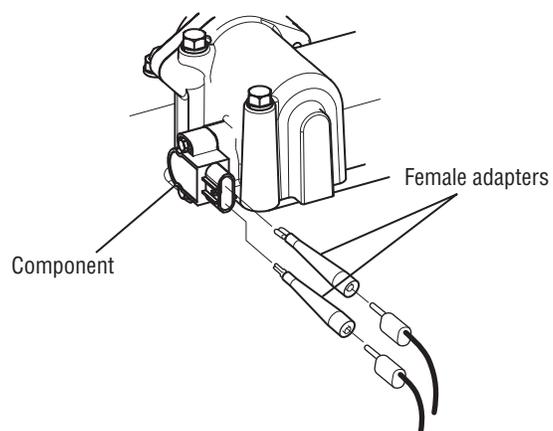
Adapter Pins

Use the male adapter to test the harness pins. Use the female adapter to test the component pins.
