# Eaton Gen III Automated Transmissions TRTS0930 EN-US

July 2014

UltraShift®  
AutoShift®

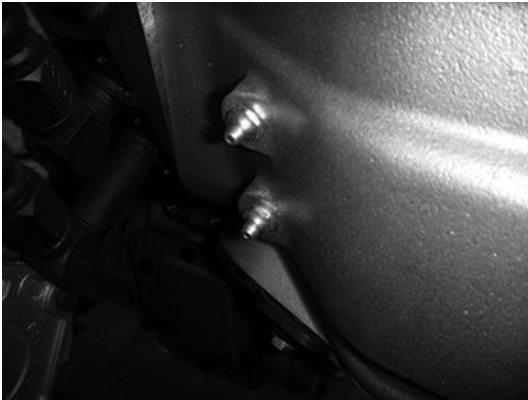
The heavy-duty ECA clutch housing has two grease fittings on the lower right side. The upper port is marked CS for the upper cross-shaft assembly, while the lower port is marked RB for the release bearing.
